# Physical Inspection of 1234 Sample Street

*c. 1907      Aprox 900 Sq Ft*

*April 16, 2008, 2:00 pm – 6:30 pm*

*Report Number: 080416P*

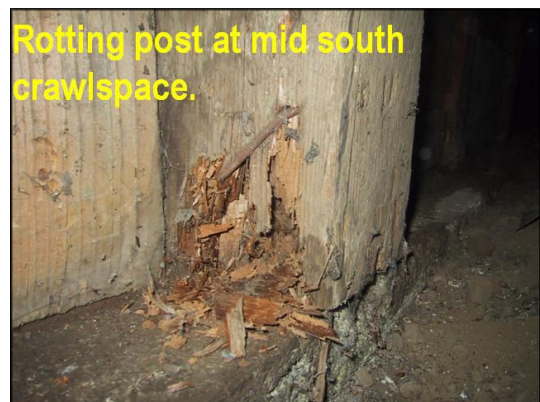
At the middle south side of the crawlspace, one of the perimeter support posts has begun to rot at its lower end.

2. **Replace the rotting post at the middle south crawlspace. Use pressure-treated wood for the replacement.**

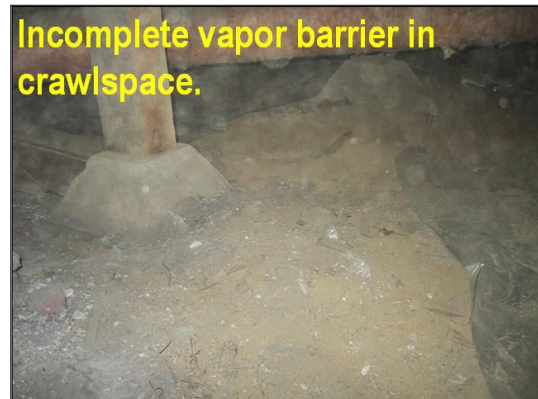
In the crawlspace, the vapor barrier is a sheet of plastic that covers the soil and prevents moisture from evaporating up into the crawlspace air. In this crawlspace, the vapor barrier is missing from several areas.

- 4. In the crawlspace, replace the missing sections of vapor barrier. Use 6 mil black poly and broadly overlap the seams to ensure that all of the soil is covered.**

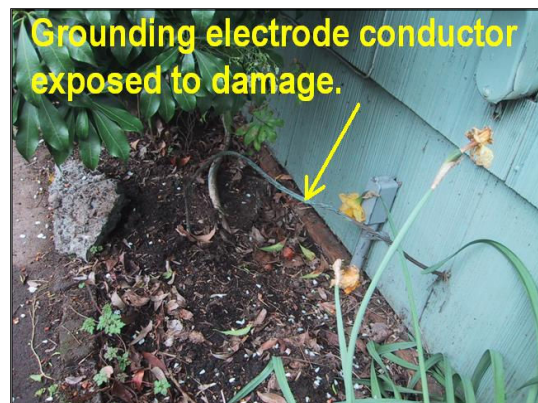
The grounding electrode conductor is the "main grounding wire" for the electrical service. It's connected to a ground rod at the north exterior and its purpose is to discharge surges to ground. This grounding electrode conductor is loose and floppy. It's strung across the air without any support or protection.

- 5. Between the house and the ground rod, properly secure the grounding electrode conductor so that it closely follows the contours of the house and the soil and is well secured and well protected against damage.**

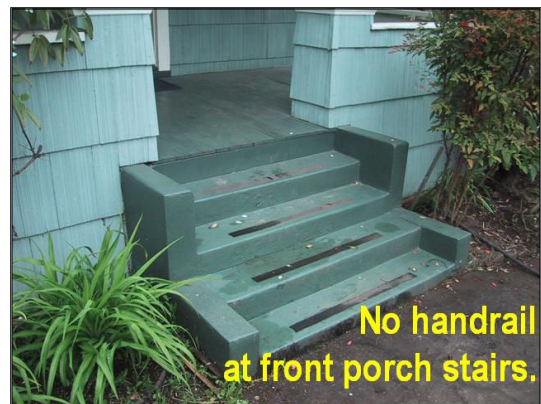
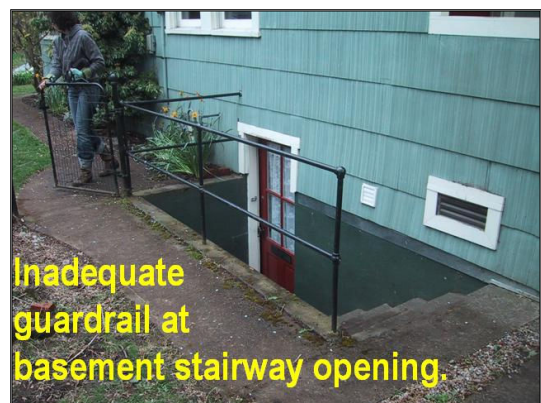
Around the exterior basement stairway, the guardrail is inadequate. Small kids can fall through and be injured.

- 24. Provide a proper guardrail around the exterior basement stairway opening.**

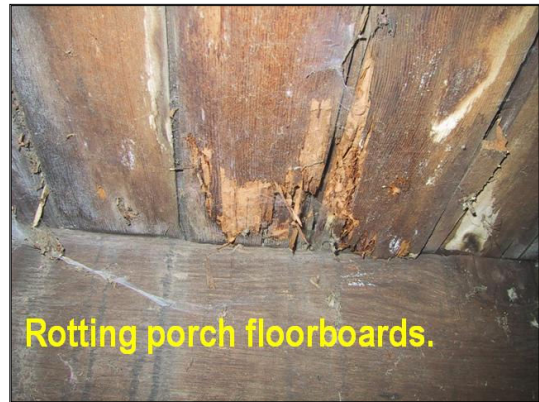
Some of the front porch's floorboards are rotting near the southeast corner of the front porch.

- 25. Replace the rotting floorboards near the southeast corner of the front porch.**

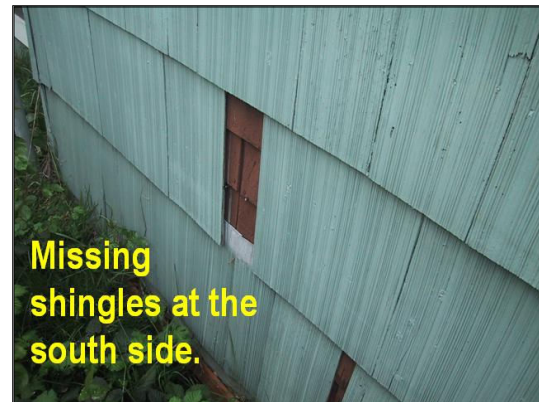
There are a couple of pieces of missing siding shingles at the south side of the house.

- 26. Replace the missing siding shingles at the south side.**

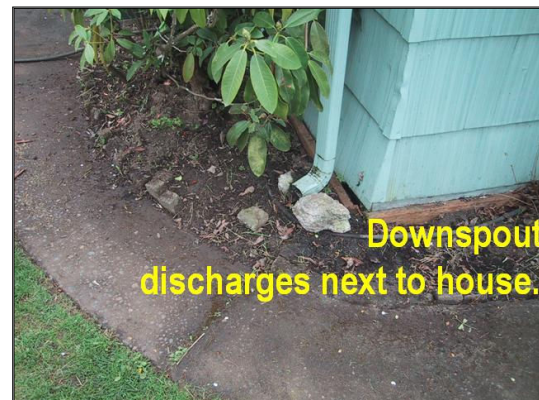
The downspouts discharge next to the house. Water from these downspouts can cause the foundation to settle and can enter the crawlspace and basement.

- 27. Install an underground drain system to capture downspout water and direct it well away from the house.**

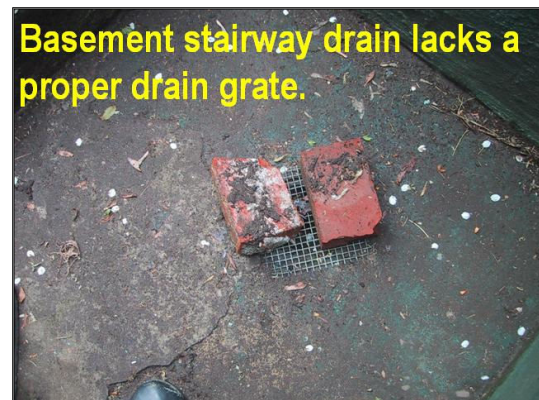
At the basement stairwell, the drain is missing its cap. Someone's improvised a cap by placing hardware cloth and bricks over the drain. This is a tripping hazard.

- 28. Install a proper heavy cast iron drain grate over the drain at the bottom of the basement stairway.**

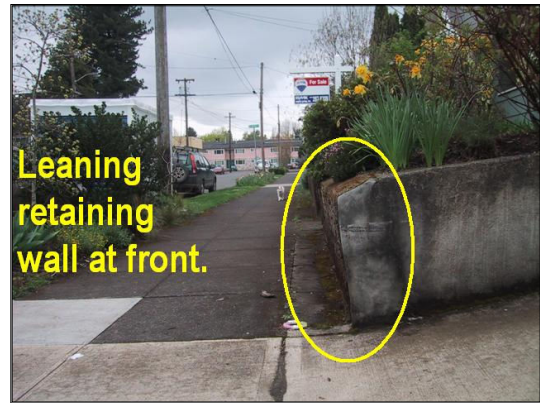
At the front sidewalk, the short concrete retaining wall is leaning. This wall is considered to have failed now. It will probably remain upright for many years yet, though it's impossible to predict exactly how long.
