Customer: **Paul Homebuyer**
Property Inspected: **3307 NW Frank St. , Portland, OR 97200**
Date of Inspection: **3-3-08**
Inspector: **Mark Lindgren** OCHI # 059 Wash. SPI # 67121 ASHI# 205164

ASSOCIATED MASTER INSPECTORS, LLC
P.O. BOX 230966
Tigard, OR 97281
OFFICE (503) 236-1812 FAX (503) 244-1297 HOME (503) 245-4784

Client / Inspection Information

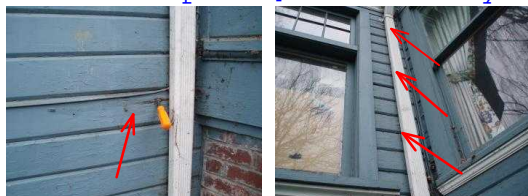
Siding Material: Shingle siding is weathered. Siding moisture damage--See the WDO WDI report. Cracked / split / missing siding / trim: in spots [no inventory made].

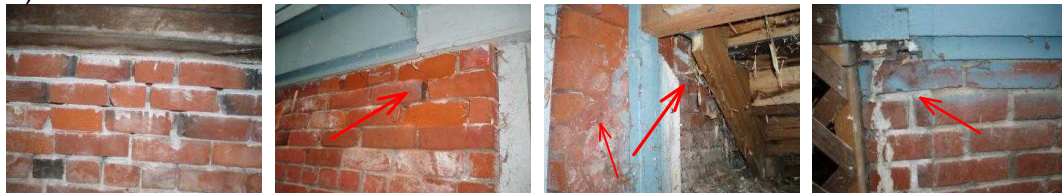
Foundation: Deterioration of the mortar and brick walls of the foundation system, we recommend further "evaluation" by a structural engineer or foundation specialist. Deterioration of the concrete walls at: Under the south and west porches and at the north west corner of the house

Foundation: (continued)

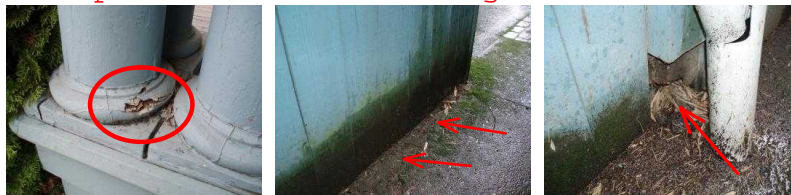
Porches: Porches appear to have settled, repair and/or replace as necessary. Front porch post bases needs repair. Rot in the west side post bases and skirting

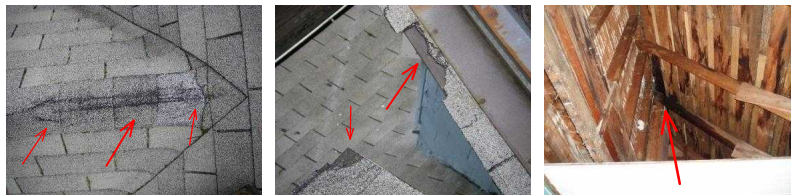
Roof Covering: Damaged ridge / hip--some cracking starting. Shingles missing / worn / split-cracked. The material has lost its flexibility. Spot repair needed through out the main body of the roof; contact a roofing contractor for necessary repairs. Active roof leak above the back deck

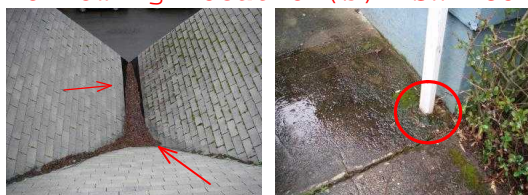
Drainage System: Debris buildup, Some overflowing gutters, Loose gutters/downspouts. The rain drain piping appears clogged in the following location(s): SW Corner

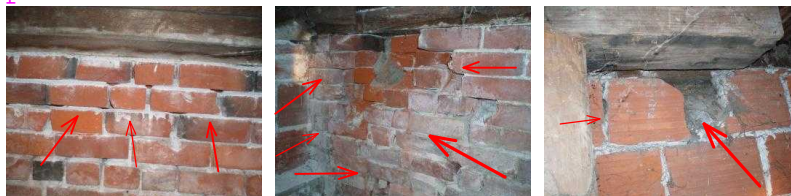
Foundation: The brick foundation was found in poor condition. The masonry block and brick foundations need repair. By design, brick foundations are weak by modern standards. They are not known for their ability to resist earthquakes. Concerned clients should consult with a foundation specialist or structural engineer who can do a complete analysis of the structure and advise you on how to proceed.

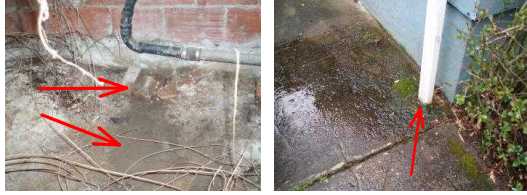
Water / Moisture Penetration: Prior moisture stains: in low areas. Seepage noted at some of the walls on the west side. The southwest rain drain is overflowing and needs repair. This is the probable source of the water coming into crawl area. This work needs to be done to prevent softening of the soil and failure of the foundation system.

Water / Moisture Penetration: (continued)

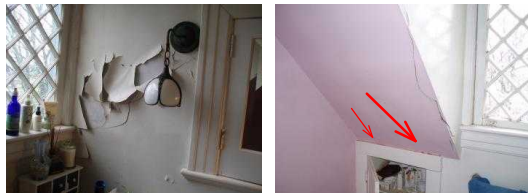
Walls / Ceiling: Moisture stains: dry at this time, Wall / ceiling cracks / holes

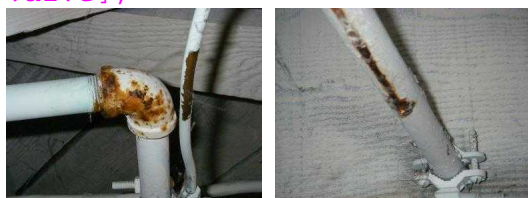
Water Supply & Distribution System (potable piping): Older galvanized water pipes will be a source of future maintenance and may need to be upgraded in the near future.

Leak(s) at: Pipes in the basement, The potable water system is very rusty and will need to be repaired / replaced in the near future. Saddle valve in use in the basement area [non standard valve],

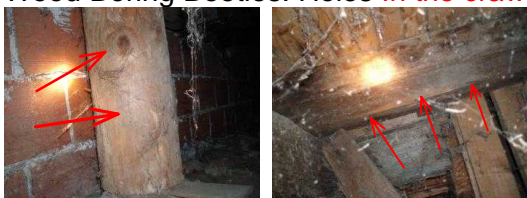
Wood Boring Beetles: Holes **In the crawl area** Anobiidae

Activity / need for treatment cannot be determined without further investigation. Reason: Off season
Check for activity during repairs No live insects found

Remove all infested wood and correct conducive conditions listed below.

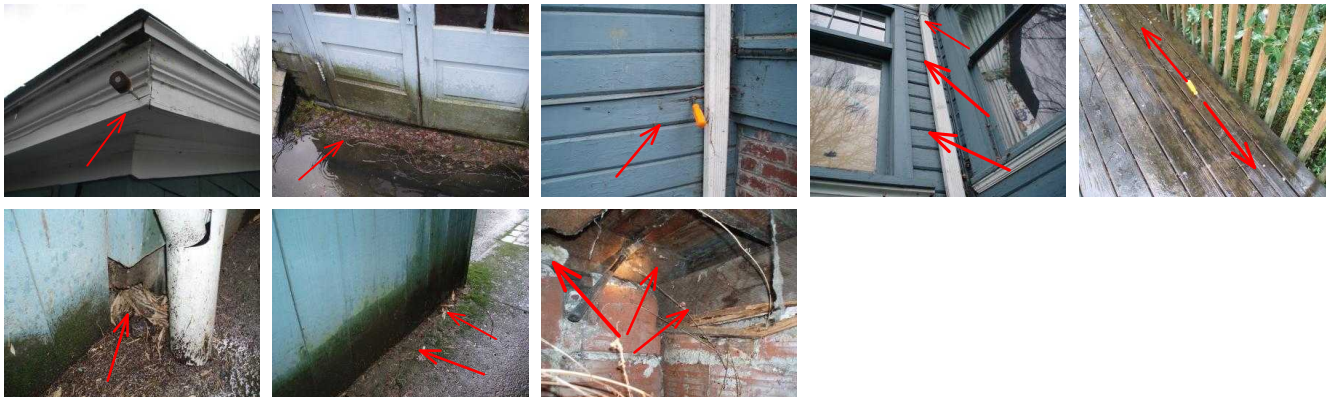
- Trim above the 3 floor door.
- 3rd floor door.
- Siding middle north side behind the downspouts
- North decking boards
- West deck posts and skirting
- Mud sills at the southwest corners under the 1/2 bath toilet as seen from the crawl area

Insect / Rot / Fungi damage---The contractor must, during the repairs, thoroughly investigate the following areas for concealed damage and repair any additional damage found and certify all repairs in writing at:

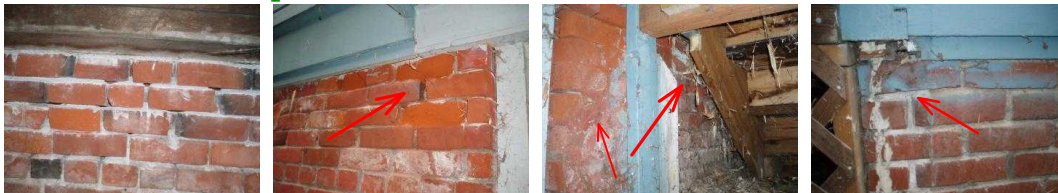
1. **Main House Exterior Surface Foundation:** Deterioration of the mortar and brick walls of the foundation system, we recommend further "evaluation" by a structural engineer or foundation specialist. Deterioration of the concrete walls at: Under the south and west porches and at the north west corner of the house

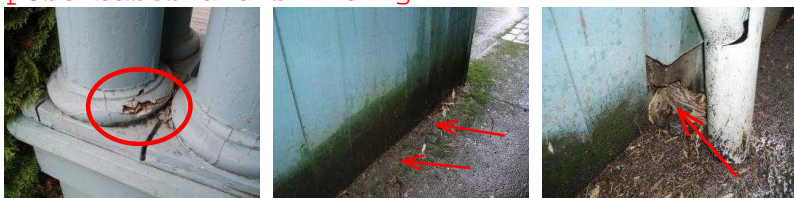
2. **Main House Exterior Surface Porches:** Porches appear to have settled, repair and/or replace as necessary. Front porch post bases needs repair. Rot in the west side post bases and skirting

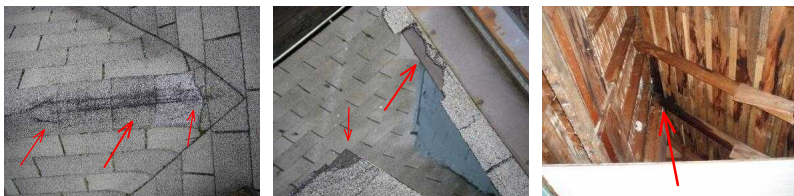
4. **Main Roof Roof Covering:** Damaged ridge / hip--some cracking starting. Shingles missing / worn / split-cracked. The material has lost its flexibility. Spot repair needed through out the main body of the roof; contact a roofing contractor for necessary repairs. Active roof leak above the back deck

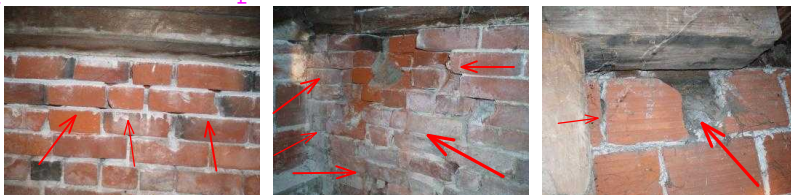
15. SW Crawl Space Foundation: The brick foundation was found in poor condition. The masonry block and brick foundations need repair. By design, brick foundations are weak by modern standards. They are not known for their ability to resist earthquakes. Concerned clients should consult with a foundation specialist or structural engineer who can do a complete analysis of the structure and advise you on how to proceed.

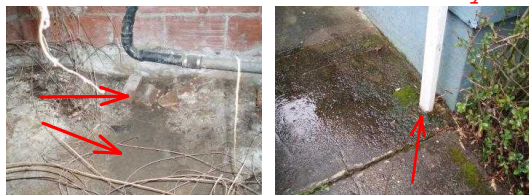
- 17. SW Crawl Space Conducive Conditions: Debris: remove wood / insulation / form boards / misc, see below
- 18. SW Crawl Space Ventilation: Minimal ventilation
- 19. SW Crawl Space Vapor Retarder: No vapor barrier present,
- 20. SW Crawl Space Water / Moisture Penetration: Prior moisture stains: in low areas. Seepage noted at some of the walls on the west side. The southwest rain drain is overflowing and needs repair. This is the probable source of the water coming into crawl area. This work needs to be done to prevent softening of the soil and failure of the foundation system.

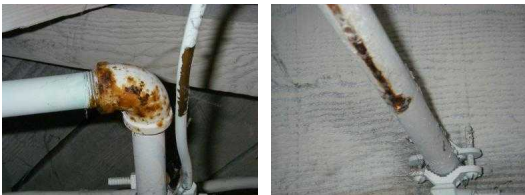
43. Water Supply & Distribution System (potable piping): **Older galvanized water pipes will be a source of future maintenance and may need to be upgraded in the near future. Leak(s) at: Pipes in the basement, The potable water system is very rusty and will need to be repaired / replaced in the near future. Saddle valve in use in the basement area [non standard valve],**
