# HOME INSPECTION REPORT

**PROPERTY ADDRESS:** 12345 Anystreet, Portland, OR 97202

<b>Date:</b> 10/1/2012	<b>Time:</b> 1:18 PM	<b>Report ID:</b> Sample-2012
<b>Property:</b> 12345 Anystreet Portland, OR 97202	<b>Customer:</b> John Doe Jane Doe	<b>Real Estate Professional:</b>

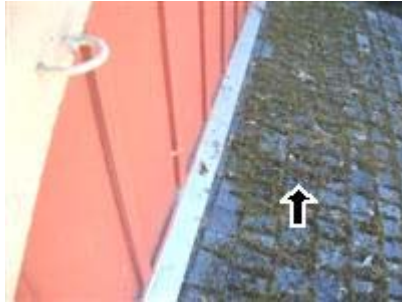
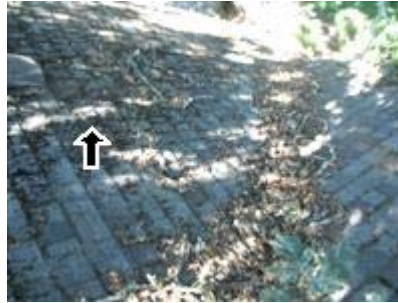
(1) Some areas of moss growth were observed on the roof ( examples Pictures 1-2 ) . Moss can lead to premature aging of the roof surface. Recommend that the roof is treated for moss.

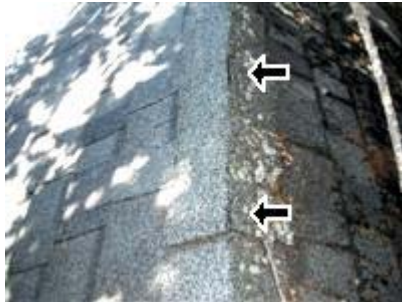
1.0 Picture 3

(3) Cracks / Gaps / Holes were observed at shingles on the ridges/peaks at several locations ( Picture 3 ) . Water could penetrate the roof surface at these locations. Recommend that a roofer repair or replace these shingles.

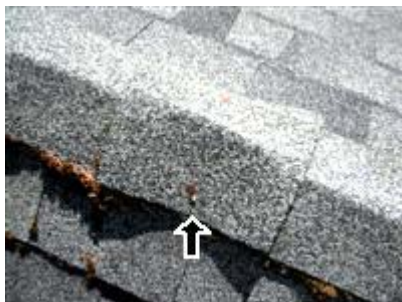
1.1 Picture 1

(1) A few exposed nail heads were observed on the roof surface ( Picture 1 ) . Water may penetrate the roof surface at these locations. These nail heads should be sealed with roof caulk as part of regular maintenance.

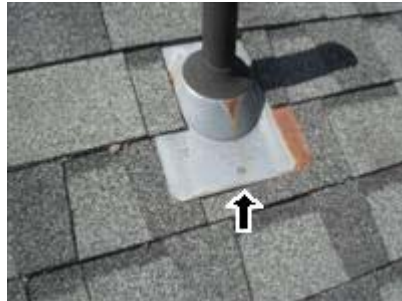
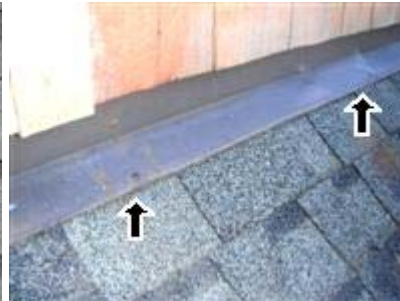
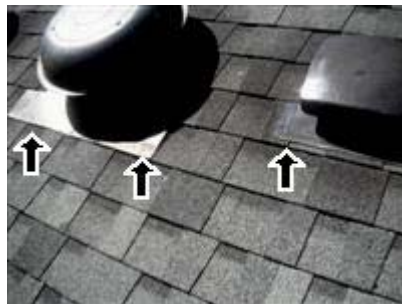
Several exposed nailheads were observed on the plumbing vent flashings, roof vents and the apron flashings ( examples Pictures 1-3 ). These nailheads may allow water to penetrate the roof surface. These nailheads should be sealed with caulk.

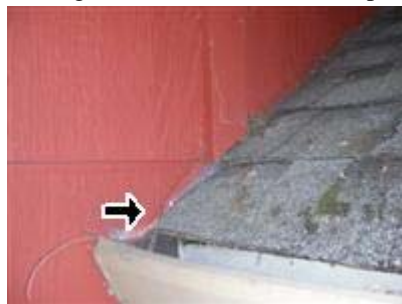
1.3 Picture 1

Kickout flashing was missing / improperly installed where the side walls meet the gutters ( Picture 1 ). Kickout flashing directs water into the gutter and minimizes water penetration in the wall. Kickout flashing needs to be installed or repaired.

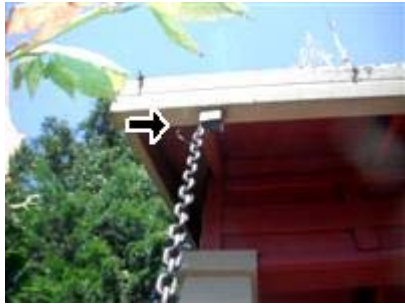
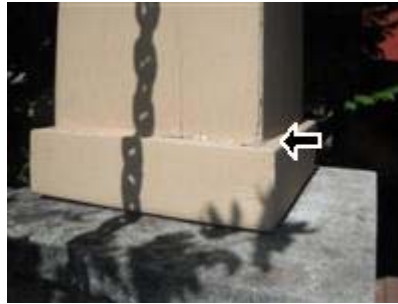
🏠 (1) The chain downspout at the SW corner does not appear to be properly fastened to the gutter ( Picture 1 ) . This may drip water on the home. Some weathered wood was noted on the post base ( Picture 2 ) . I recommend that a traditional downspout is installed at this location.

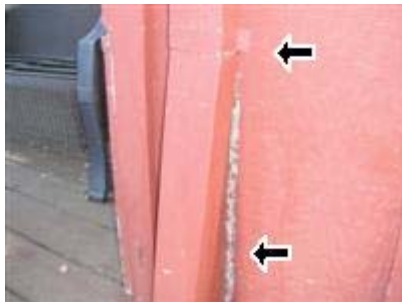
1.5 Picture 3

🏠 (3) Evidence of a leak at a downspout near the exterior master bedroom door ( Picture 3 ) . Repair the gutter and repaint/repair the siding.

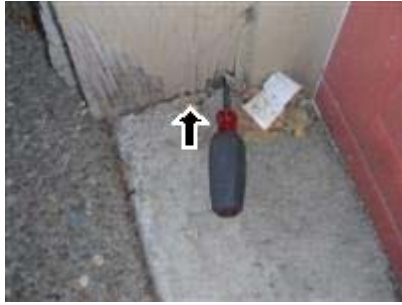
2.0 Picture 1

🏠 (1) The vertical trim is in contact with the concrete at the garage ( Picture 1 ). This can trap moisture at the trim and lead to rot. Some minor rot was observed in the garage. These trim pieces should be trimmed at least 1/2" above the concrete surface and all rotted wood removed or replaced.

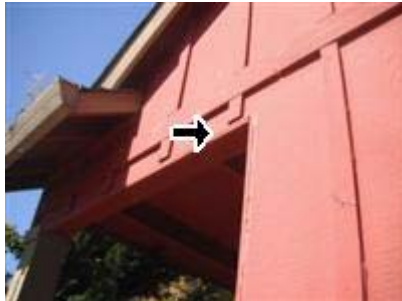
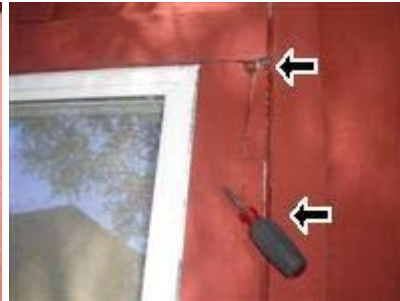
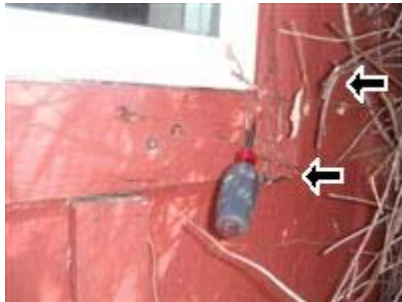
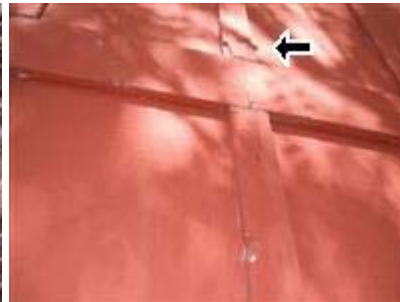
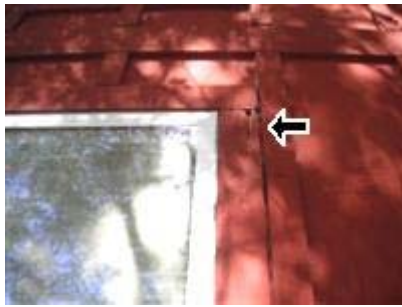
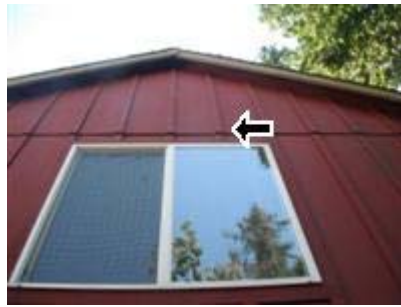
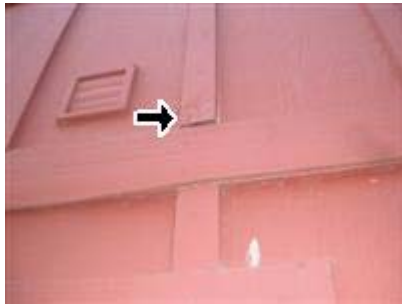
🏠 (2) Wood rot and evidence of water penetration in the was noted on the south wall of the home ( Pictures 2-6 ) and minor rot in trim noted on the north side ( Pictures 7-8 ). The siding is LP brand wood fiber siding that is prone to water damage. A siding contractor should evaluate and replace the siding and trim as needed around the entire home. At the very least, the south wall will need to be re-sided.

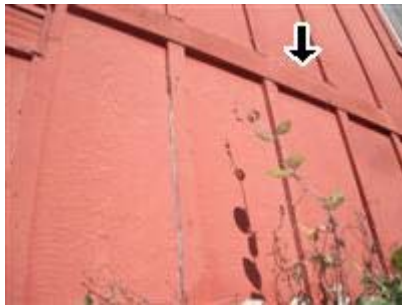
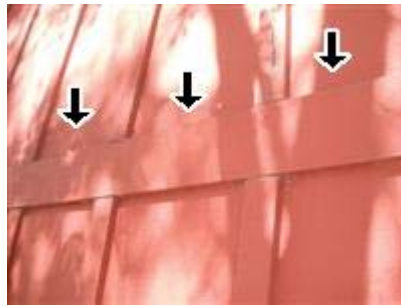
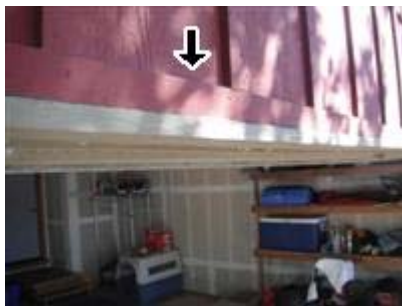
(2) The horizontal trim on the windows and siding was surface mounted to the siding ( Pictures 1-3 ) . This can trap moisture between the trim and siding and lead to rot ( as observed ) . At the garage door, the water is leading to peeling paint ( Picture 3 ) The top surface of the horizontal trim should be caulked annually to prevent water penetration. Alternatively, a contractor could properly install Z-metal flashing above all horizontal trim to eliminate the need for annual maintenance.

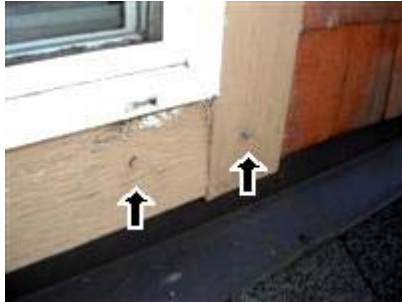
2.1 Picture 4

(3) Some loose nails in the window trim at the upper front window were noted ( Picture 4 ) . A contractor

should drive these back in and seal the trim and nails with caulk.

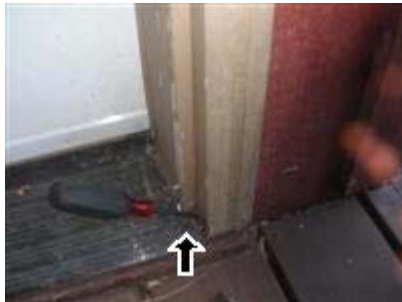
2.2 Picture 1

(1) Wood rot was observed on the door jamb and trim at the back entry to the master bedroom ( Picture 1 ). This rot will continue unless repaired. Repair and remove all rotted wood at this location.

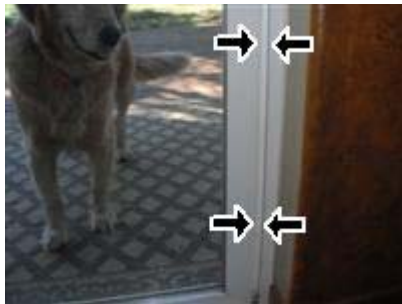
2.2 Picture 2

(2) The slider door is not parallel to the door jamb ( Picture 2 ) . This could use adjustment to close fully.

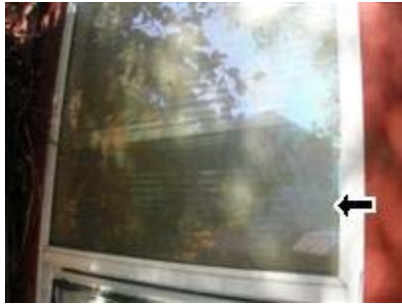
2.3 Picture 1

(2) The glazing between glass panes are failing at some windows (also known as a broken seal): dining room ( Picture 1 ) . This can reduce the energy efficiency of the window and clouds the view through the window. Replace the panes as desired.

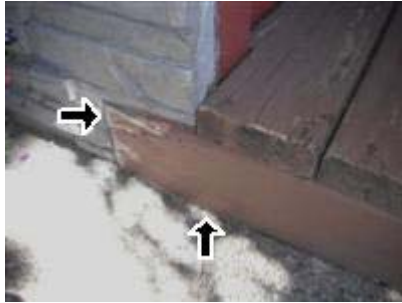
2.4 Picture 1

(2) Wood at the front step was in contact with the concrete and faux stone siding ( Picture 1 ) . No rot was observed, although the wood was weathered. Monitor this step for wood rot. Replace the wood with pressure treated wood once wood rot is noted.

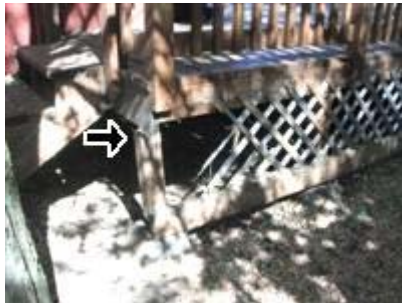
2.5 Picture 1

The rim joist at the SW corner of the deck is not well secured to the post and the post is only supporting the west rim joist( Picture 1 ) . This could fail. A contractor should repair this area so the post is plumb, well secured, and supporting both the west and south rim joists.

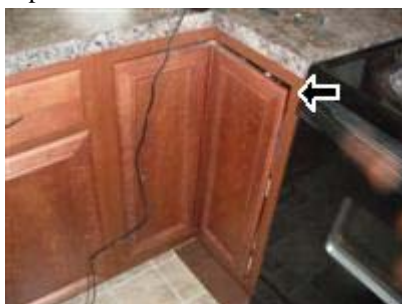
4.4 Picture 1

4.4 COUNTERTOPS AND CABINETS  
**Cabinetry:** Wood, Veneer, Melamine  
**Countertop:** Laminate  
**Comments:**  
 (1) The lazy Susan cabinet to the west of the stove was off its track and would not function properly. Repairs are needed.

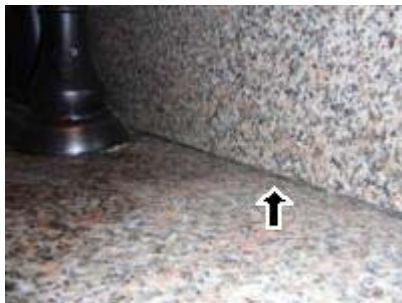
4.4 Picture 2

(3) Some gaps and cracks were observed between the countertop and backsplash in the entry bathroom (Picture 2). Water may penetrate the counter surface at these locations. Recommend that the caulk is stripped and re-caulked.

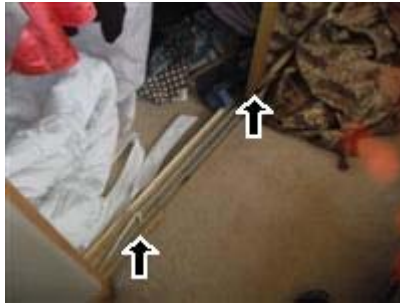
4.6 Picture 1

(1) The bypass closet door and track in the south bedroom needs adjustment/fastening ( Picture 1 ).

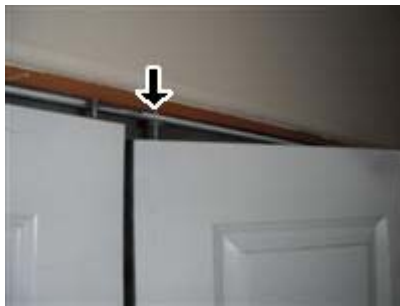
4.6 Picture 2

(2) A bifold closet door needs adjustment at the upper wheel for proper operation ( Picture 1 ).

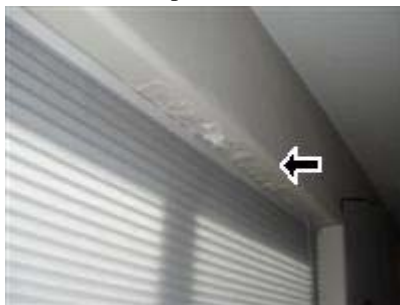
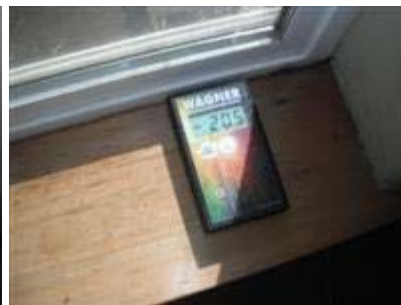
Water damage noted at the south window in the dining room ( Picture 1 ). A moisture meter indicated elevated moisture in the window sill ( Picture 2 ). A contractor should repair the damage. Repairs to the siding, trim, and window flashing should be made during re-siding the south wall of the home, and should eliminate water penetration.

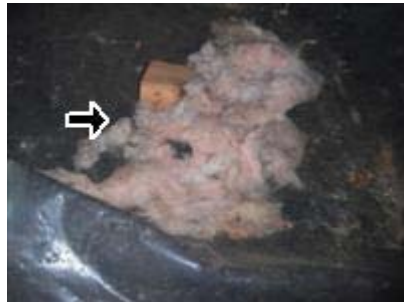
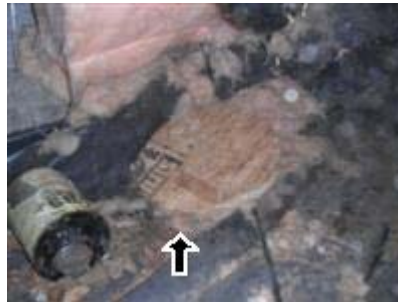
(1) Wood and insulation debris was observed in the crawlspace. This can trap moisture and attract wood destroying insects. Recommend removing all construction debris from the crawlspace.

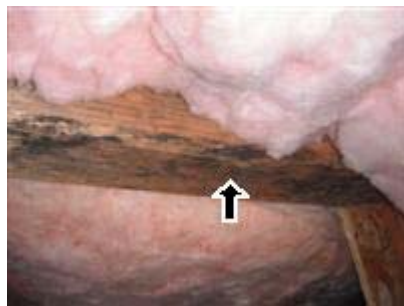
5.2 Picture 3

(3) Some mold/mildew growth noted on one beam in the crawlspace ( Picture 3 ). This appears to be limited to this piece of wood and may from characteristics of the wood at installation. Treat this wood for mold/mildew if desired.

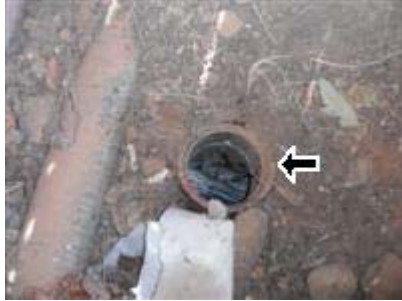
6.0 Picture 1

Missing cleanout cap under the front porch ( Picture 1 ) . A new cap is needed for health and safety.

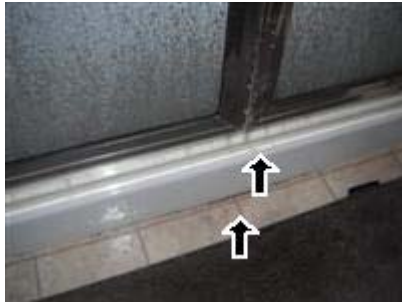
6.1 Picture 1

(2) The master shower door leaks some water when the shower is running ( Picture 1 ) . Minor mold/mildew noted in the caulk at the floor near the shower. The door may need repairs or adjustment.

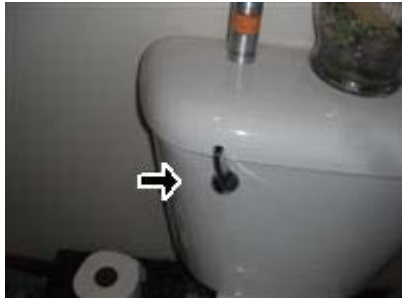
6.1 Picture 2

(3) The toilet in the entry hall bathroom has a loose handle ( Picture 2 ) . Repairs are needed for proper operation.

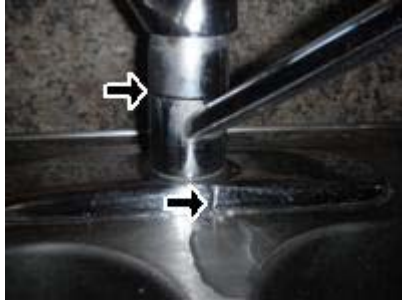
6.2 Picture 1

(2) A minor leak at the kitchen faucet handle was noted when the faucet was on ( Picture 1 ) . A plumber should repair.

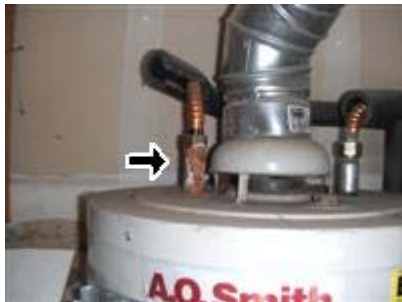
6.3 Picture 1

The water heater has corrosion on the galvanized nipples at the cold water inlet and hot water outlet ( Picture 1 ) . This is a maintenance issue and should be repaired to avoid leaks. A qualified licensed plumber should repair or correct as needed.

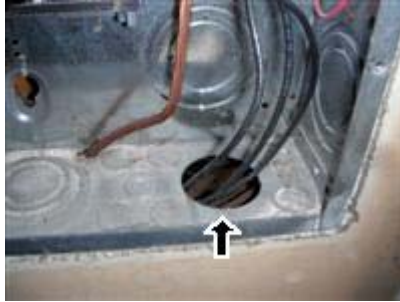
7.1 Picture 1

7.1 SERVICE AND GROUNDING EQUIPMENT, MAIN OVERCURRENT DEVICE, MAIN AND DISTRIBUTION PANELS  
**Panel capacity:** 200 AMP  
**Panel Type:** Circuit breakers  
**Electric Panel Manufacturer:** CUTLER HAMMER  
**Panel Voltage:** 240 Volt  
**Comments:**  
📌 Some wiring passes through the panel case without a bushing or strain relief clamp ( Picture 1 ) . This wiring is susceptible to damage. An electrician should install a bushing or clamp at this location.

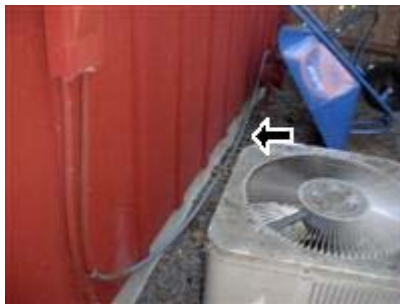
7.3 Picture 1

7.3 CONNECTED DEVICES AND FIXTURES  
**Comments:**  
The conduit to the AC line was not well supported along the outside of the home ( Picture 1 ) . The conduit should be fastened to the home.

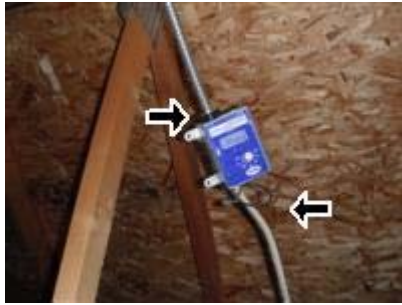
7.4 Picture 1

7.4 CONNECTED DEVICES AND FIXTURES  
**Comments:**  
📌 The thermostat for the attic power fan was not properly fastened to the framing, and the wiring does not have a bushing or clamp installed at the thermostat box ( Picture 1 ) . This is an electrical hazard. An electrician should evaluate and repair this installation.

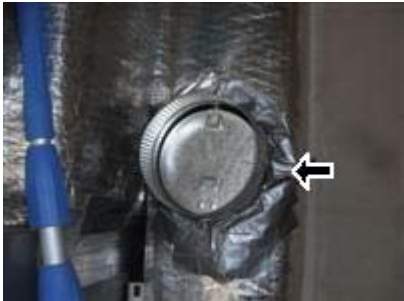
<input type="checkbox"/>	<input checked="" type="checkbox"/>	<input type="checkbox"/>	<input type="checkbox"/>	<input type="checkbox"/>	<p>8.3 DISTRIBUTION SYSTEMS (including fans, pumps, ducts and piping, with supports, insulation, air filters, registers, radiators, fan coil units and convectors)  <b>Ductwork:</b> Insulated, Flex Duct  <b>Filter Type:</b> Disposable  <b>Filter Size:</b> (Two filters), 12x20  <b>Comments:</b>                      (1) The disposable filters are clogged and dirty. The filters need to be replaced for good air quality and energy efficiency.                       (2) The return air grating is dirty. Clean for improved air quality.                       (3) A heat duct is open to the garage with a baffle to stop airflow. This baffle does not fit tight and air with always spill into the garage reducing the efficiency of the HVAC. This could also allow garage air to enter the home via the stack effect. A contractor should seal up this opening.</p>

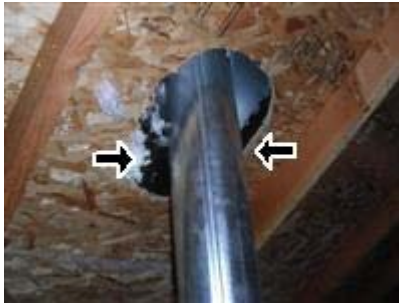
8.5 Picture 1

There was inadequate clearance between the B-vent flue from the furnace and combustible materials: roofing felt ( Picture 1 ) . B-vent requires at least 1" clearance. Recommend that a licensed HVAC contractor inspect and remedy this issue.</p>

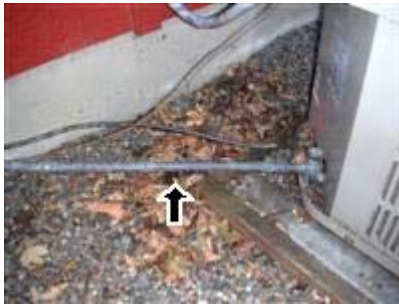
8.8 Picture 1

The foam sleeve on suction line is missing at the outside unit ( Picture 1 ) . Missing foam on suction line can cause energy loss and condensation. Repair or replace the foam sleeve where needed.

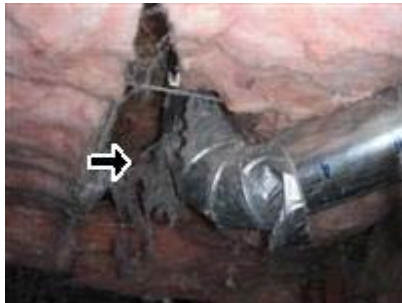
9.5 Picture 1

(1) The dryer duct vents into the crawlspace ( Picture 1 ). This delivers moisture and lint into the crawlspace that can lead to mold/mildew and lint build-up can be a fire hazard. A contractor need to repair or replace the duct so it vents outside the home.

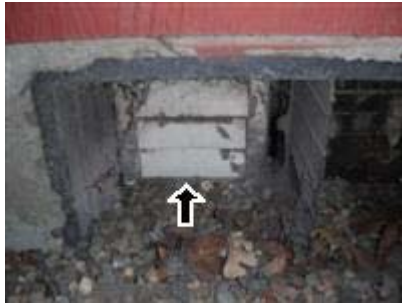
9.5 Picture 2

(2) Excess hair and lint debris was observed at the exterior dryer vent ( Picture 2 ). This can be a fire hazard and reduces the efficiency of the dryer. Recommend that the dryer vent line is cleaned out.

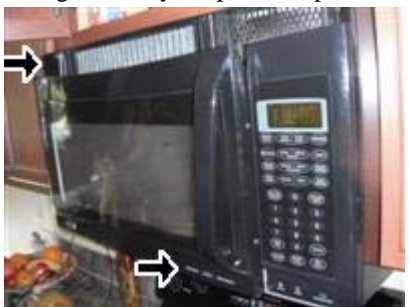
10.5 Picture 1

The microwave door handle and trim are broken ( Picture 1 ) . The unit still functioned, but further damage is likely. Repair or replace the appliance..
--------------------------	--------------------------	-------------------------------------	--------------------------	--------------------------	--------------------------------------------------------------------------------------------------------------------------------------------------------------------------------------------------------------------------------------------------------------------------------------------------------------------------------------------
