Physical Inspection of 123 Sample Street

Monday, September 13, 2010

Report Number: 100913P

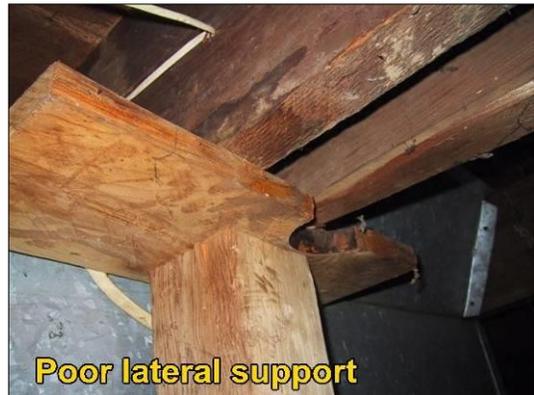
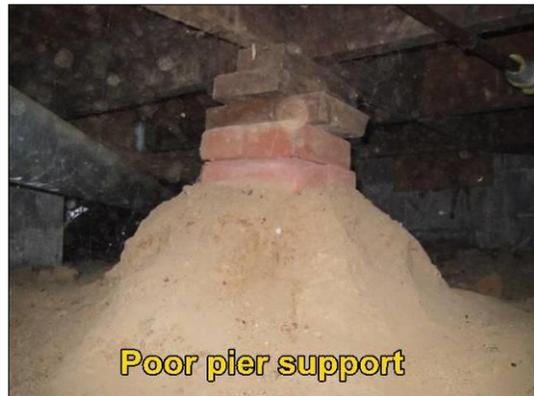
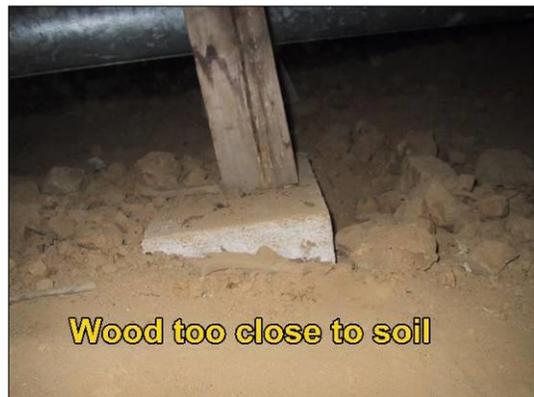
- In a few places, I see untreated wood posts that bear on the surface of concrete piers that are less than 8" above the surrounding grade. All untreated wood should be at least 8" above the surrounding soil to reduce the risk of rot & insect attack.

descend away from the piers at an angle steeper than 45 degrees. The posts should be correctly sized, without the need for shims. There should be a moisture break, such as an asphalt shingle, between the concrete and the post base. Any post that isn't 8" above grade should be made from pressure-treated wood. Each post should be firmly secured to its beam or girder with Simpson hardware or plywood gussets.

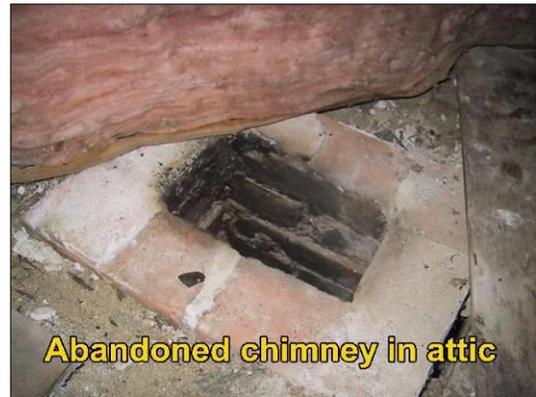
Abandoned Chimney

An abandoned brick chimney remains in place. It begins mid-story at the first floor, and ends at the floor of the attic. This chimney can never be used to vent anything; it's a useless remnant. The space where the chimney exists, however, might be useful to increase floor space in the first & second floor, or it might be used as a chase to bring a heating duct up to the 2nd floor rooms. Also consider that the chimney might collapse during an earthquake and injure someone.

- 2. Consider dismantling the abandoned chimney and using its chase for other purposes.**

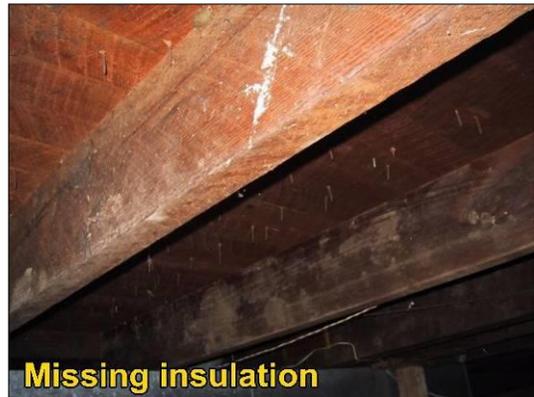
Missing Underfloor Insulation

There's no underfloor insulation at all. A persistent myth is that underfloor insulation isn't important because "heat rises." This is not true. Heat does not rise, it radiates equally in all directions. (Hot air rises.) Lots of heat will be lost to the crawlspace through this floor. If you install insulation under the floor, the house will use less energy and will be more comfortable. The modern standard for underfloor insulation is R-25.

4. **Consider hiring an insulation contractor to insulate the underside of the floor to at least R-25. Be sure to improve the insulation at the heating ducts and the plumbing pipes as well.**

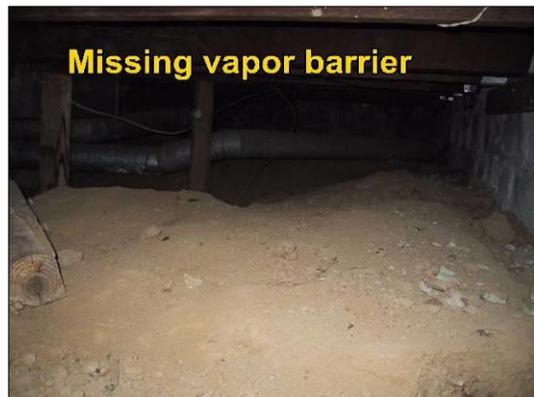
***Missing Vapor Barrier***

In a crawlspace, the purpose of a vapor barrier is to provide a vapor-impermeable covering on the soil. Moisture in the soil will condense on the underside of the vapor barrier and drip back into the soil instead of evaporating into the crawlspace air. Vapor barriers reduce indoor humidity, increase occupant comfort, and lessen the likelihood of insect infestation and decay in the structure. In this crawlspace, there's no vapor barrier covering most of the soil. I can see a small section of vapor barrier covering only the southeast corner.

5. **In the crawlspace, remove all debris, rake the soil clean, and install a 6-mil black polyethylene vapor barrier to completely cover the soil. Broadly overlap the seams and place bricks along the edges to hold the plastic in place.**

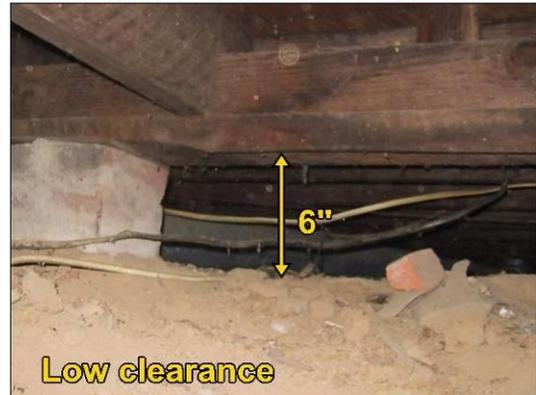
Limited Clearance in Places

Some portions of this crawlspace have very little clearance between the bottom of the joists and the surface of the soil below them. In some spots, as little as 6"-8" of clearance is present. This not only makes it difficult to inspect the crawlspace effectively, it makes it difficult to do pretty much anything down there, including running wiring, installing insulation, and performing maintenance. The small space also means that there's less air down there to act as a buffer to absorb and remove moisture.

- 6. Excavate the crawlspace to provide not less than 18" clearance between the bottom of the joists and the surface of the soil. In order to prevent undermining, don't excavate below a 45-degree line extending downward from the bottom edge of every footing.**

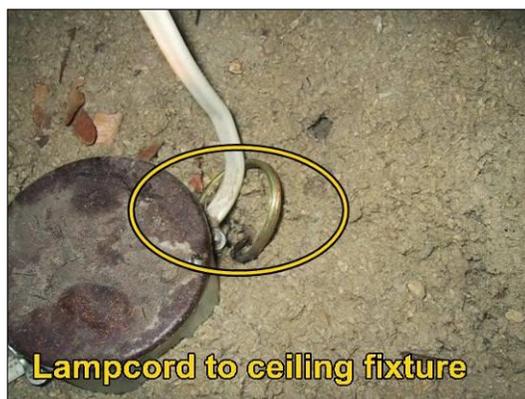
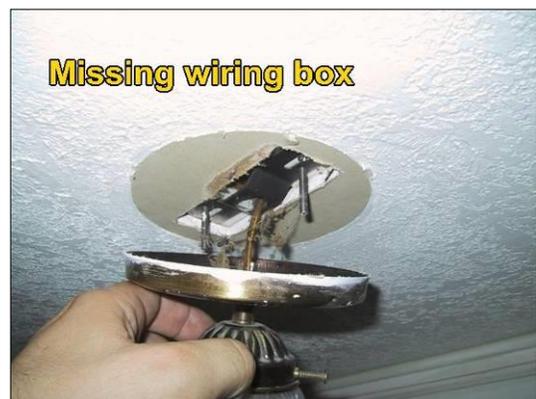
***Missing Ceiling Boxes Upstairs***

At least two of the upstairs light fixtures are mounted directly on the ceiling, without being attached to wiring boxes. Their fixture wires run through the ceiling and into the round boxes mounted in the attic.

10. Ask your electrician to ensure that all wall- and ceiling-mounted light fixtures have proper wiring boxes behind their canopies.

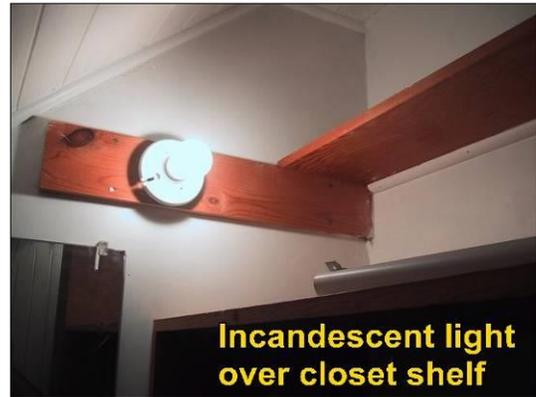
Incandescent Light in Closet

In the south bedroom closet, the incandescent light above the storage shelf can ignite combustible materials.

- 11. Remove the incandescent light fixture from the south bedroom closet. Replace it with a fluorescent fixture.**

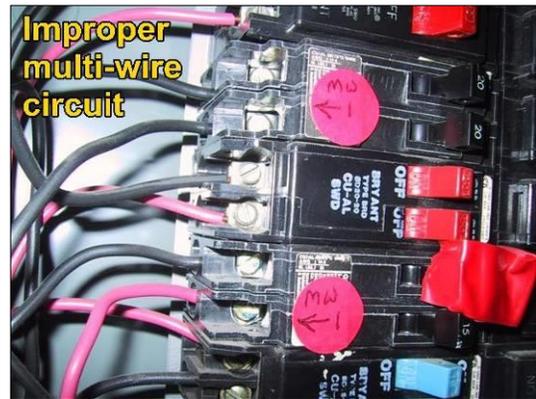
***Improper Multi-Wire Circuit***

A multi-wire circuit uses three wires to do the job normally done by four wires. It does this by using one of the wires as a shared neutral. If the circuit is installed properly, there's never too much electricity on this wire. If installed improperly, this shared neutral can become overloaded. There's an improperly installed multi-wire circuit in this service panel. It's at the middle left side of the panel. I marked it with a round red sticker with the letters MW written on it.

- 12. Have your electrician correct the improperly installed multi-wire circuit in the service panel. Ensure that each side of each multi-wire circuit originates on different legs of the system.**

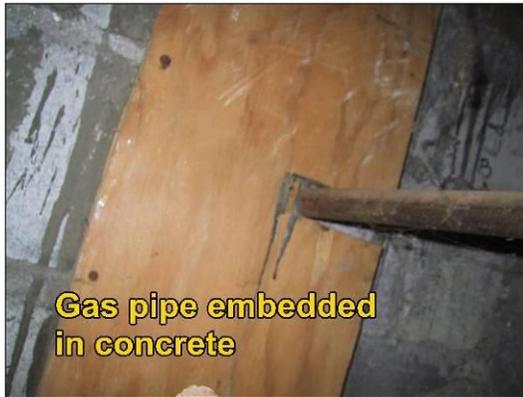
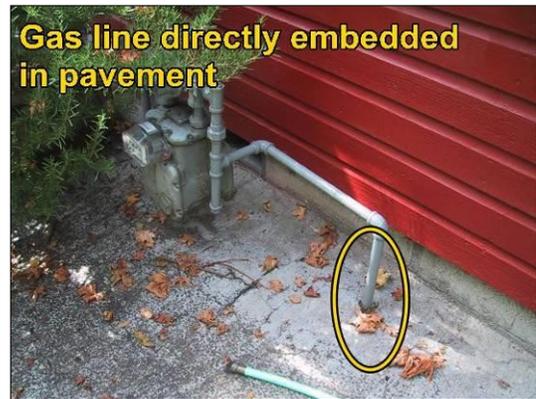
Missing Sleeve at Gas Main

The main gas pipe is directly through the pavement at the east exterior and then directly through the grouted concrete block foundation wall. This pipe should have been run through a sleeve to lessen the risk of damage if the soil, pavement, or foundation were to settle. Also, the sleeve is supposed to be vented to the exterior so that, if the pipe breaks or develops a leak, the gas will be directed outdoors, where it can dissipate, rather than indoors, where it can concentrate.

- 20. Hire a gas pipefitter to provide proper sleeving of the gas pipe where it passes through the paved surface and through the foundation wall.**

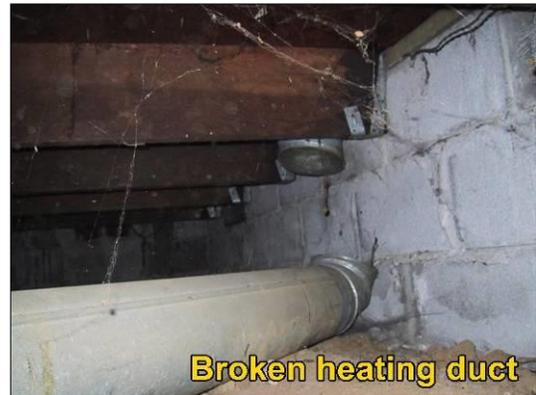
***Disconnected Duct***

At the west end of the crawlspace, there's a duct that's disconnected at its elbow. This duct currently pours conditioned air into the crawlspace. This is very inefficient and a big waste of energy & money.

- 21. Replace the broken elbow at the crawlspace's west heating duct.**

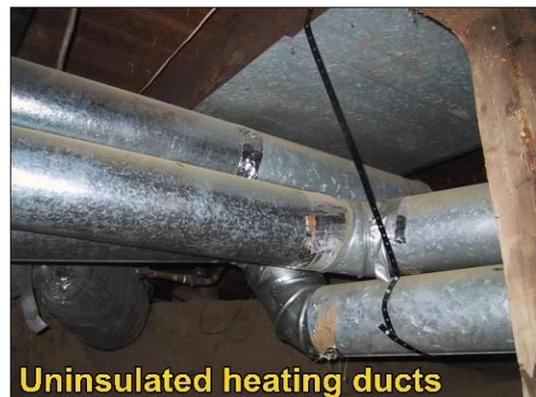
***Uninsulated Ducts***

The heating ducts aren't insulated and their joints aren't sealed. This makes the heating system extremely inefficient; lots of heat is lost to the crawlspace.

- 22. Seal & insulate the heating ducts to save money and make the heating system much more efficient.**

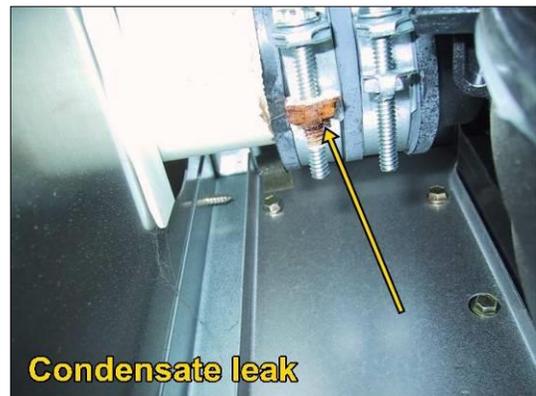
Leaking Condensate

Condensate water is leaking out of the furnace's PVC exhaust vent. This water is slightly acidic and is causing corrosion at the furnace cabinet, the floor of the blower compartment. Left unchecked, this leak will damage the furnace.

- 25. Have an HVAC contractor properly repair the furnace's leaking PVC exhaust vent.**

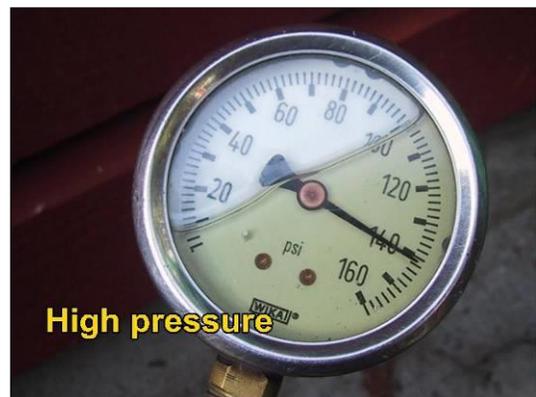
The water pressure at the hose bib is 140 psi. This is very high. Water in the distribution pipes isn't supposed to exceed 80 psi. High water pressure can damage automatic valves and stress plumbing connections. Note that the water heater's temperature & pressure relief valve seems to have been replaced once already. This valve is set to open at 150 psi. The old one might have leaked.

27. **Install a pressure reducing valve to provide water pressure at or below 80 psi. If the pressure reducing valve doesn't have a bypass valve, then be sure to install an expansion tank at the water heater.**

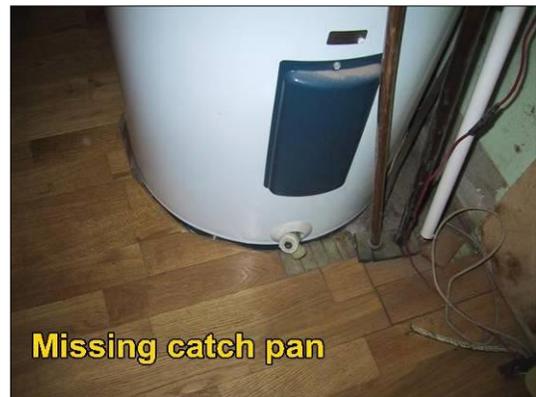
***Missing Catch Pan at Water Heater***

When the water heater leaks, it will damage the nearby wooden floor.

- 30. Install a catch pan under the water heater and plumb its drain to a conspicuous location outdoors.**

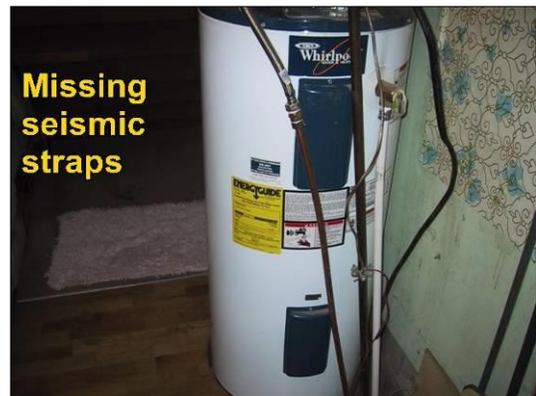
***Missing Seismic Support at Water Heater***

The water heater isn't strapped in place. During an earthquake, it might move about and damage its water connections or its gas connections.

- 31. Install proper seismic support at the water heater.**

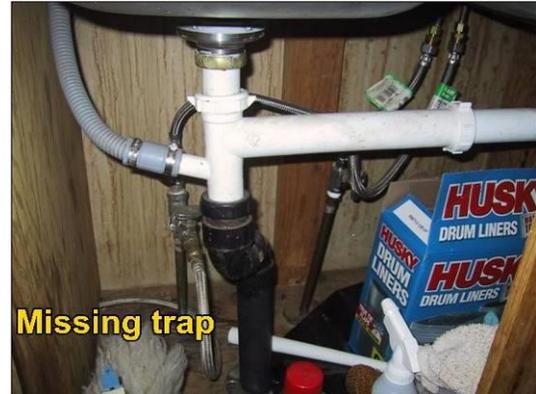
Improper Trap in Kitchen

At the kitchen sink's drainpipe, the trap is located below the floor, in the crawlspace. This trap should be located in the cabinet below the sink.

- 32. Have a plumber replumb the kitchen sink's drain line so that the trap is in the cabinet below the sink.**

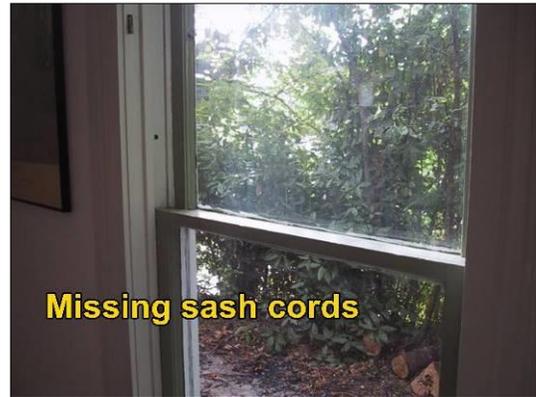
Damaged Counterbalances

At the east bedroom window, the counterbalance springs are missing. The window won't operate properly unless these springs are installed correctly. Never prop open a window that has non-working counterbalance springs. It can fall unexpectedly and severely injure someone's hands.

- 37. Replace the counterbalance assemblies at the east bedroom's window. NEVER PROP OPEN THIS WINDOW.**

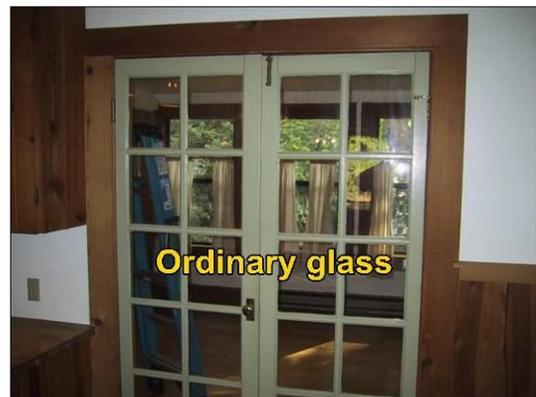
***Ordinary Glass at Doors***

Three of the first floor doors are glazed with panels of ordinary glass. Doors are considered hazardous locations for glass. If the glass were to break, it would break into large, sharp shards that could severely injure someone.

- 39. Reglaze the first floor glass doors with safety glass to reduce the risk of injuries.**

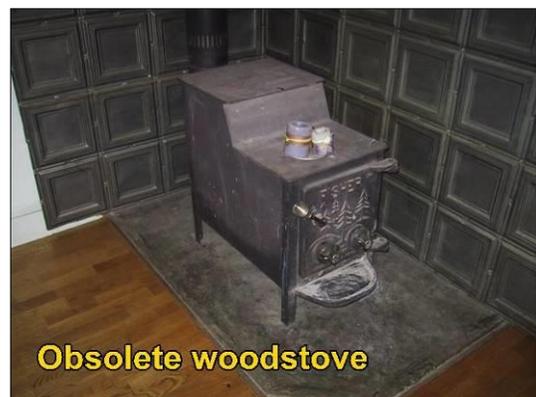
The woodstove is obsolete. It lacks EPA and DEQ listings and is very inefficient compared to modern woodstoves. As of August 1, 2010, the wood stove has to be removed and destroyed. See <http://www.deq.state.or.us/aq/burning/woodstoves/> for more information.

- 40. Remove the existing wood stove.**

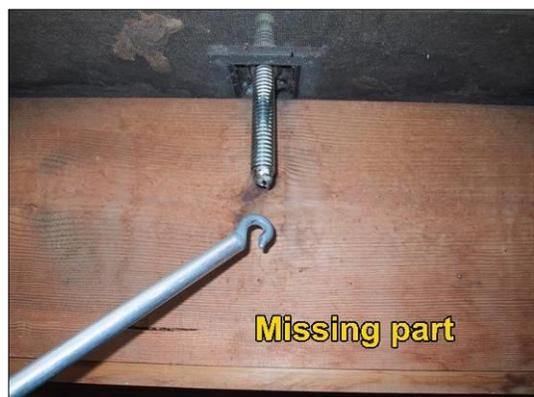
***Broken Skylight Crank***

At the east bedroom, the east skylight's opening crank is missing its handle linkage.

- 47. Replace the opening crank assembly at the east bedroom's east skylight.**

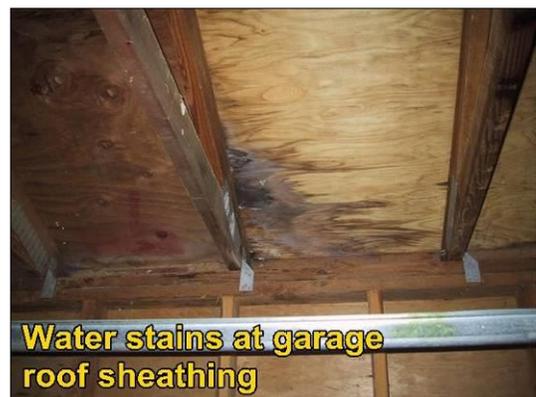
FYI – Past Leaks

Note staining from past roof leaks at the garage roof sheathing. I can't determine with certainty that the roof no longer leaks, but it looks as if these stains are the result of leaks from a previous layer of roof shingles. Watch the garage roof during a strong rain & wind storm to confirm that it doesn't leak.
