# INSPECTION REPORT

**PROPERTY ADDRESS:** 835 SE Klickitat Ave, Portland, OR 97213

**INSPECTION REPORT ID:** 2441

**DATE AND TIME OF INSPECTION:** 10/17/2017, 08:45 AM - 02:00 PM

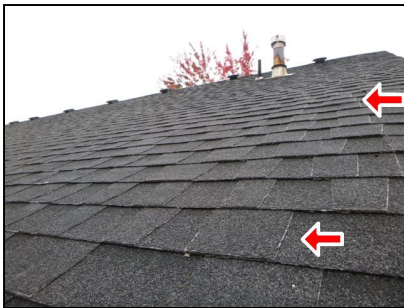
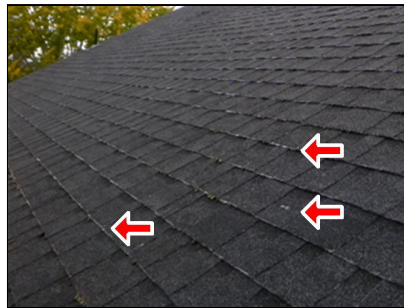
**!** The roof is nearing the end of its life. There are areas of widespread granule loose and exposed fiberglass fibers (examples Pictures 1-2). The ridge shingles are cracked indicating roof age and brittle conditions of the shingles. The roof was installed with roof staples which is an older installation method. Some staples are backing out which is lifting some shingles. With some maintenance and repair by a roofer, the roof may provide a few more years of service. You should plan to replace the roof surface within this time frame.

The roof is nearing the end of its life. There are areas of widespread granule loose and exposed fiberglass fibers (examples Pictures 1-2). The ridge shingles are cracked indicating roof age and brittle conditions of the shingles. The roof was installed with roof staples which is an older installation method. Some staples are backing out which is lifting some shingles. With some maintenance and repair by a roofer, the roof may provide a few more years of service. You should plan to replace the roof surface within this time frame.

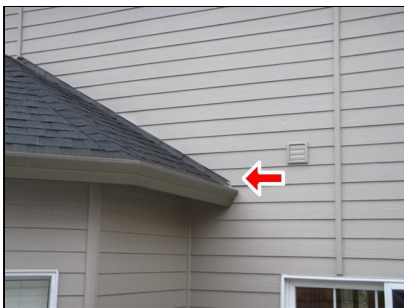
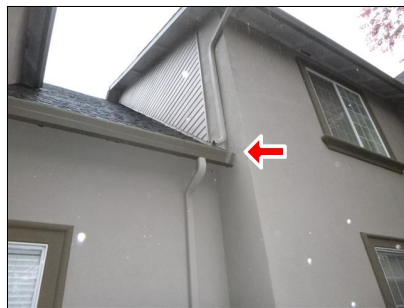
(1) Kickout flashings are missing / improperly installed where the gutters meet the side walls of the home at several locations (examples Pictures 1-2). Kickout flashing directs water into the gutter and minimizes water penetration in the wall. Kickout flashings need to be installed on the house. This should be done when the roof is replaced in the foreseeable future.

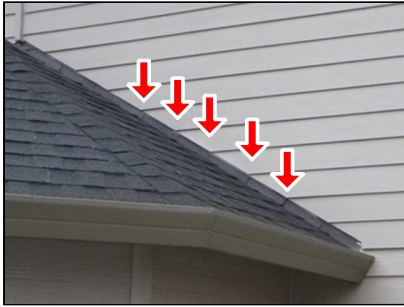
1.1 (Picture 3)

(2) The step flashings used where the roof meets the back sidewall of the home do not properly align with the courses of the roofing (Picture 3). This is a installation error. Given the age of the roof, have the flashings replaced when the roof is replaced in the foreseeable future.

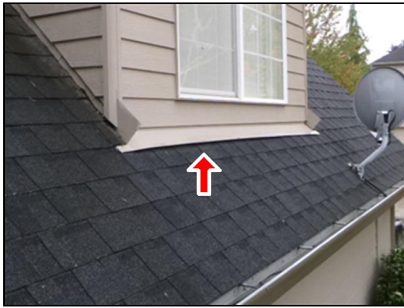
1.1 (Picture 4)

(3) Some of the apron flashings at dormers are loose/coming up (example Picture 4). This may allow wind to further damage the flashing. Have the flashings replaced/secured when the roof is replaced.

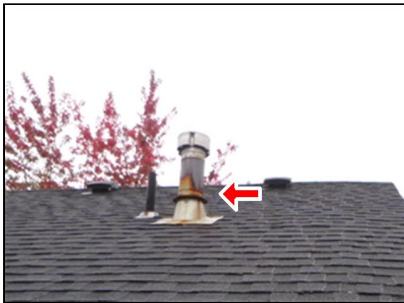
1.2 (Picture 1)

- ❗ (1) Gaps/cracks were observed on some of the plumbing vent boot flanges. This can allow water to penetrate the roof surface. Have a roofer replace/repair the plumbing vent flanges at this time.
- (2) The metal flue has excessive corrosion (Picture 1). Have this metal flue replaced when the roof is replaced.

(1) Gaps/cracks were observed on some of the plumbing vent boot flanges. This can allow water to penetrate the roof surface. Have a roofer replace/repair the plumbing vent flanges at this time.

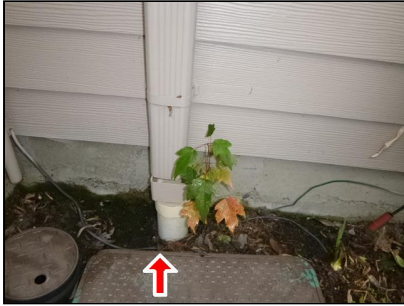
1.3 (Picture 1)

- ❗ (2) A downspout at the back of the home is misaligned with the rain drain (Picture 1). This can spill water at the home and lead to erosion/settling and water penetration in the crawlspace. Have the downspout repositioned/repared.

(2) A downspout at the back of the home is misaligned with the rain drain (Picture 1). This can spill water at the home and lead to erosion/settling and water penetration in the crawlspace. Have the downspout repositioned/ repaired.

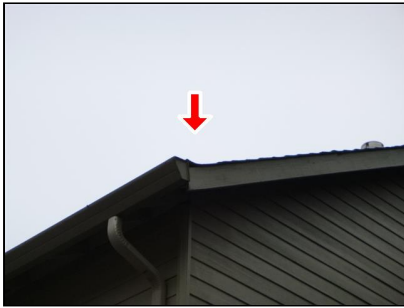
1.3 (Picture 2)

- (3) The gutters may be installed a little high in some areas which can lift the outside edge of the roof and lead to pooling and water penetration (example Picture 2). When the roof is replaced, have the elevation of the gutters adjusted as needed.

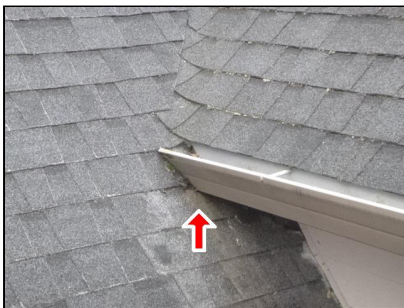
1.3 (Picture 3)

- (4) The gutters "return to the roof" in some locations and terminate too close to the roof surface (example Picture 3). This is trapping debris and reducing gutter flow. The gutters can also damage the roof surface if they are in contact with the roof. Have the gutters trimmed back at these locations.

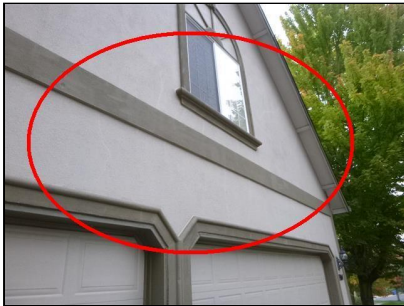
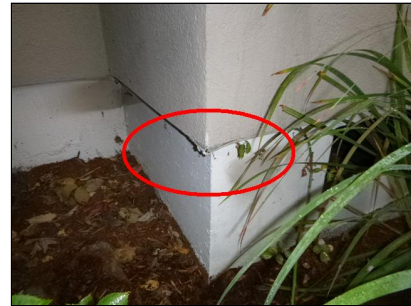
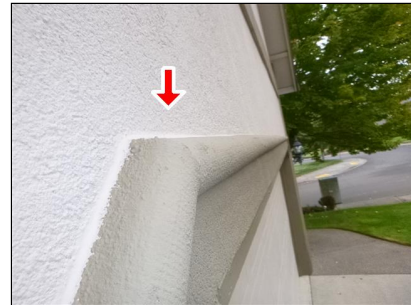
- ❗ (1) The siding on the front and side of the home is a type of single coat stucco with foam-backed trim details. There are some repaired cracks on various surfaces of the siding (Pictures 1-2). There are a few minor damaged areas along the bottom edge (Picture 3). Some of the trim details have minor impact damage and some may be delaminating a bit (examples Pictures 4-5). The details to prevent water penetration at the horizontal trims are not obvious (example Picture 6). Because this is a fairly unique siding installation for our area, and because water penetration can be problematic for all types of stucco, I recommend further evaluation of this siding installation by a building envelop specialist.

(1) The siding on the front and side of the home is a type of single coat stucco with foam-backed trim details. There are some repaired cracks on various surfaces of the siding (Pictures 1-2). There are a few minor damaged areas along the bottom edge (Picture 3). Some of the trim details have minor impact damage and some may be

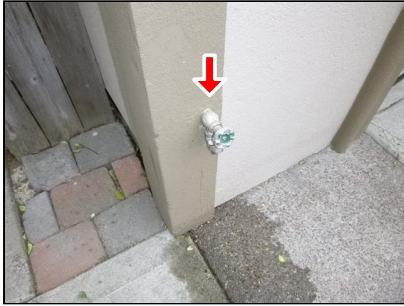
2.0 (Picture 7)

- ❗ (2) The hose bib at the SE corner of the garage is not properly flashed/blocked where it comes through the siding (Picture 7). This poses a risk for water penetration. Have a siding contractor correct this installation.

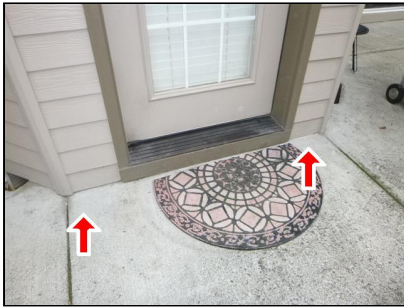
2.0 (Picture 8)

- (3) There is inadequate clearance from concrete to lap siding and trim at back patio (Picture 8). This style of siding requires 2" to concrete surfaces. This could result in damage to siding and trim in the area over time. Monitor and repair as needed. Correction of this issue is probably not cost effective.

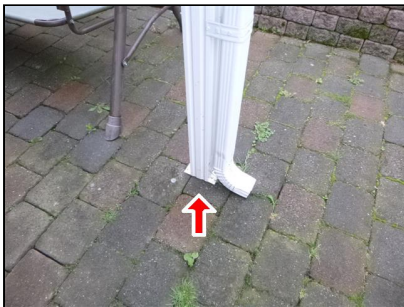
2.3 (Picture 1)

- ❗ (1) The back patio roof structure does not have a solid footing at the NE post (Picture 1). This could be an issue for uplift during strong winds. I recommend that some type of concrete foot is installed/poured and the post secured to it.

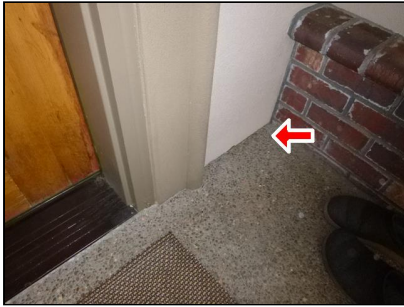
2.3 (Picture 2)

(2) The concrete front steps/entry was poured in contact with the siding (Picture 2). This can trap moisture against the siding/framing. Hidden damage may exist in the wall at this location. Monitor for evidence of regular water contact. Consider removing the concrete and having a different entry platform installed.

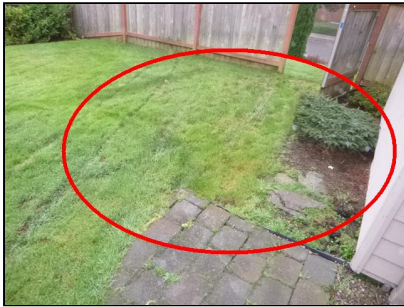
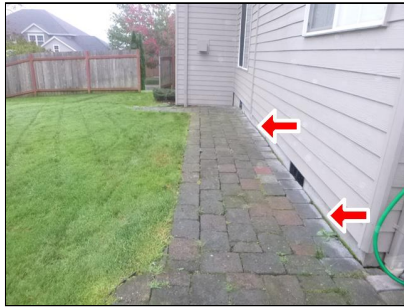
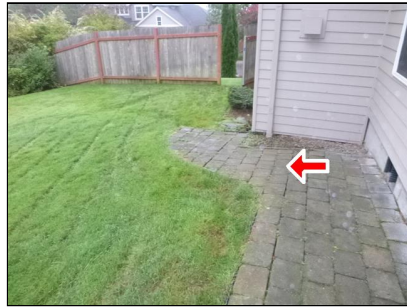
- !** (1) The yard is saturated at the NE corner of the home (Picture 1) and the paver walkway is settled in this area (Pictures 2-3). This may be from over-watering the yard at this point in time, but I suspect that this area will be saturated with winter weather. Have a drainage contractor evaluate this area of the yard and install a drainage system as needed.

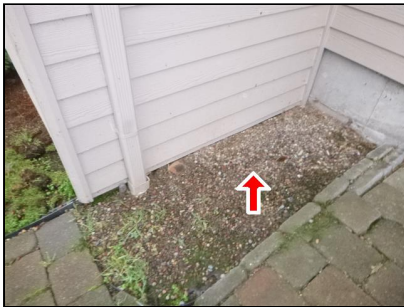
2.4 (Picture 4)

- !** (2) Inadequate clearance soil to siding at the NE corner of the home (Picture 4). Regrade at this area to provide 4-6" of clearance.

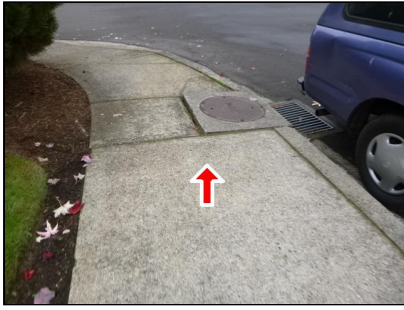
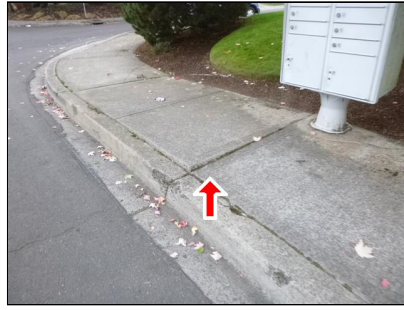
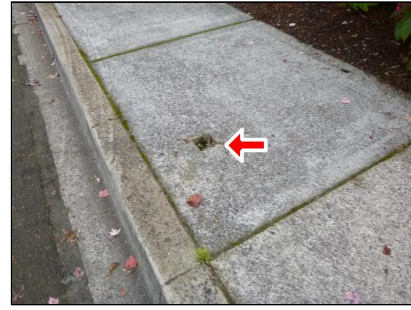
- ⚠ (4) Uneven areas are present in the city sidewalk where it has settled. Several tripping hazards are present (examples Pictures 5-6). There is also a hole in the sidewalk presumably where an old sign post or mail box post has rotted off (Picture 7). Maintenance and repair of city sidewalks usually falls to the homeowner, and homeowners can be held liable for injuries suffered by passersby. Have these trip hazards repaired.

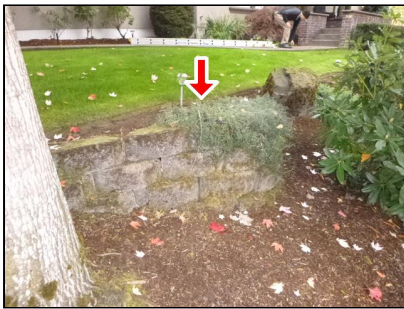
2.4 (Picture 8)

- (5) Some of the small retaining walls in the front yard are settling (Picture 8). Have these walls rebuilt as part of ongoing yard maintenance.

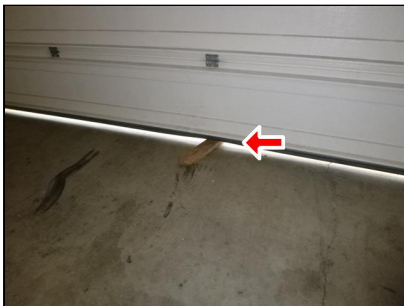
3.4 (Picture 1)

- ❗ (1) The east garage door opener did not reverse when met with resistance at the floor (Picture 1). This is an important safety issue that needs to be corrected. I recommend that an overhead door contractor adjust the door as needed to reverse properly.

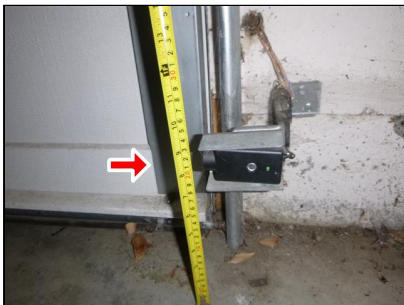
3.4 (Picture 2)

- ❗ (2) The electronic sensors for both garage doors are 8-10" above the floor surface (Pictures 1-2). This can be hazardous for people and pets. The sensors should be lowered to about 4-6" above the floor surface for safety.

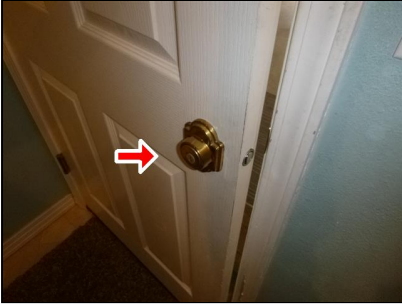
3.5 (Picture 1)

- ❗ (1) The door into the house only has a deadbolt lock installed at this time (Picture 1). This poses a risk for egress and is a nuisance. Have a locking style door knob installed.

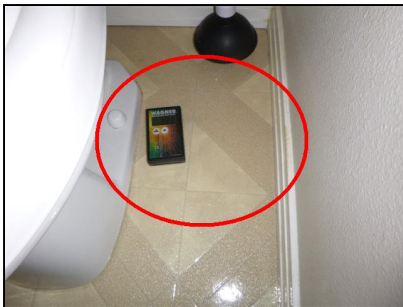
4.2 (Picture 1)

(1) A moisture meter was used and it detected elevated moisture in the floor near the toilet at the upstairs hall bathroom (Picture 1). The floor is a little swollen in this area as well. Damage to the floor underlayment is present and there is some possibility that the sub-floor is also damaged. A qualified contractor should inspect and repair as needed. The toilet will need a new wax ring.

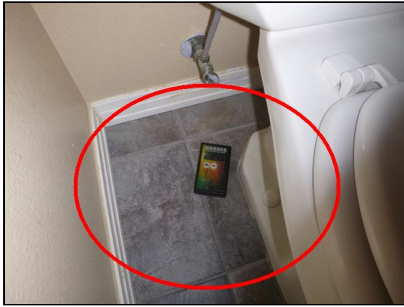
4.2 (Picture 2)

- ❗ (2) A moisture meter was used and it detected elevated moisture in the floor near the toilet at the master bathroom (Picture 2). Damage to the floor underlayment and subfloor may be present. A qualified contractor should inspect and repair as needed. The toilet will need a new wax ring.

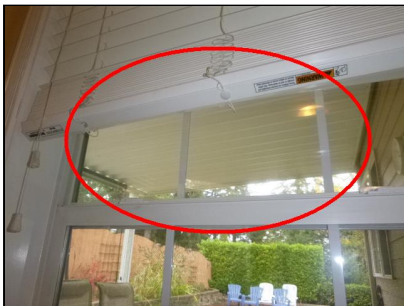
4.6 (Picture 1)

- ❗ (1) The glazing between glass panes are failing at some windows (also known as a broken seal): upper pane of north dining nook window. This clouds the view through the window. Replace the panes as desired.

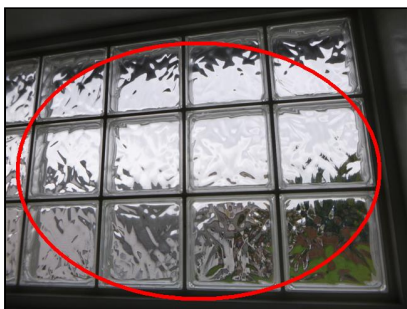
4.6 (Picture 2)

(3) There are some small cracks in the master bathroom block window (Picture 2). This is primarily a cosmetic issue. Repair as desired.

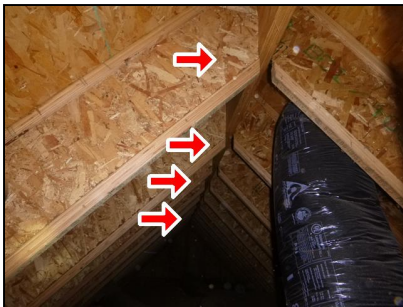
5.0 (Picture 1)

- ⚠ Some of the roof structure consists of TJI rafters. The TJI rafter are not properly supported at the ridge in the attic (Picture 1). The ends should be fully supported from below and should have stiffeners installed at the webbing. Have a framing contractor experience with TJI rafters evaluate and upgrade/repair the installation as needed.

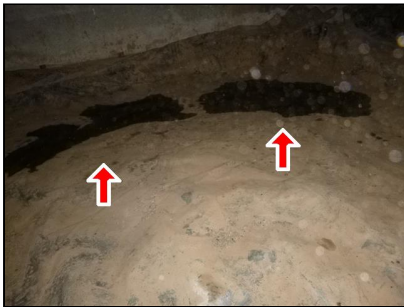
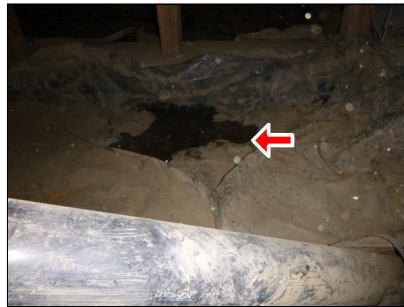
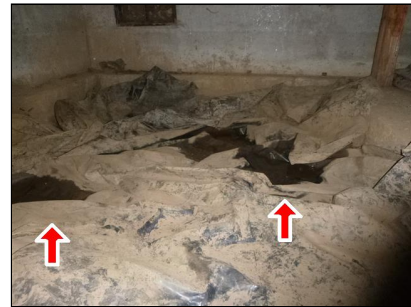
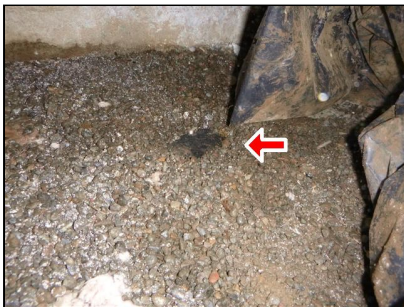
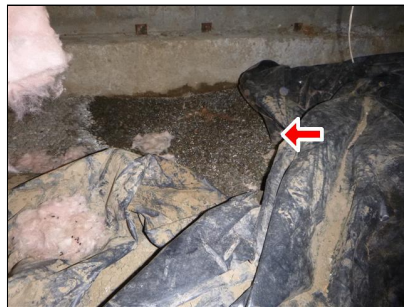
- !** (1) Pooling water is present in the NE area of the crawlspace (examples Pictures 1-3). A drainage system consisting of slotted drain piping and gravel has been installed around the crawlspace (examples Pictures 4-5). With a properly installed drainage system, no pooling water should be present, especially during the dry season. I suspect additional water penetration and pooling will occur during winter months. You should have a drainage specialist evaluate and upgrade/improve the crawlspace drainage.

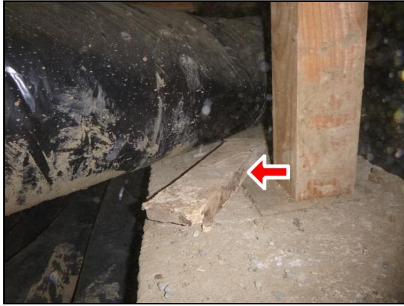
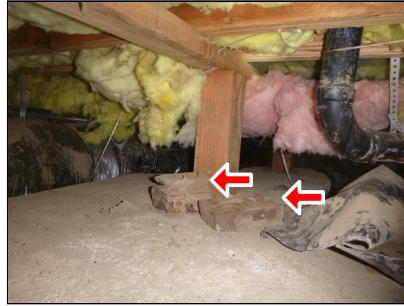
- !** (2) Wood debris was observed in the crawlspace (Pictures 6-7). This can trap moisture and attract wood destroying insects. I recommend removing all construction debris from the crawlspace.

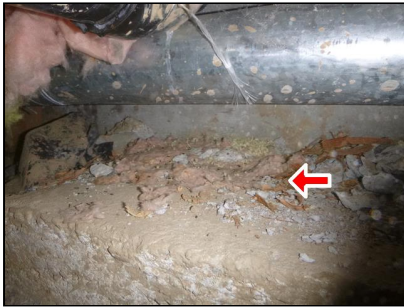
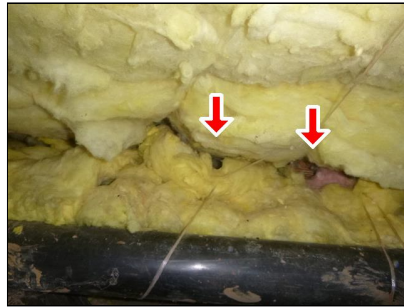
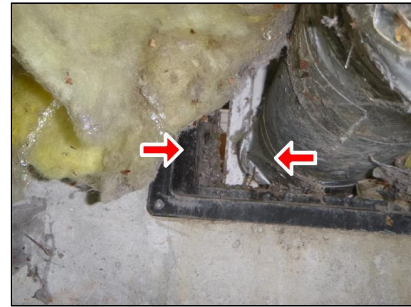
- !** (3) Some evidence of rodent pests was observed in the crawlspace: bait stations, droppings (Picture 8), tunnels in insulation (Picture 9). Additional evidence of rodents is present under the dishwasher and kitchen sink cabinet. Mice can enter a home through a hole the size of a dime. You should carefully search for and seal up any potential points of entry. There is a large gap in the foundation vent at the dryer vent (Picture 10). Contract with a pest control contractor to bait and trap as needed. Search for and seal up additional entry points as needed.

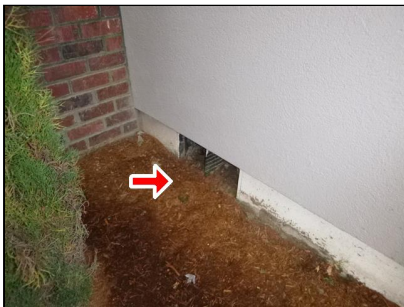
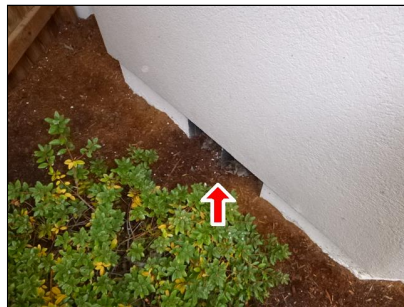
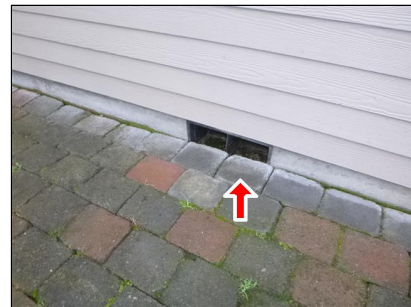
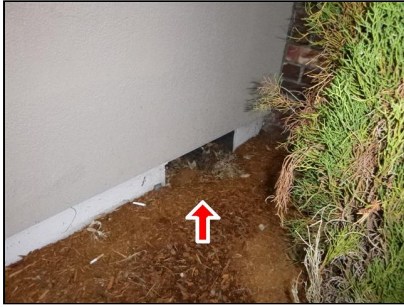
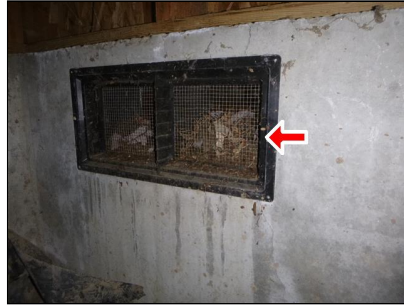
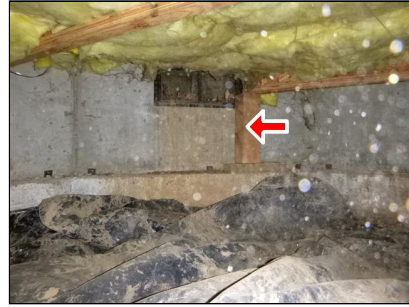
- !** Some of the foundation vents are at or below ground level (examples Pictures 1-4). There is some evidence of debris build-up (Picture 5) and water penetration (Picture 6) at the foundation vents. Have the soil dug down and vent wells installed to provide at least 2-4" of clearance between the soil and the foundation vents.

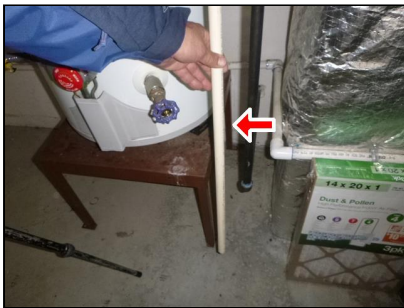
7.3 (Picture 1)

- ❗ (1) The water heater has exceeded its designed life span. The water heater is working now, and may continue to work for some time. It is impossible to predict when it will stop working or leak. You should plan on replacing the water heater in the foreseeable future, although with all the additional issues listed below, it would be pragmatic to have it replaced at this time.
- ❗ (2) The temperature pressure relief valve piping should be secured at the base of the water heater (Picture 1). A plumber or handyman can secure the piping to the water heater using a pipe bracket or plumbers tape and small sheet metal screws.

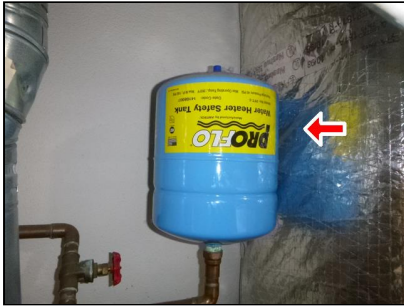
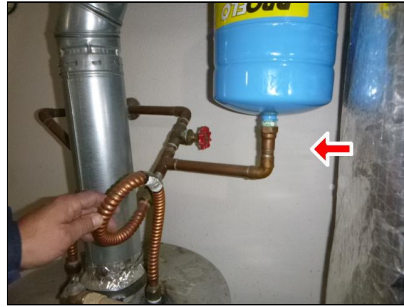
- ❗ (3) The thermal expansion tank is waterlogged (Picture 2). The tank is also not well supported at the end of a fairly long horizontal offset in the copper tubing (Picture 3). Have a plumber replace the expansion tank and properly secure the new one.

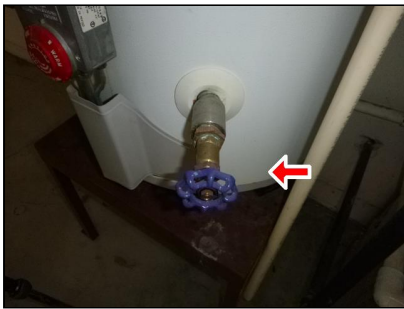
7.3 (Picture 4)

- ❗ (4) The water heater drain valve has been replaced (Picture 4). I cannot tell if this valve is lead-free and therefore rated for potable water systems. Have a plumber evaluate and replace the valve if needed. Alternatively, if you replace the aged water heater, this issue will be resolved.

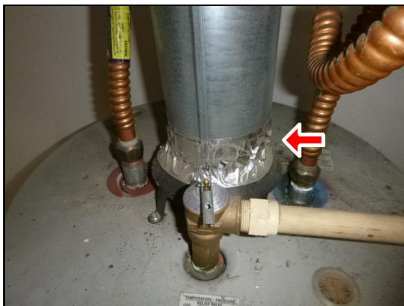
7.3 (Picture 5)

- ❗ (5) There is some adhesive duct tape on the water heater flue (Picture 5). Have this removed.

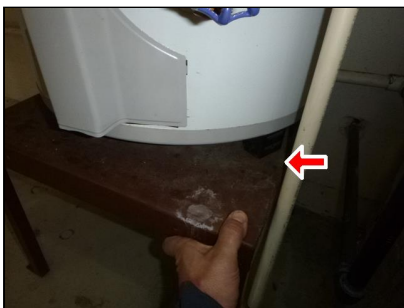
7.3 (Picture 6)

- ❗ (6) The water heater is bearing very little weight on the stand and must be hanging from the wall (Picture 6). This is a very unusual occurrence. I suspect the garage floor has settled some. No repairs are recommended, although caution should be exercised when the water heater is replaced.

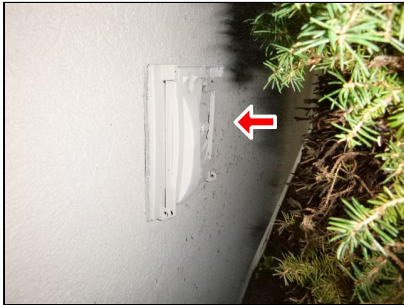
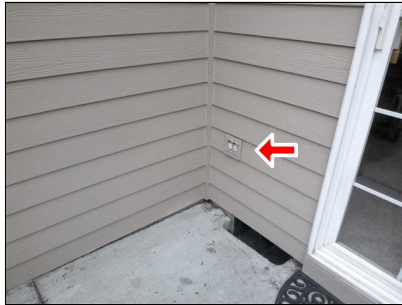
**!** (1) Exterior outlet broken covers: SE corner (Picture 1), west side (Picture 2) . These covers are an older style (example Picture 2). Have these upgraded to the newer "in-use, bubble-style" outlet covers.

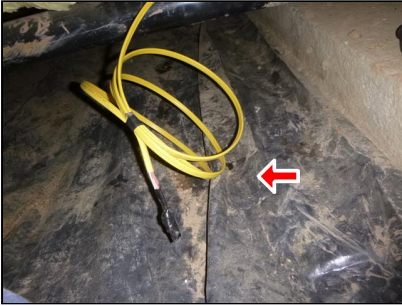
8.3 (Picture 3)

- ❗ (3) Improperly terminated wires were observed in the crawlspace (Picture 3). The wires were tested and were not energized. Have these wires removed if not being used, or terminated in an enclosed junction box.

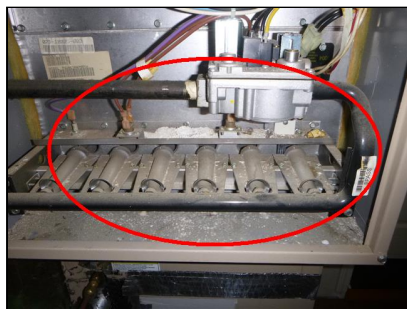
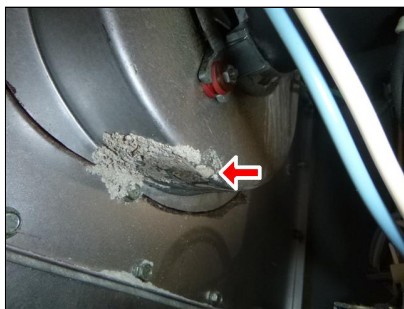
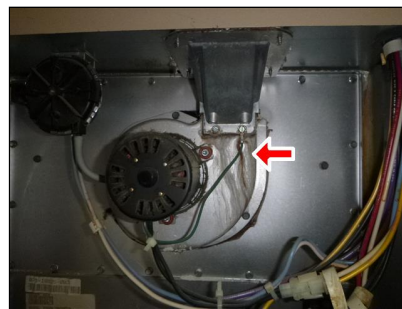
- !** The furnace is original to the home and nearing the end of its useful life. No recent service records were observed for the furnace. Some white deposits in burner compartment indicate that the furnace may be burning inefficiently (Picture 1). The induction fan housing is severely pitted at the bottom (Picture 2) and may leak condensates and exhaust at that location and where it connects to the flue (Picture 3). I recommend that as part of regular maintenance, an HVAC contractor inspect, service and clean the furnace. The furnace will need to be replaced in the foreseeable future.

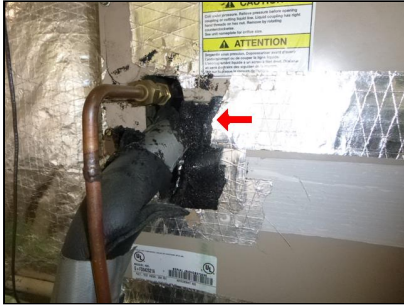
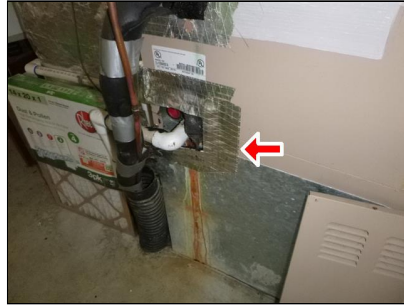
- ❗ (1) There are some gaps at the front of the furnace where the AC lines enter the case (Pictures 1-2). Have these sealed up for efficiency.

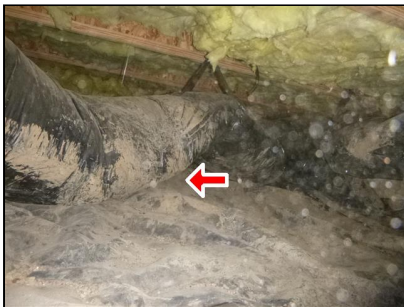
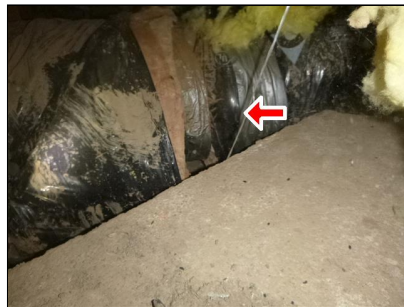
- ❗ (2) Some ducts in the crawlspace are in contact with the ground (Picture 3) . Other ducts have been partially crushed from previous work in the crawlspace. The outer jacket of one larger duct is loose (Picture 4). Crushed lengths of duct should be replaced. Ductwork on the ground should be strapped up to the house framing. Have any loose connections of inner and outer jackets reconnected properly tensioned zip ties.

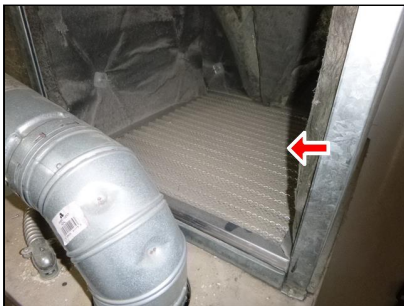
9.2 (Picture 5)

- ❗ (3) The filter in the furnace is dirty (Picture 5). Have the filter cleaned or replaced.

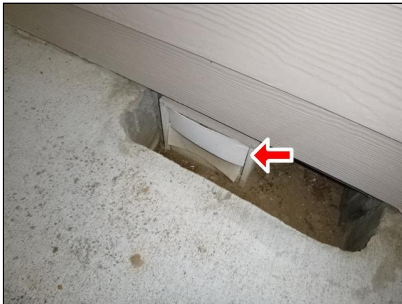
10.2 (Picture 1)

- (1) The button is broken/worn out. Have the button repaired.
- (2) The filters on the range hood are dirty. This can reduce the efficiency of the unit. Replace or clean the filters.
- (3) The range hood vent flappers are weathered and do not open fully (Picture 1), Have the vent termination repaired.

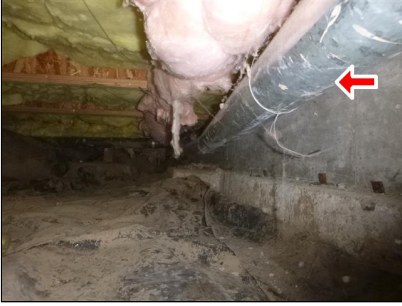
10.7 (Picture 1)

The dryer duct has a very long run (Picture 1). The dryer vent termination is constrained by the concrete patio (Picture 2). These two conditions make build-up of lint more likely. Have the duct cleaned out as part of regular maintenance. You might consider changing the route and location of the dryer duct to shorten its length and improve air flow.
