# Physical Inspection of 835 SE Klickitat Street

*Tuesday, October 17, 2017*

*Report Number: 171017A*

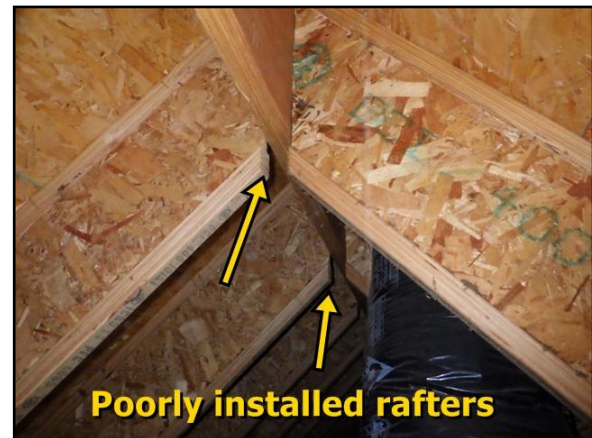
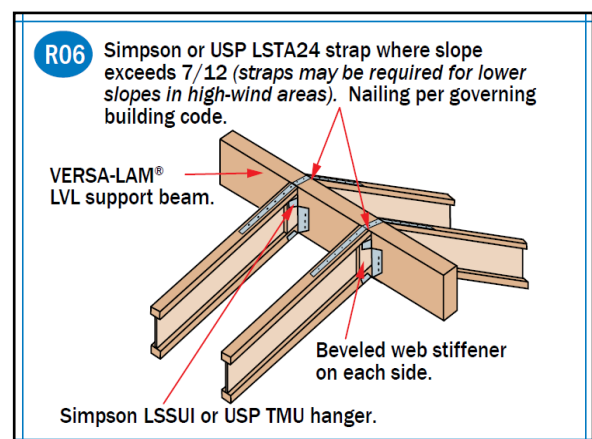
#### *Improper Roof Framing*

Above the bonus room, the cut ends of the BCI rafters extend down farther than the bottom of the ridge board and no metal connectors are visible. This doesn't comply with the manufacturer's installation instructions. The rafter ends could crush, split, or otherwise distort under heavy loads. Note that this is an engineered system: repairs should not be improvised. Only an engineer or the manufacturer should specify how this issue should be resolved.

1. Ask a Boise Cascade representative to determine whether or not the bonus room rafters need to be repaired and, if necessary, provide repair specifications. Then hire a contractor to make the repairs.

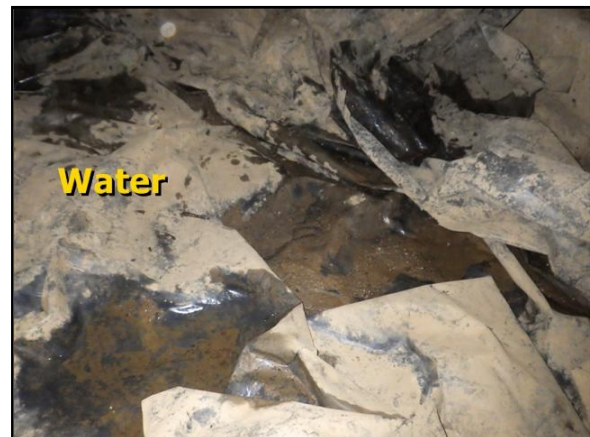
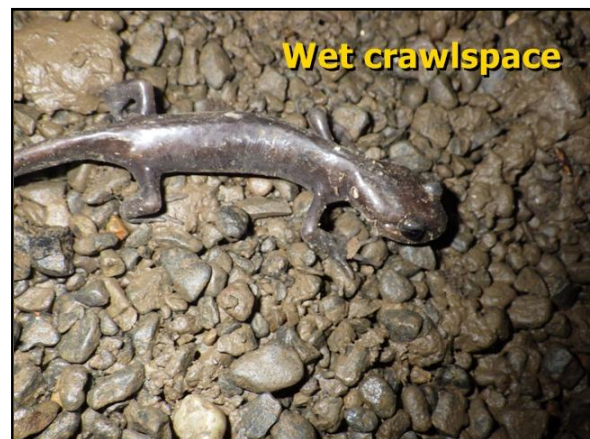
Water stands in pools at the northeast side of the crawlspace today. Mineral-crusted outlines of other ponds suggest that during wet weather even more water accumulates down there. A live salamander under the vapor barrier wouldn't be there if the crawlspace was dry. Wet crawlspaces are bad for several reasons. The water grows algae and fungi, humidifies the crawlspace, encourages the presence of rot and insects and, in many cases, causes uneven settlement of the footings and the foundation. Note that someone has already attempted to install a drainage system, but it's not working properly yet.

2. Hire a drainage contractor to design and install improvements to the crawlspace drainage system that will ensure water doesn't accumulate down there. Be sure that the work includes a warranty.

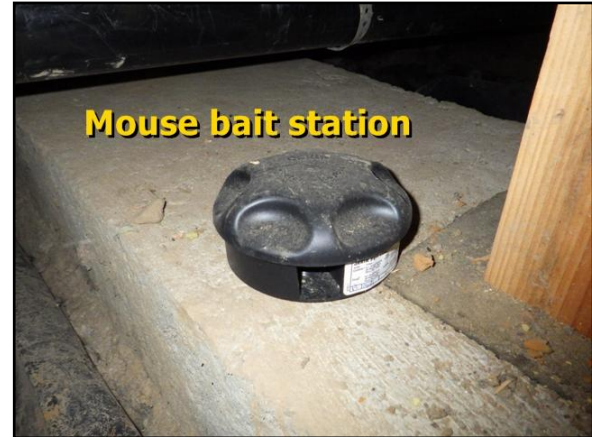
Mice are living in the crawlspace, and in and under the kitchen cabinets, where I can see their droppings, urine, and nesting material. The crawlspace also has a strong mousy smell in places and several mouse bait stations, all of which have no bait left. Mice can cause damage to insulation, wood framing, plumbing pipes, and wiring. In some cases, they can transmit diseases. It's best to exclude them from your house.

- 4. Survey the exterior of the house to locate and block off all rodent entry points. Remember that mice can pass through an opening the size of a dime. Use 1/8" galvanized steel hardware cloth to seal large openings and stainless steel wool to seal small openings. Begin by patching the opening near the dryer vent.**
- 5. After all entry points have been sealed, place mouse traps in the crawlspace to monitor the population. If the traps catch mice, go back to find and seal the openings that you missed.**

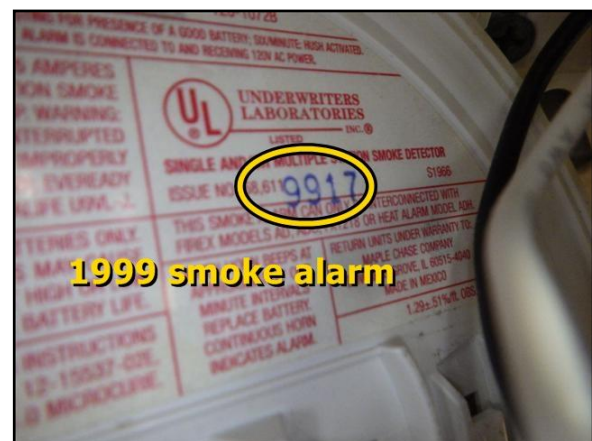
The 1999 smoke alarms are obsolete; after 10 years of service, their sensors are no longer dependable and the manufacturer \*requires\* that they be replaced.

6. Replace all of the existing hardwired, interconnected smoke alarms with new hardwired, interconnected smoke alarms. I suggest that you install photoelectric-type alarms because they're more reliable and they have fewer false alarms than the ionization kind. To learn more about this topic, read this article:

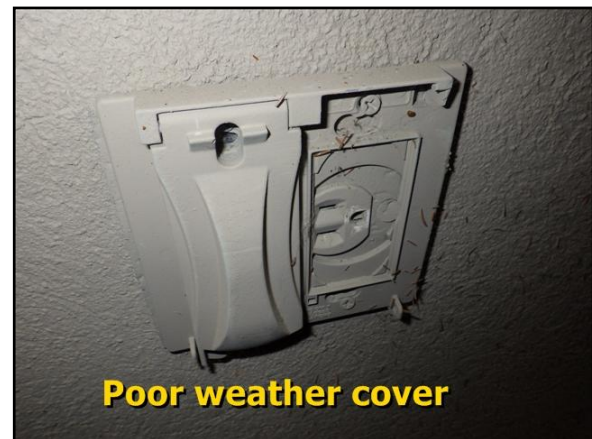
Two of the exterior receptacles have broken covers:

- At the southeast exterior corner of the garage, the receptacle outlet has the wrong kind of weather cover, installed sideways.
- At the midwest side, the exterior receptacle’s weather cover is broken.

9. **Remove the broken snap covers from the southeast and midwest exterior receptacles and replace them with “extra duty in-use” covers.**

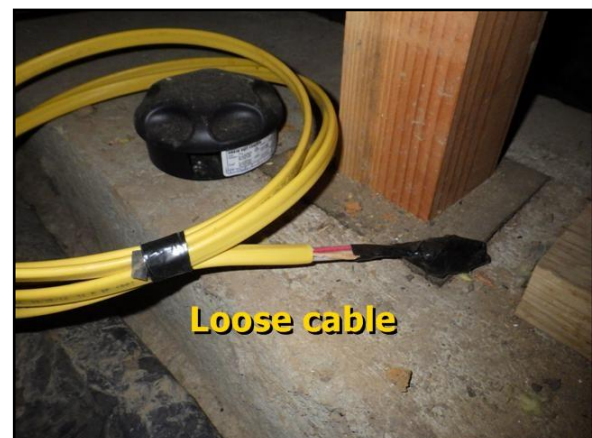
### ***Poorly Terminated Cable***

Under the crawlspace, right next to the access hatch, an electrical cable is coiled up with its wires taped shut. This cable shouldn’t be loose and its ends should always be safety contained.

10. **Ask your electrician to secure the loose coil of cable in the crawlspace and enclose its wire ends in a junction box.**

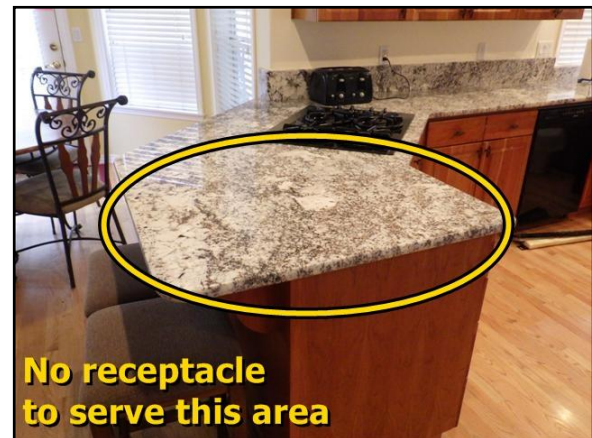
### ***Missing Receptacles***

There's no electrical receptacle at the kitchen peninsula or at the 23" countertop to the left of the freezer. These areas should each have one, so that you don't need to use extension cords to reach appliances there.<sup>1</sup>

- 13. Have an electrician install GFCI-protected receptacle outlets at the kitchen peninsula and at the countertop to the left of the freezer.**

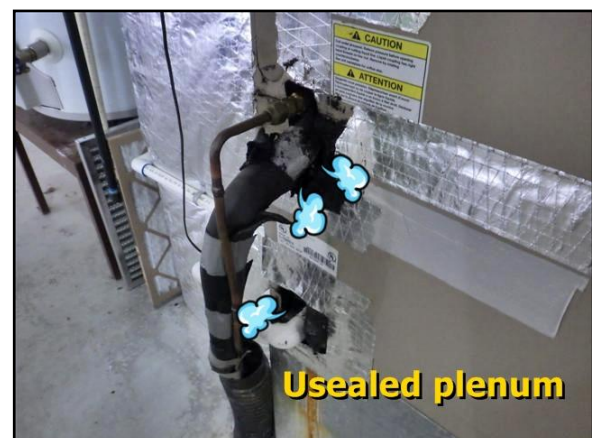
Just below the furnace, gaps in the air conditioner coil housing are allowing conditioned air to blow into the garage in both the heating and cooling modes. This wastes energy.

**15. When you have the furnace serviced, ask the technician to carefully seal the evaporator coil plenum while he's there.**

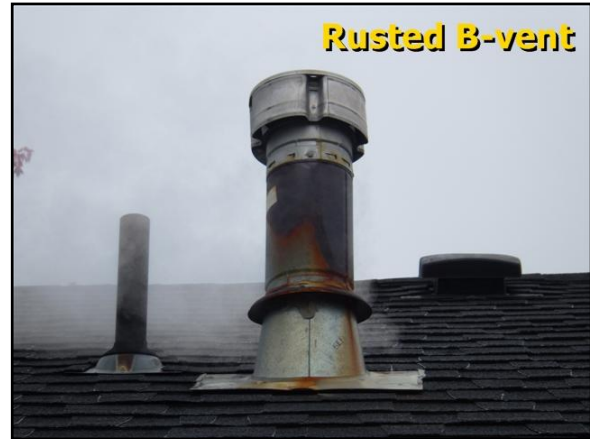
### ***Rusted B-Vent***

A *B-vent* is a double-walled metal pipe that carries exhaust gas from the furnace and water heater to the rooftop. The part of this B-vent that's above the roof has begun to rust. It's still useable but should be protected to prevent further rusting. Replace this vent when you replace the furnace.

- 16. Paint the rusting B-vent above the roof to prevent further rusting. Replace the vent when you replace the furnace.**

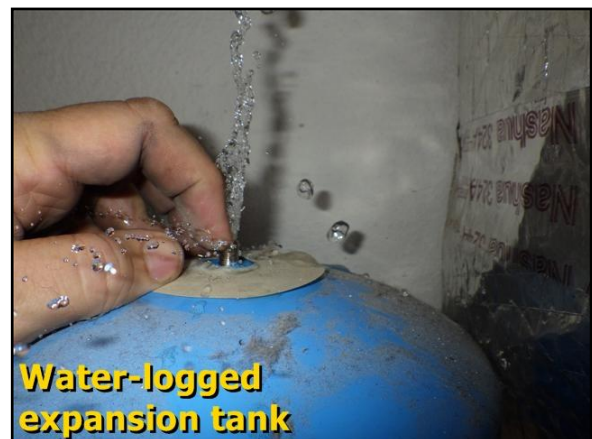
The water heater's accessory expansion tank is useless. Its bladder has broken and the tank is waterlogged. It can't be repaired. Without a working expansion tank, water that expands as it's heated might cause damage to the plumbing pipes or cause the safety valve to open.

20. **Hire a plumber to install a new, working, expansion tank at the water heater. Be sure to follow the directions regarding pressurizing the tank \*before\* installing it.**

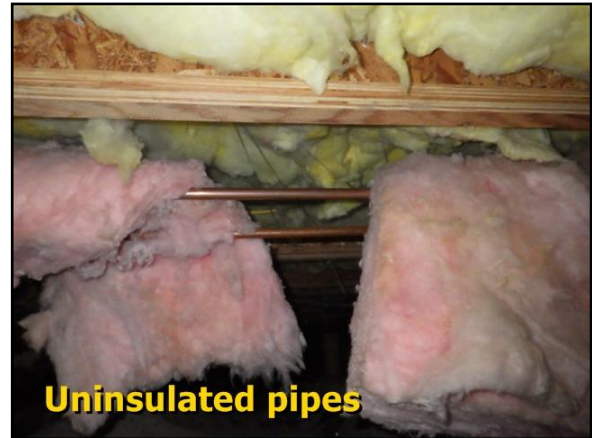
### ***Uninsulated Plumbing Pipes***

In the crawlspace, a few sections of the plumbing pipes aren't insulated. The hot water pipes will lose heat to the crawlspace quickly and, in very cold weather, the water in the pipes could freeze.

- 21. Thoroughly insulate the water distribution pipes in the crawlspace. During freezing weather, close the crawlspace vents to reduce the risk of frozen pipes.**

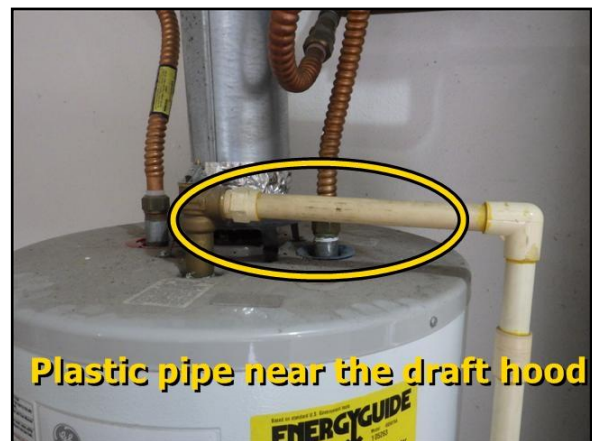
### ***Poorly Placed Plastic Pipe***

The water heater's safety valve discharge pipe is made from plastic and too close to the draft hood.<sup>3</sup>

- 22. When you replace the water heater, be sure to provide proper clearance between any plastic pipes and the water heater's draft hood.**

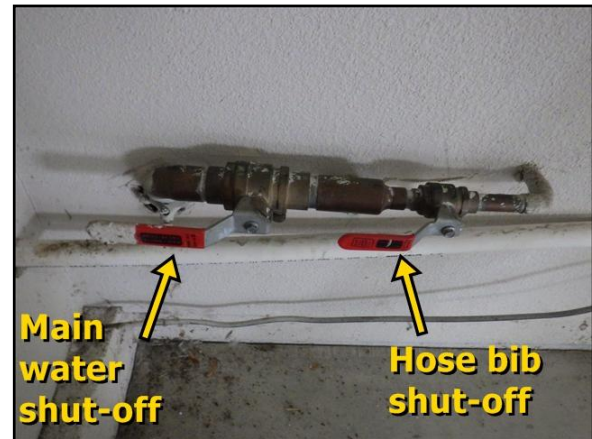
***FYI – Frost Proof Bib on Cold Wall***

The southwest hose bib is also the frost proof kind, but since it's installed on an unheated garage wall, its frost-proof design will not be very useful. To reduce the risk of frozen water in its pipe you should shut its water supply and drain it each fall. Its shut off valve is located on the garage's northwest interior wall, right next to the main shut-off valve. Each fall, shut this valve, open its drain cap a half turn, and then open the hose bib to allow all of the water in its pipe to drain out. Reverse the procedure in the spring.

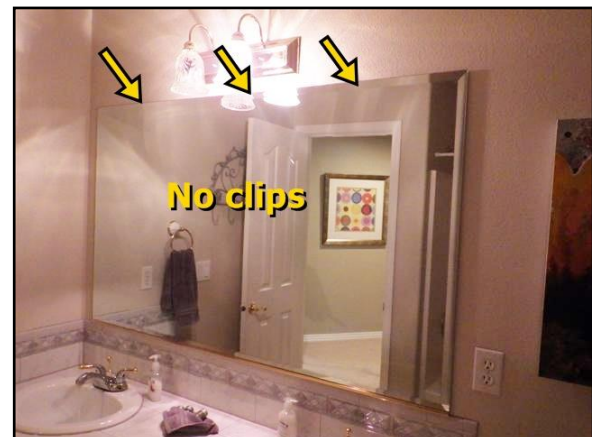
- In the two upstairs bathrooms, the bottom edges of the mirrors sit in metal mirror channels, but the top edges are only supported by mastic. This is inadequate. The mastic can fail, the mirrors can tip forward, and someone could be injured.
- In the half bathroom, the oval mirror only has one plastic clip at the top, and one at the bottom. If its mastic were to fail, the mirror would fall.

**25. Install mechanical clips to thoroughly secure the wall mirrors in the bathrooms.**

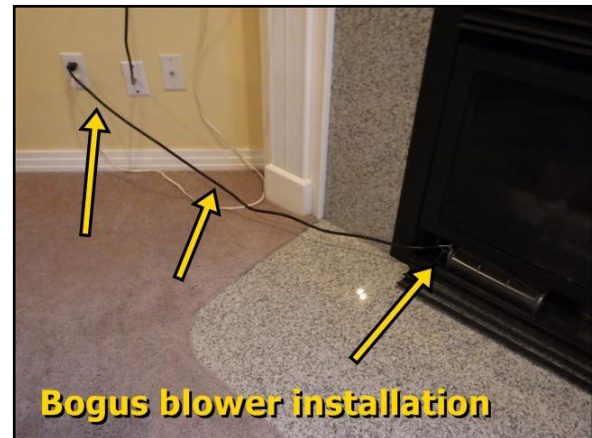
### ***Poorly Installed Fireplace Blower***

The living room's fireplace has no blower. In the family room, someone installed an aftermarket blower on the fireplace, but did it poorly. The blower is in the wrong place, it has to be plugged in manually, and its electrical cord is poorly secured.

- 31. Ask your gas fireplace service contractor or chimney sweep to re-install the family room fireplace blower properly.**

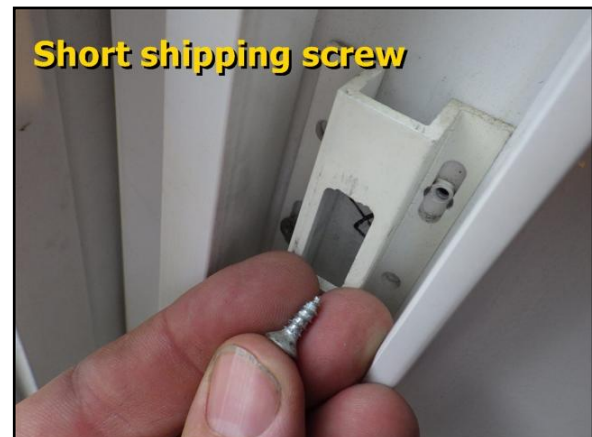
### ***Missing Security Screws***

At the rear sliding door, the door catch is still only installed with its short shipping screws. This is not a secure way to latch the door. After the door was installed, the installer was supposed to replace these temporary screws with long screws that go into the wall framing.

- 32. Install long security screws at the rear sliding door's catch.**

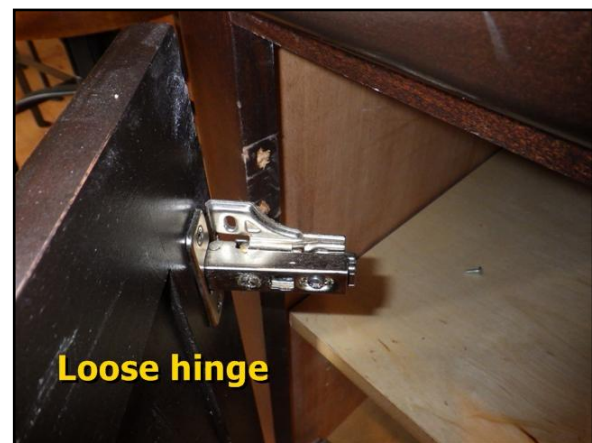
### ***Loose Cabinet Door Hinge***

In the kitchen, the island's north cabinet door has one hinge that's not attached.

- 36. Re-secure the loose cabinet door hinge on the north side of the kitchen island.**

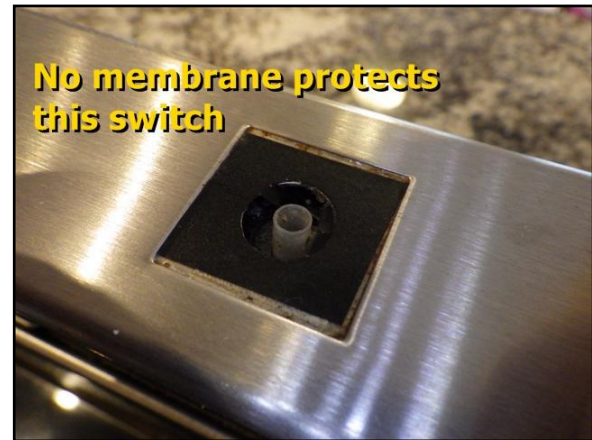
**No membrane protects this switch**

- 38. Replace the control button membrane cover at the cooktop's downdraft fan.**

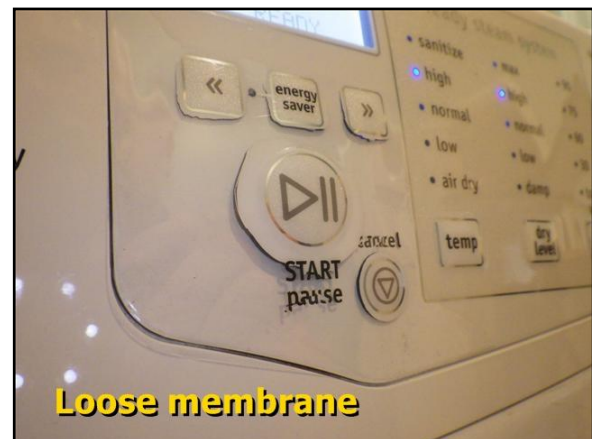
**Loose membrane**

- 39. Plan to replace the dryer's control pad.**

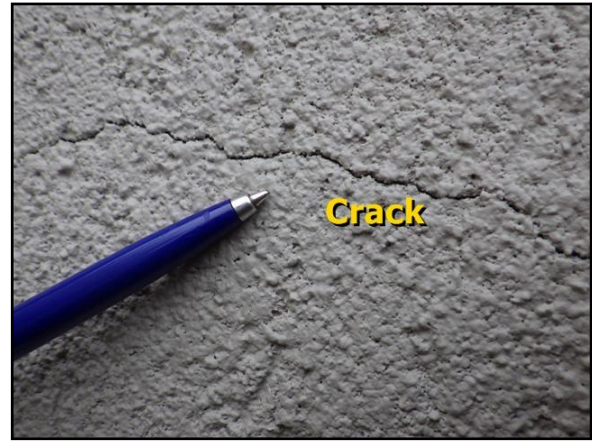
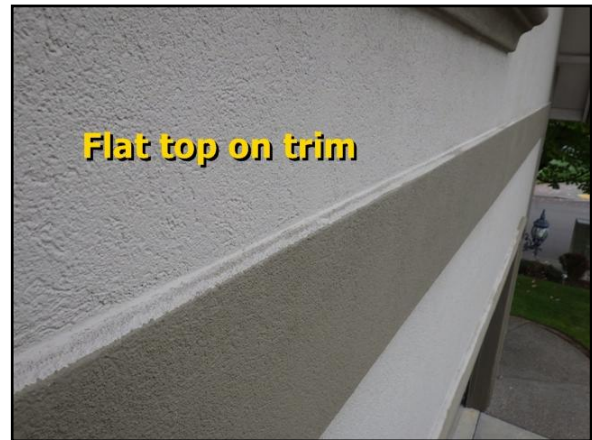
### ***Imperfect Stucco***

- The caulk joints at the windows are narrow and, in places, separating from the window frames. These might admit water behind the stucco.
