Confidential Inspection Report

LOCATED AT:
835 SE Kickitat Ave.
Portland, Oregon 97213

INSPECTED ON:
Tuesday, October 17, 2017

AMI Inspector: Toby Deming
CCB #146715, OCHI #16, Report # 171017A16

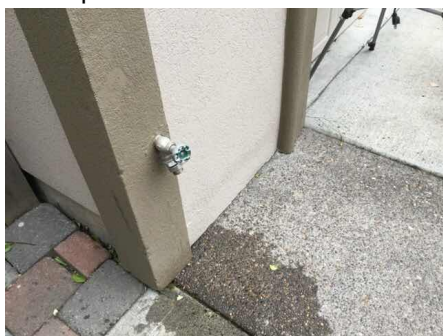
12: - In the SW corner of the garage, the stucco trim was placed over the hose faucet. This will complicate repairs and replacement of the faucet:

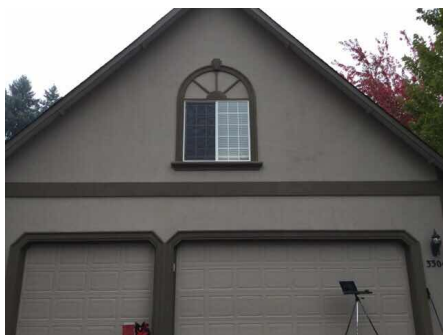
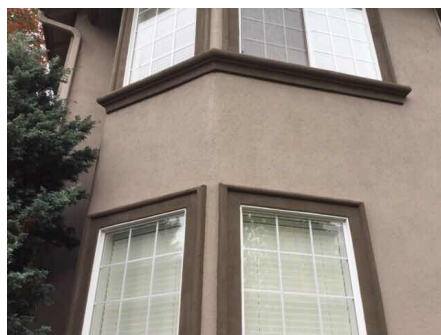
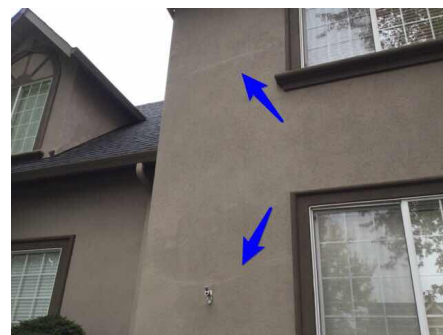
14: - The stucco has multiple cracks throughout. Most of the cracks have been patched. Hire a stucco repairman to repair the remaining cracks then have a painter repaint the stucco on the home. Some example of the cracking is shown below:

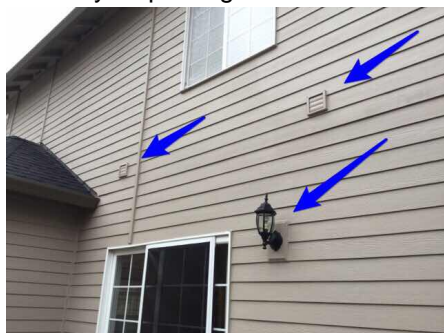
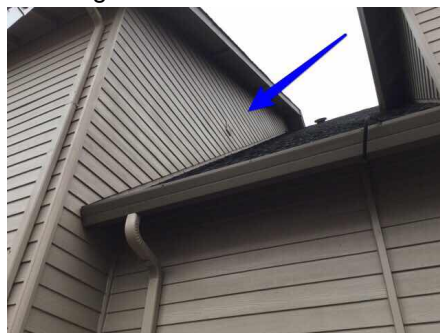
16: - Another notable difference in how this siding is installed, is how exhaust fan hoods, electric meters, hose faucets, lights, outlets and other penetrations in the siding are installed. These penetrations are now placed in blocking that is then flashed to the siding. One of the most important places to make this upgrade is where exhaust fan hoods are mounted directly on the surface of the siding. These are easier places for water to get in. Have a siding contractor install blocking and flashing especially on the weather sides of the home or get in the habit of routinely inspecting these areas and maintaining the sealants around them.

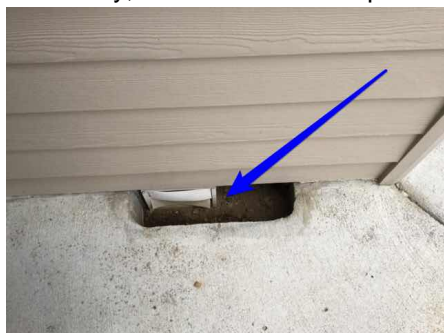
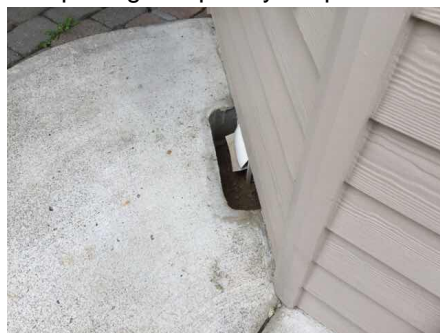
18: - In the NW area of the west kitchen bump-out, the kitchen exhaust fan exists the crawlspace. The dirt in the well is blocking the louver from opening. Dig out the well so all the louvers can open completely. In addition to the soil in the way, the louvers are warped and not opening completely. Replace the louvers to improve the air flow.

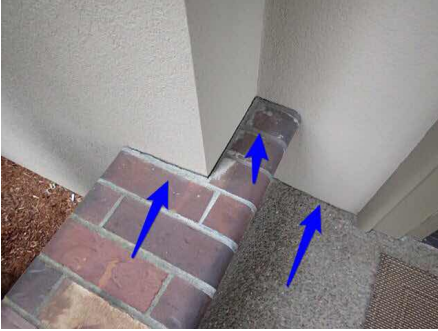
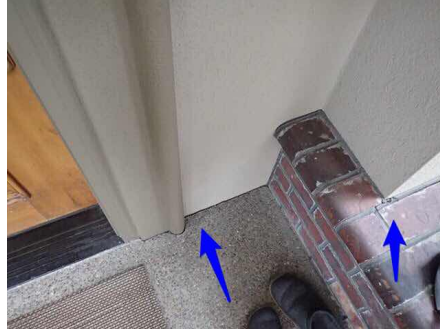
Caut 25: - Common amounts of settlement were found in the front porch on the exterior of the home. No repairs are necessary at this time. Monitor for change and repair as needed if the settlement continues or creates other issues.

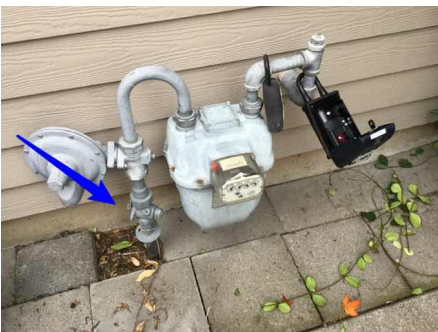
28: - There is a main shut-off valve for the gas service to the home located on the pipe coming out of the ground and feeding the gas meter above. When the valve stem is in line with the pipe the gas is on. Turn the stem perpendicular to the pipe to turn the gas off. I recommend you buy a cheap Crescent wrench, about 12" long, at a garage sale before you move in. Adjust the jaws of the wrench to fit onto the gas shut-off stem, then hang the wrench beside the meter so it is easily accessible in case there is an emergency and you need to shut the gas off in a hurry. Show anyone of age, who will be at the home alone, how to do this. Hopefully, you will never have to use this wrench!

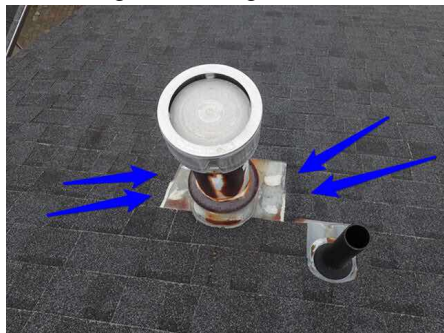
41: - Tingles missing on either side of the furnace vent flashing:

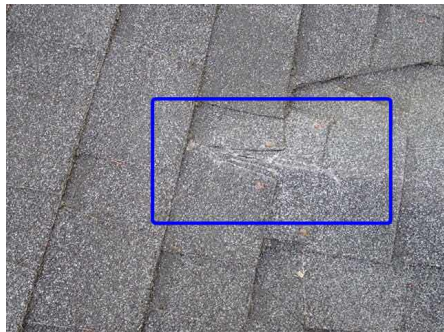
42: - Some of the ridge shingles have cracked. Most are very close to needing replacement. On the main roof above the front porch, the shingles are cracked and should be repaired.

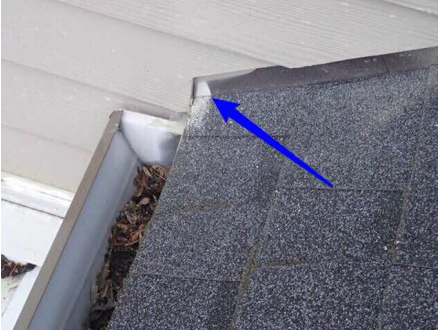
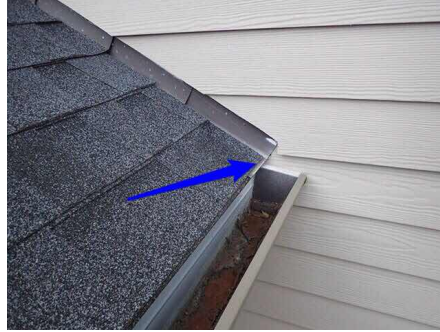
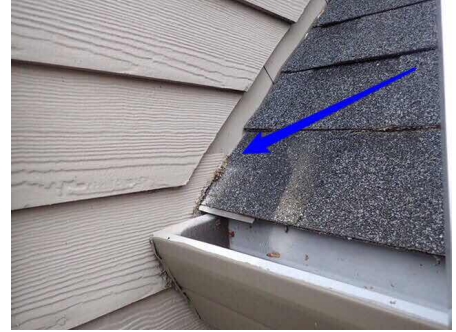
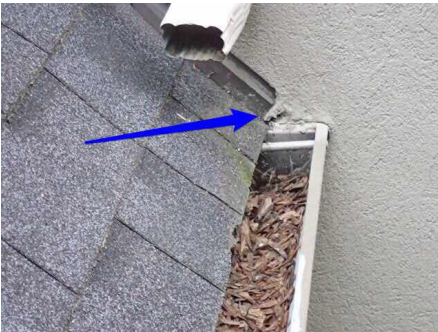
Warn **44:** - Kick out flashing is missing from all joints above the end of gutters. Water off the roof in these areas could find its way into the wall voids below. Hire a roofer to install kick-out flashing at all points where the gutters butt into the home. Some examples are shown below:

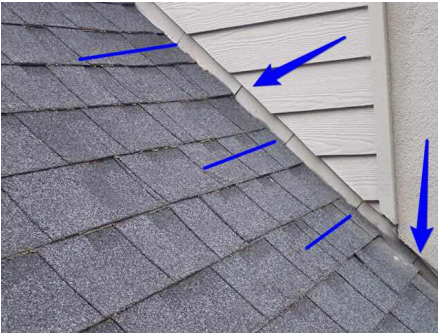
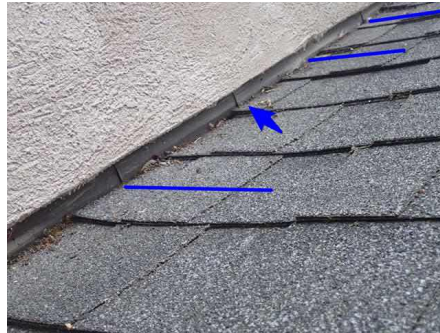
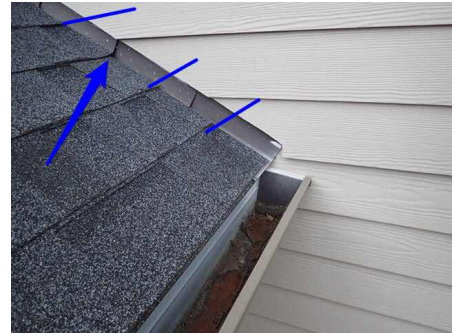
45: - The wall flashing is designed for a shake roof. The exposure is too much of a comp shingle. When the roof is replaced have the roofer replace all of the wall flashing to match the shingles being installed.

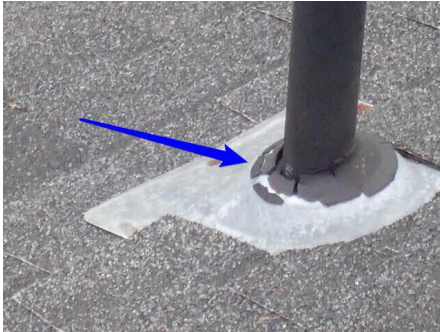
Warn 46: - The rubber gaskets around the sewer vent pipes have cracked and are overdue for replacement. These penetrations will leak. Have a roofing repair contractor replace the sewer vent flashings before the rainy season begins.

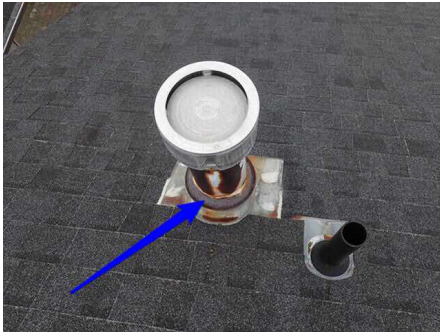
60: - This fall, recaulk the storm collar to the vent:

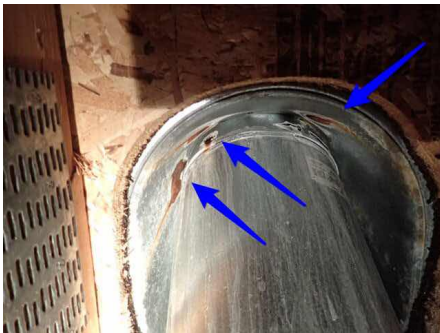
61: - In the attic, there are rust spots in the furnace vent and it's flashing. They don't appear to be leaking yet. Keep an eye on the and plan on replacing them when the furnace is replaced.

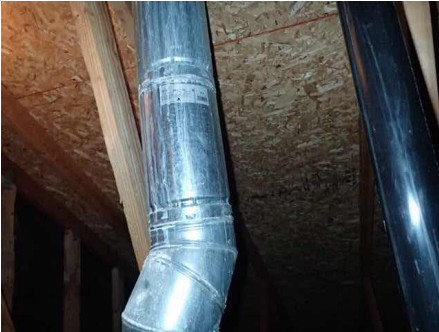
62: - Also in the attic, there is a lot of moisture staining on the furnace vent. There are a number of possible sources for this moisture. One is condensation from the furnace exhaust. In the winter when the furnace is being used on a regular basis, have a heating contractor inspect the vent to see if it is wet. If so, have him determine why and repair as needed. Another source is rain. During a rain storm, have someone inspect the vent pipe for wet areas. Proceed further based on the findings and repair as needed.

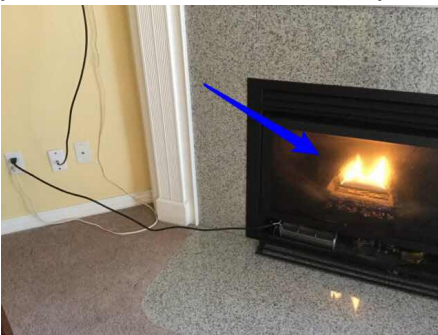
66: - The gas fireplace in the Family room was left on for a period of time to see if it would shut down on its own or begin to burn "incompletely". I found a significant change in the color of the flames over a short period of time. The fireplace does not appear to be functioning correctly and should be inspected by a gas fireplace expert before using. This "rich" color in the flames will also generate the soot found on the front glass and the siding outside. I suspect it just needs to be cleaned and adjusted. Repair per his recommendations.

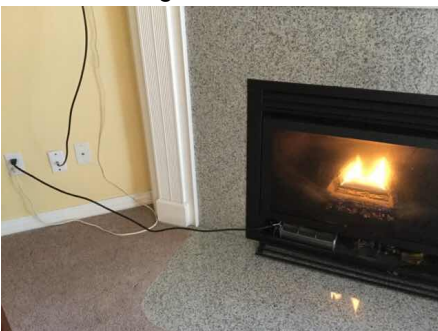
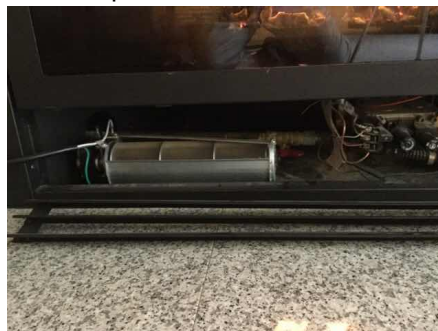
67: - The heatolator fan has not been completely or properly installed. Hire a gas fireplace installer to finish installing this fan. The fan should be located in the back of this space under the firebox. The contractor should work with an electrician to get an outlet installed in the same space as the fan. The fan sounds fine otherwise:

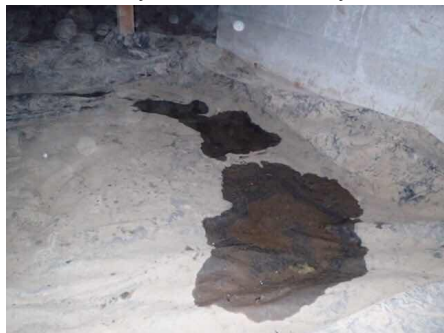
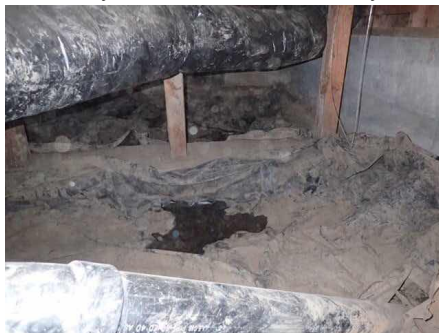
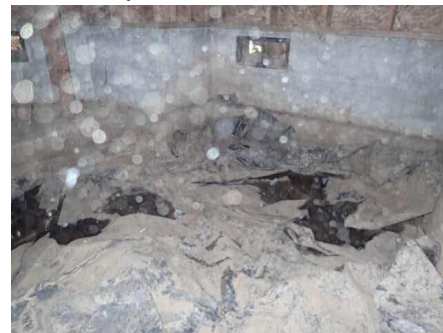
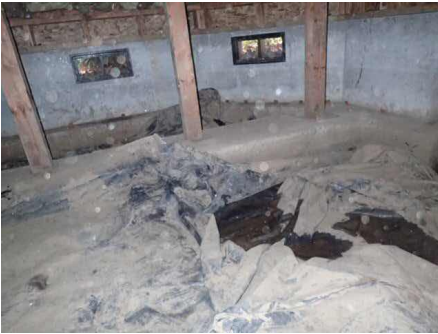
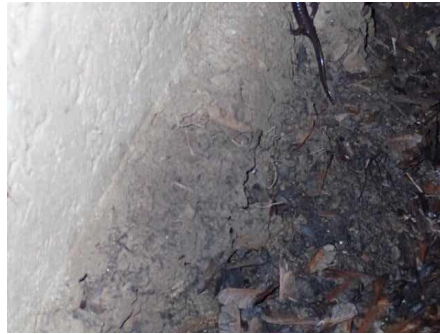
Warn 74: - A drainage system appears to have been recently installed. Find out who did the work and when. Obtain a drawing from the contractor or the owners showing you where their system was installed. The owner may have this information. I also recommend that you verify that any warranties that came with this work are transferable to you. The goal is to keep all ground water below the black plastic vapor barrier at all times. It is not unusual for drainage systems to need modification during their life time and there are many reasons why they worked fine this year but not the next. You should also know that over time, the system will have to be replaced.

This system is not doing its job. I found puddles of water throughout the eastern areas of the crawl space. The trenches are filled with a very Fine aggregate which will tend to clog easily and be hard for ground water to move through. The trenches, their rock and pipe, which I did not find, should be the "easy" place for water to travel. Hire an experienced drainage contractor to inspect the crawlspace and the property then design and install a drainage system which he will guarantee will keep all ground water below the vapor barrier at all times. Now is the perfect time of the year to install a system. Later in the year and it is too muddy to work effectively.

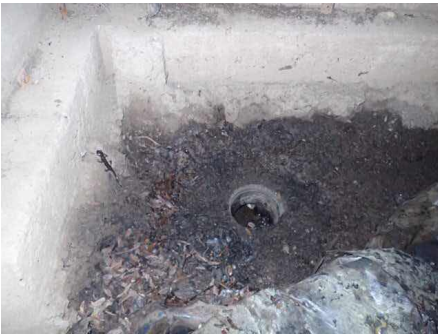
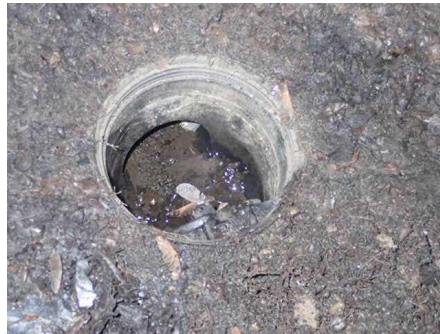
Warn 75: - In the NE corner of the crawl space, a drain was installed. The drain has a one way valve in it. This valve is installed to keep water in the roof storm drain pipes from backing up into the crawl space. The valve is missing its cap. Without the cap, water from the storm drains might back up into the crawlspace. Before the rainy season begins, install the missing cap.

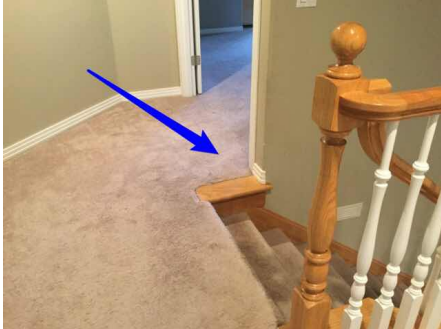
Warn 76: - Guard rail is missing at the top of the stairs at the master bedroom. Add a guard rail for safety reasons.

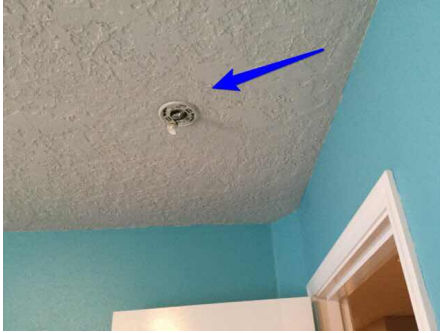
Warn 78: - A smoke alarm is missing in the following locations. Have an electrical contractor install one in the upstairs west bedroom,

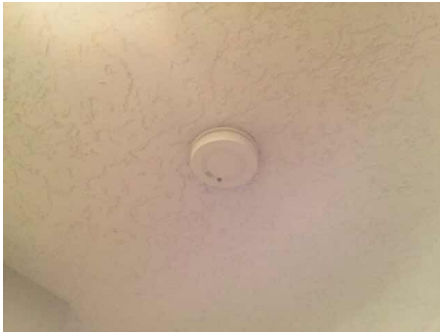
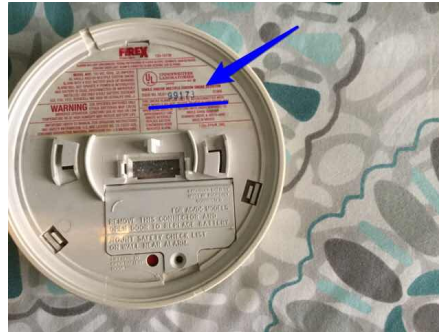
Warn 79: - The fire marshal and most smoke alarm manufacturers recommend that smoke alarms be replaced if they are more than 10 years old as these are. Replace any that are more than ten years old with a style that meets current standards for fire safety concerns. The alarm may fail to operate as intended. Since these alarms are hard wired, this work should be done by a licensed electrical contractor. Make sure the new alarms are the photoelectric type. Ionization types of alarms have a very poor safety and performance record and should not be installed.

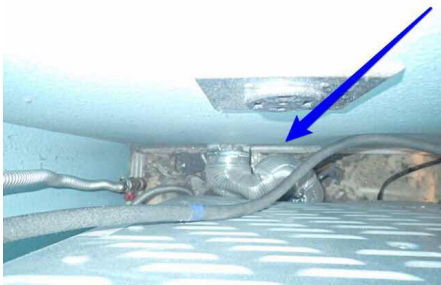
- Caut** 97: - Metal flex type of dryer ducting used in the laundry room is uneven on the inside. The uneven surfaces tend to reduce the air flow inside the ducting and the uneven surfaces tend to trap lint. This type of ducting can easily get clogged with lint causing the dryer to over heat and in extreme cases, catch fire. In addition to these concerns the ducting is crushed behind the dryer. Hire a heating contractor to replace the ducting with smooth walled metal ducting with a few joints in the system as possible.

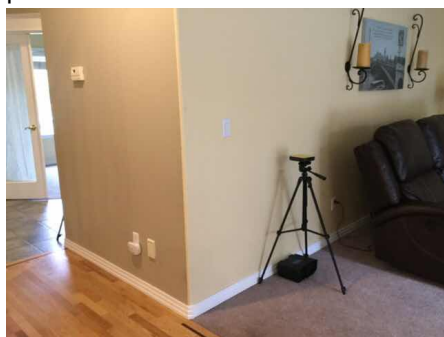
Caut 106: - Radon is an invisible, odorless and tasteless radioactive gas that can cause cancer. In fact, it is the second leading cause of lung cancer in the U.S.. For further information, go to www.epa.gov/radiation/docs/assessment/402-r-03-003.pdf. Radon testing is the only way to determine your home's radon levels. (Source: U.S. EPA 402-K-05-005, May 2005 booklet "Home Buyer's and Seller's Guide to Radon") The home is currently being tested for radon by AMI. A report will be sent to you upon completion of the testing period. Proceed further based on the findings and recommendations.

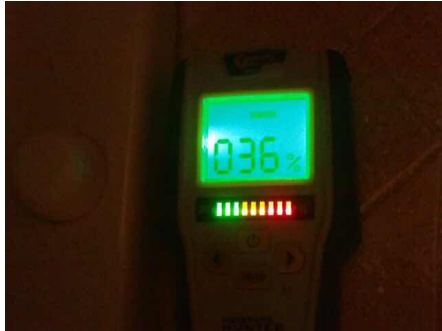
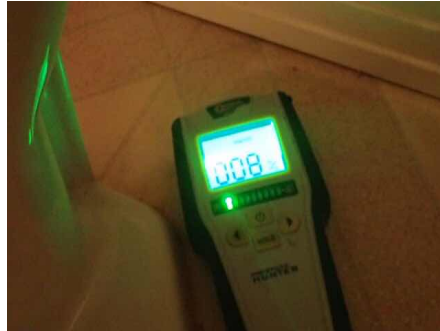
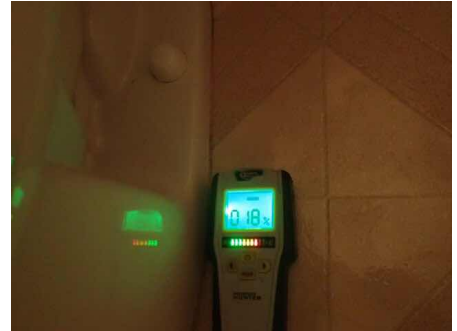
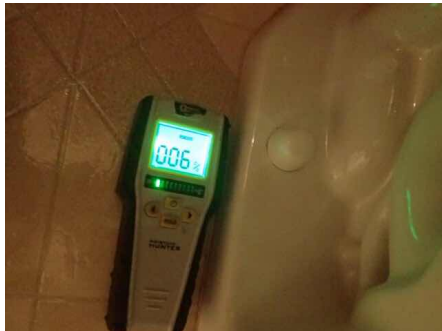
Warn 107: - High levels of moisture were detected under the floor covering on right side of the toilet. The underlayment has swollen. Swelling / moisture damage in the flooring may extend beyond what is apparent. Additional repairs may be needed once the damage is uncovered. Hire a licensed plumbing contractor to work with a general contractor to pull the toilet, replace the subflooring and sheet vinyl, the wax seal and any other damaged materials found. The plumber should also repair any other leaks found then, secure the toilet to its piping and the new floor system.

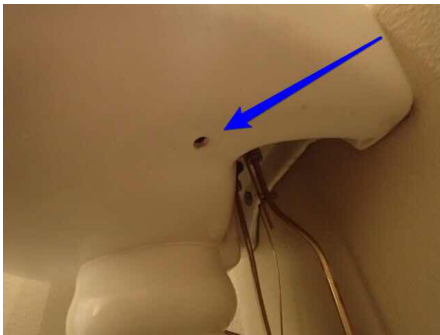
110: - The sink basin is leaking from the casting port when the sink is filled to the overflow. This usually means the drain was improperly installed. Have the plumber evaluate and repair as needed.

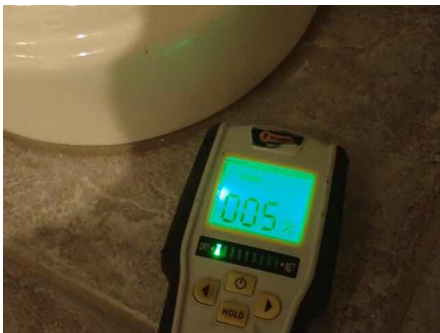
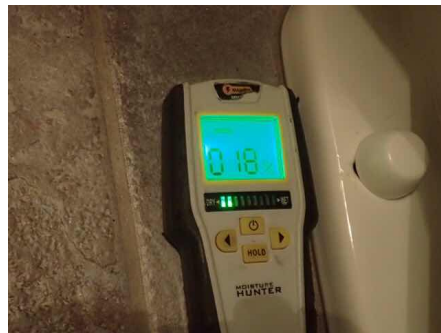
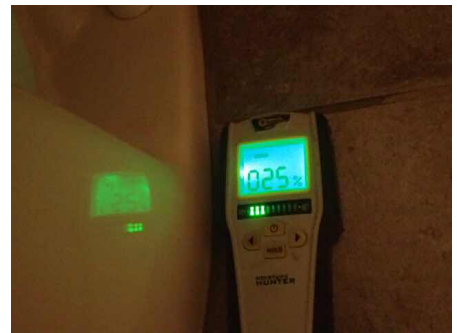
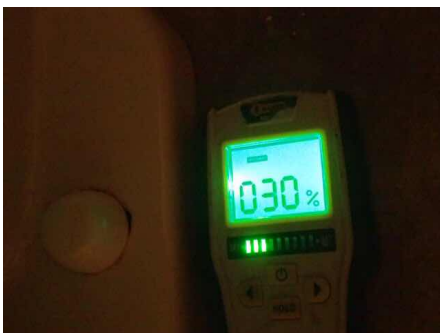
Warn 111: - High levels of moisture were detected under the tile floor covering on both sides of the toilet and in the areas between the toilet and the entry (east) wall. In the hallway outside this bathroom, there are also loose tiles and indications of higher moisture levels under the tiles. It is possible for the moisture to travel. Additional repairs may be needed once the damage is uncovered. Hire a licensed plumbing contractor to work with a general contractor to pull the toilet, replace any damaged subflooring, replace the loose tiles, the wax seal and any other damaged materials found. The plumber should also repair any other leaks found then, secure the toilet to its piping and the new floor system.

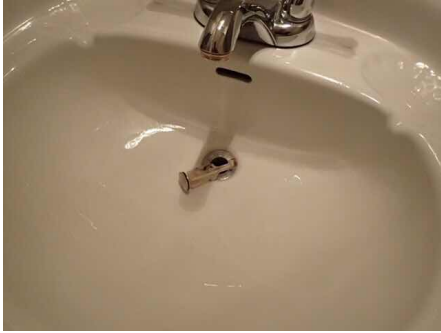
112: - Drain stop was not hooked up:

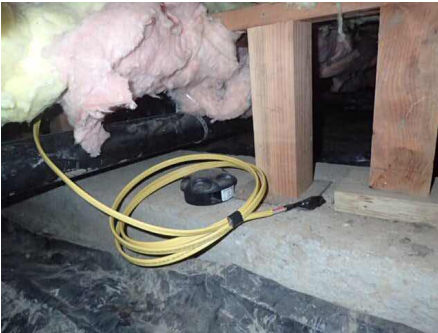
142: - In the crawlspace near the access opening, there is a coil of electrical cable that should be secured into place and the end terminated in a junction box:

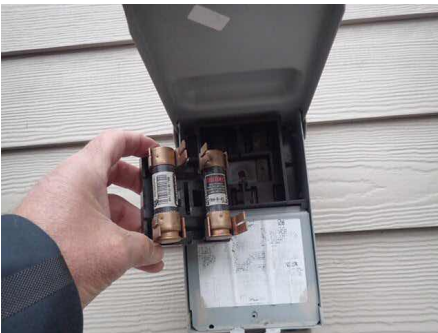
143: - The AC service disconnect panel contains two fuses for the protection of the condenser.

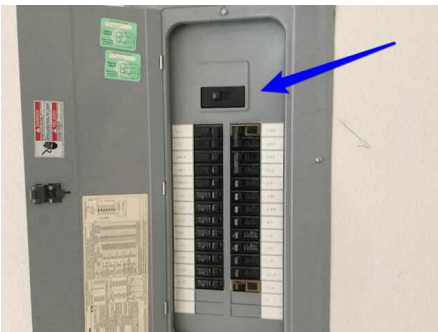
146: - The main service disconnect breaker(s) are located at the meter base / main panel in the garage

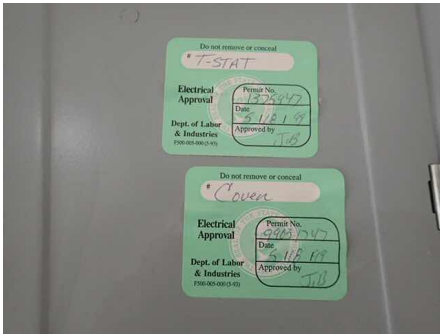
147: - A permit for the service is on the main panel. It is dated 1999,

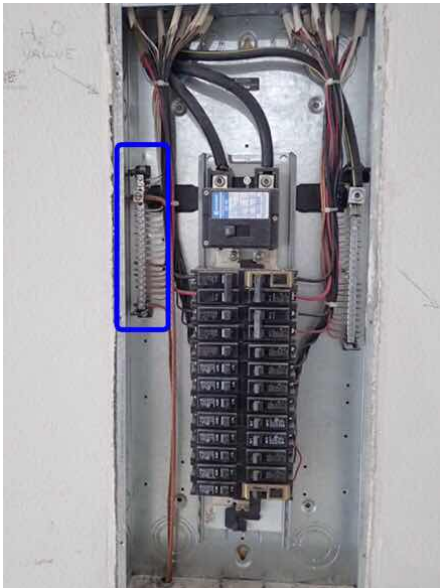
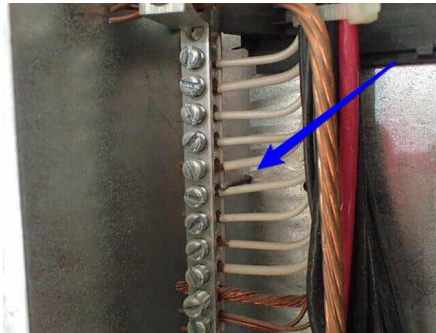
149: - Beside the left bus bar, a nail was driven into the panel. It is resting on a neutral conductor. Have an electrical clip this nail back so it can not come in contact with any electrical conductors or devices in the panel.

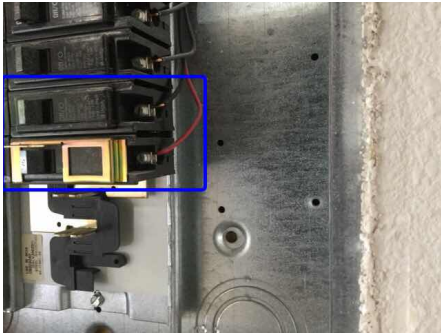
151: - There is one four conductor cables coming into this panel that is going to 120v circuits that does not have a bridge or tie bar on the breaker handles. Have an electrician install a bridge so that if one leg of this cable is trips or turned off, the other leg is also turned off.

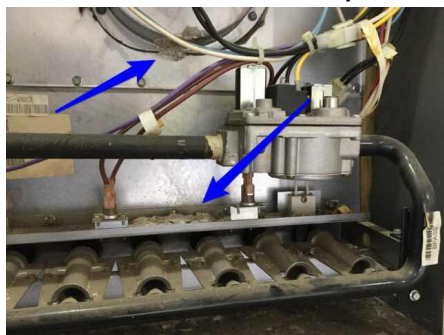
154: - Efflorescent build-up found inside the furnace on and below the draft inducer fan. Have a heating contractor take a look and clean and adjust or replace, the draft inducer fan assembly as needed.

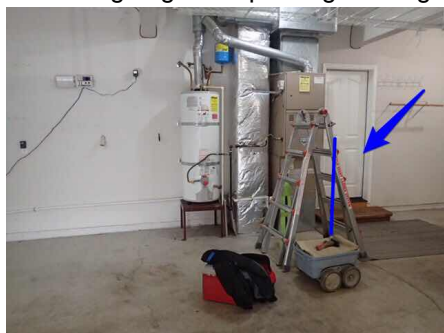
Caut 155: - In the garage, when the gas piping for the furnace is located in a space where a vehicle could hit it, a steel pipe bollard is required to be placed in front of the gas service so a vehicle can not hit the piping or regulator. If cars are going to be parking in the garage, a contractor should install a bollard to protect the gas service.

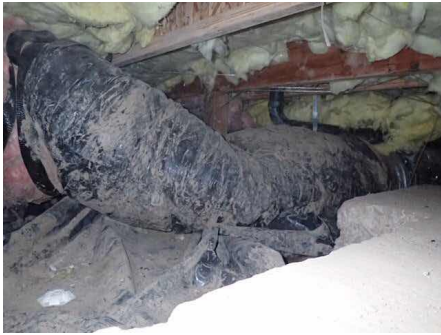
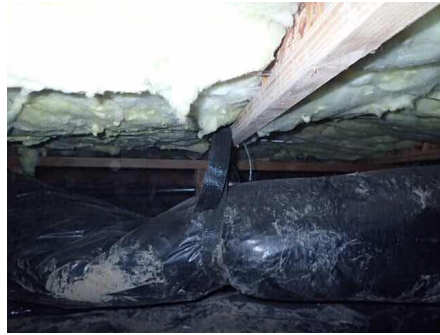
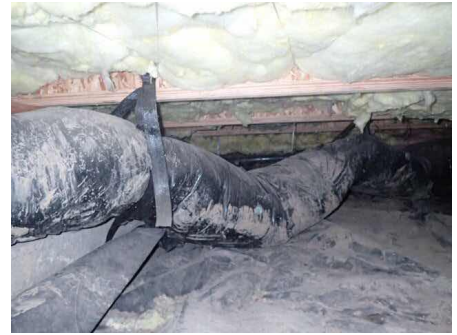
158: - In the crawlspace there are a number of ducts, mainly in the southern areas under the family room and guest bathroom that are crushed and damaged. The air flow through these ducts is poor. Hire a heating contractor to replace the damaged sections of ducting to improve the air flow through the ducts. Some examples are shown below:

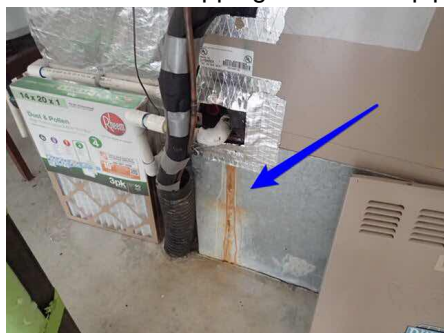
Caut 164: - Stains on the garage floor in the area of the condensate drain may be an indication of current condensate "leaks". Monitor when the AC has been running for a while. Usually, this type of leak is just condensation dripping off the cold pipes and insulating the pipes better is the fix.

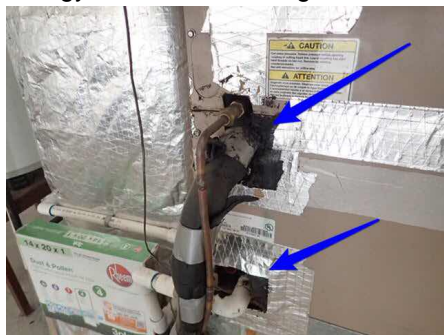
165: - In the jacket of the evaporator, the seals around the pipes are leaking air into the garage. This is a waste of energy. Have the heating contractor seal these openings.

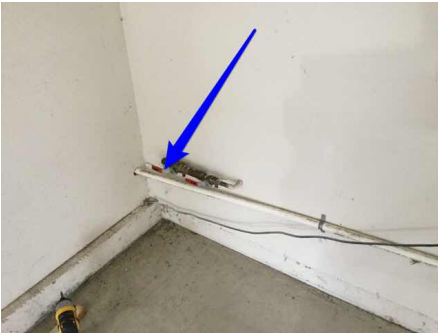
167: - The main water line is made of 1" Copper tubing. The shut-off valve is located in the garage:

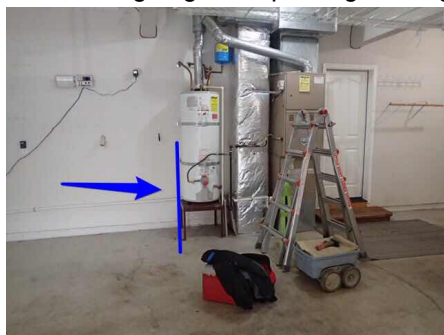
Caut 179: - In the garage, when the gas piping for the water heater is located in a space where a vehicle could hit it, a steel pipe bollard is required to be placed in front of the gas service so a vehicle can not hit the piping or regulator. If cars are going to be parking in the garage, a contractor should install a bollard to protect the gas service.
