AMI ASSOCIATED MASTER INSPECTORS

PROPERTY INSPECTED: 212 S.E. Somewhere St., Portland, Oregon 97214

DATE OF INSPECTION: May 7, 2012

REPORT NUMBER: 120507B7

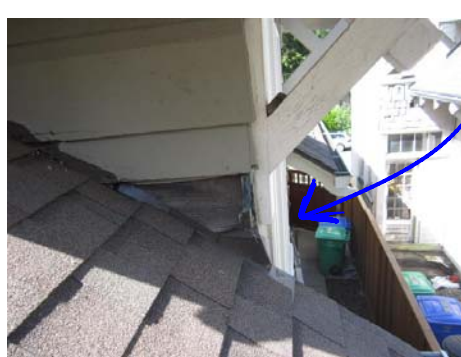
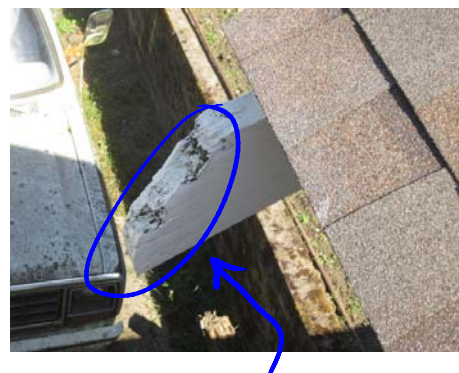
- A. Unless otherwise noted in this report, the exterior components are checked from the ground. These observations are not exhaustive. A board-by-board search of the exterior systems and components was not performed and is beyond the scope of this inspection.
- B. Siding is missing on the SE corner of the east dormer at the roof line:

- C. The north end of the north end rafter on the east dormer has rot in the end of it. I would cut off the rotten section and live with the detail in this rafter. Some of the rafter tails also had varied amounts of decay or damage. They can be cut off also. The best time to replace these decorative details is when the roof is being replaced and the sheathing can be removed and the rafters replaced.

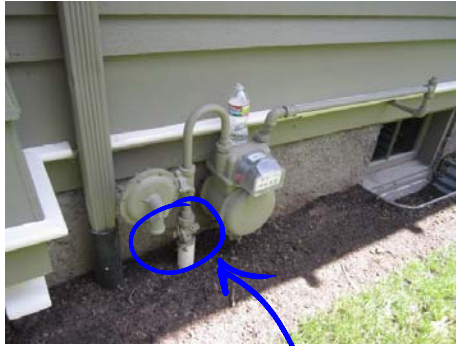
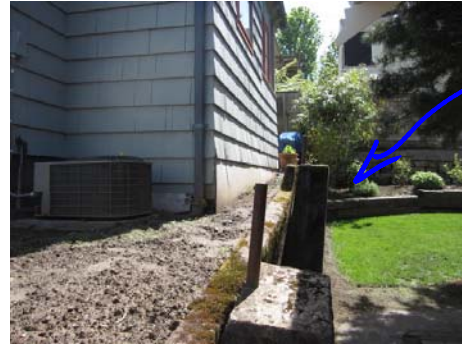
- D. Best to install "Z" flashing over the tops of window and door trim to help keep water out of wall voids. Keep these areas well caulked and sealed until you can get this flashing installed.
- E. The concrete retaining wall between the two properties on the east side of the home is leaning in toward your property. This wall would be considered structurally necessary to hold the western portion of your neighbor's house in place. If the wall continues to move, it will need replacing or some means to hold it in place. I recommend you have a structural engineer or a general contractor who specializes in foundations and retaining wall installations, inspect this wall and give you a budget and some options in case replacement become necessary. I would also fill the gap between the wall and the piers so that further movement can be detected, evaluated and monitored.

- F. There is a main shut-off valve for the gas service to the home located on the pipe coming out of the ground and feeding the gas meter above. When the valve stem is in line with the pipe the gas is on. Turn the stem perpendicular to the pipe to turn the gas off. I recommend you buy a cheap Crescent wrench, about 12" long, at a garage sale before you move in. Adjust the jaws of the wrench to fit onto the gas shut-off stem, then hang the wrench beside the meter so it is easily accessible in case there is an emergency and you need to shut the gas off in a hurry. Show anyone of age, who will be at the home alone, how to do this. Hopefully, you will never have to use this wrench!

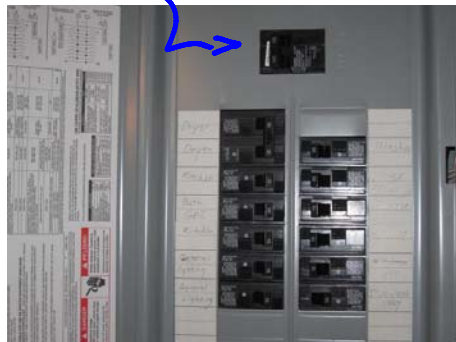
- A. Electrical systems are inspected only in a very limited and general way.
- B. We found no permits for the following work. Verify that permits were obtained and that “Final” approval was granted. Obtain each for the following: Main electrical panel and newer wiring.
- C. Main panel:
 - a. The “Dishwasher” breaker was found in the off position. It was turned on with Noel’s permission.
 - b. Main disconnect breaker:

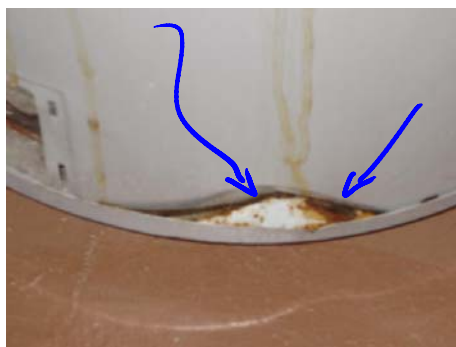
- A. Recommend that you check the temperature of the water heater(s) upon move in to verify they are not set too high for your lifestyle or safety needs. Water heaters set to hot can burn unsuspecting or unknowing users. Elderly and young children are particularly at risk.
- B. The water heater is old. I recommend that you start saving up for a new one and monitor this one on a regular basis. Typically a gas water heater will last about 10-15 years and an electric 15-20 years. This one appears to have been made around 1989.
- C. The water heater is leaking. The insulation found at the bottom of the tank was wet. I did not find any leaks in the pipe connections at the top of the tank. Based on this moisture and the age of the tank, I recommend that the tank be replaced.
