The Importance of Kick-Out Flashing

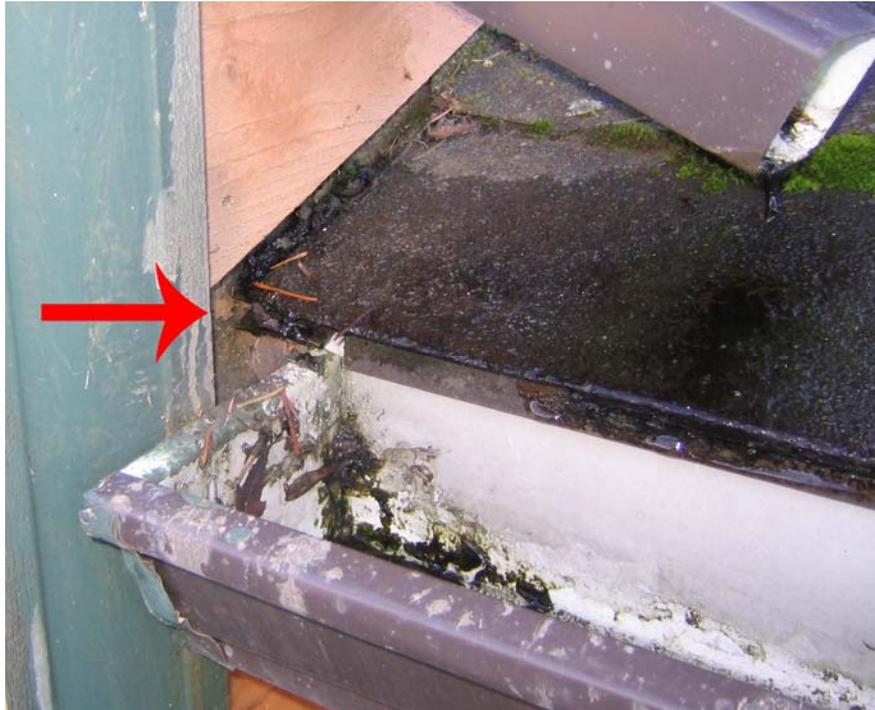
Here is a picture of inadequate kick-out flashing. Notice the gaps where water runs down the wall.

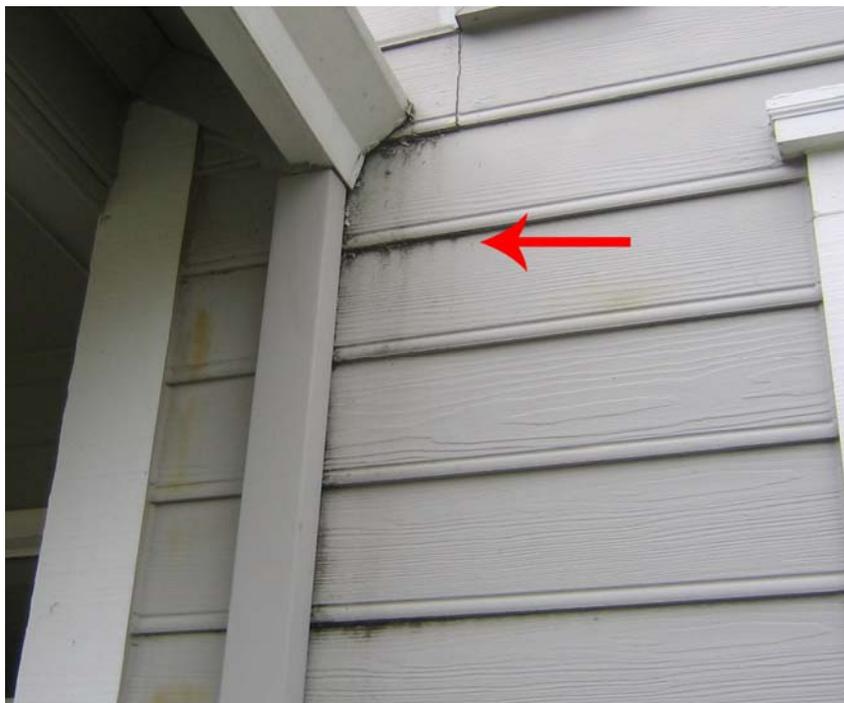
Here are some other telltale signs that kick-out flashing is either missing or improperly installed. Note the stains on the siding.

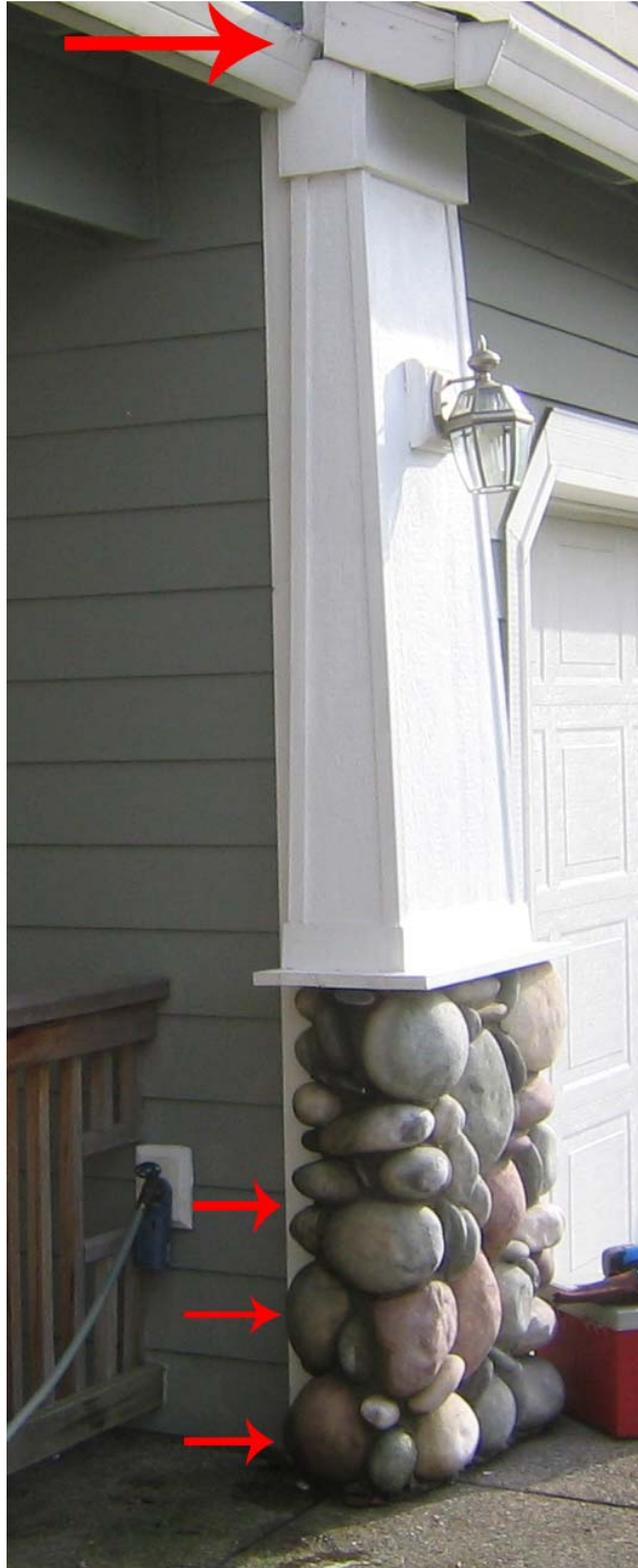
In this photo, you can see where water is coming out from behind the siding. Imagine the implications if this is not corrected.

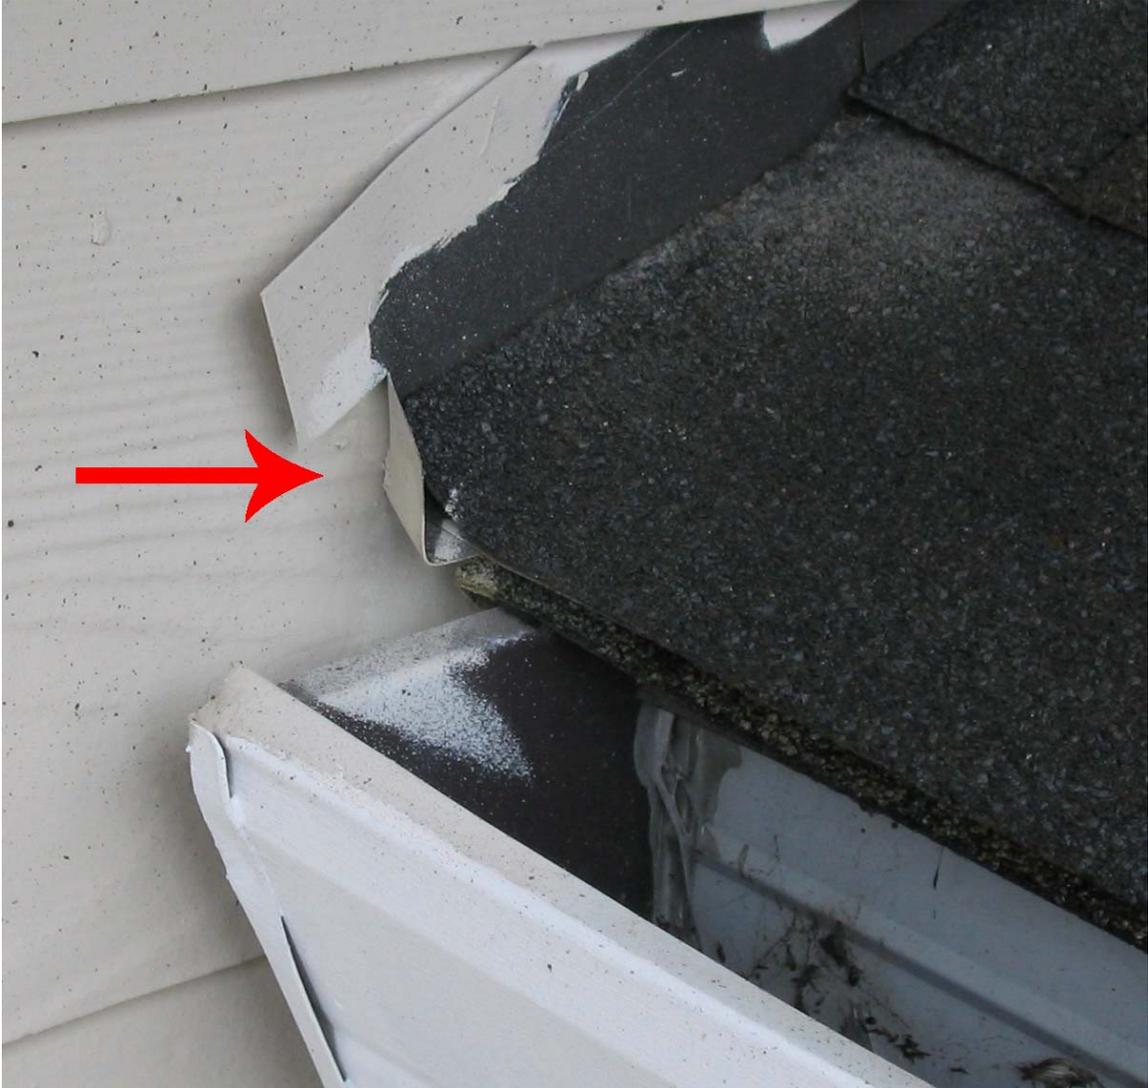
This photo shows an attempt to use proper diverter flashing but it is not extended far enough past the roof edge to allow water to get into the gutter:
