Customer: **Paul Homebuyer**
Property Inspected: **3307 NW Frank St. , Portland, OR 97200**
Date of Inspection: **3-3-08**
Inspector: **Mark Lindgren** OCHI # 059 Wash. SPI # 67121 ASHI# 205164

ASSOCIATED MASTER INSPECTORS, LLC
P.O. BOX 230966
Tigard, OR 97281
OFFICE (503) 236-1812 FAX (503) 244-1297 HOME (503) 245-4784

Client / Inspection Information

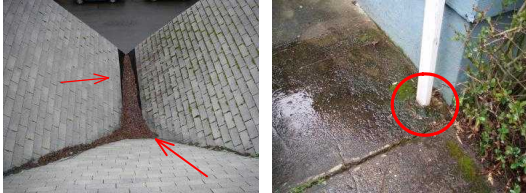
8. Flat roof Roof Flat roof Covering: The roof is older but appears in serviceable condition other than the comments above and below. Some ponding noted. Debris buildup. The roof is not sloped to drain fully, Improperly Installed.
