Physical Inspection of 123 Sample Street

Monday, September 13, 2010

Report Number: 100913P

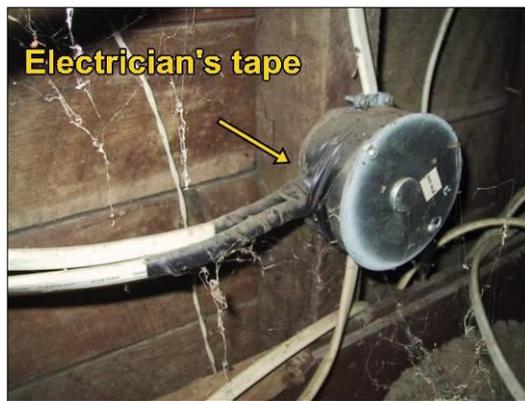
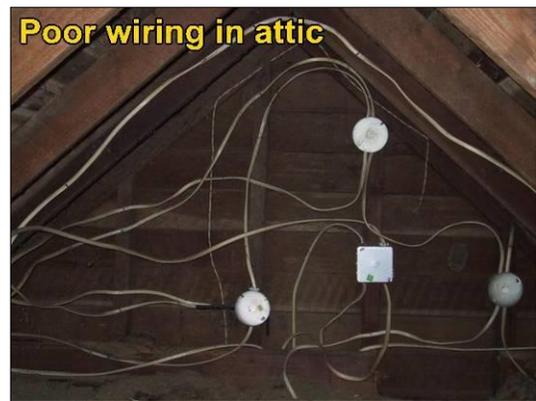
In the upper attic, there's a jumble of poorly installed NM cable. I see poorly protected cables and cables not properly secured. At one box at the north side, I see open knockouts & electrical tape used in lieu of clamps.

9. Hire an electrician to clean up the poor wiring in the attic.

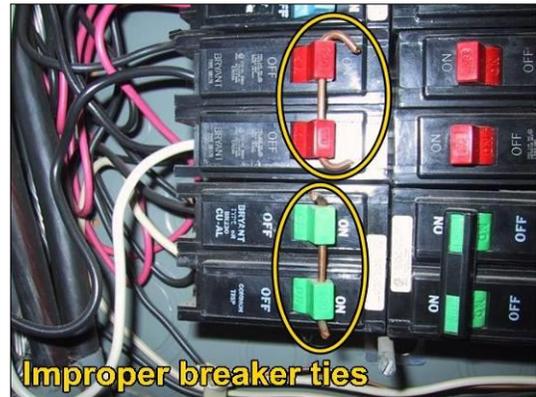
In the service panel, two 240-volt circuits (one for the water heater and one for an electric heating circuit) are each protected by a pair of single-pole circuit breakers that are joined with improvised breaker ties made from short lengths of #12 copper wires. While this was commonly done, it has always been wrong. These ties might allow only one breaker to be switched off while the other remains energized. Sometimes, when this happens, the breaker handle snaps from the stress. This could be dangerous.

14. Ask your electrician to ensure that all of the 240-volt circuits have proper breaker ties that are listed for use with those breakers.

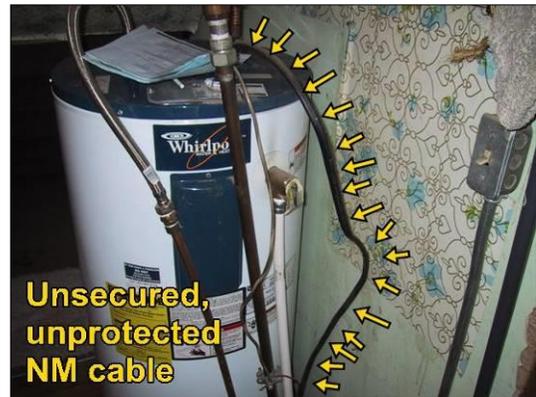
The water heater's power cable is not supported or protected and it isn't secured within 12" of the water heater as it should be. The simplest solution to this issue is usually to run it through flexible conduit.

16. Ask your electrician to provide physical protection to the water heater's NM cable.

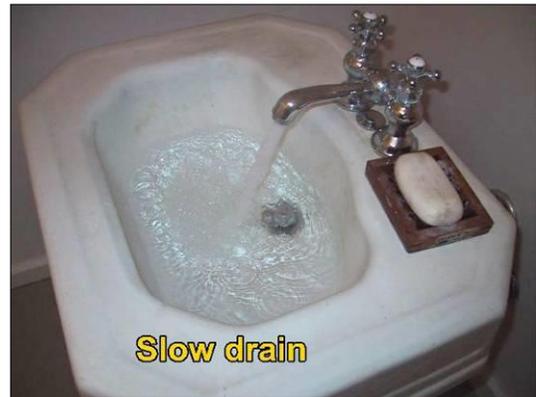
At both bathrooms, the lavatory drains are slow. They can't keep up with the flow from the faucets.

- 29. Clear the slow drains at the bathroom sinks.**

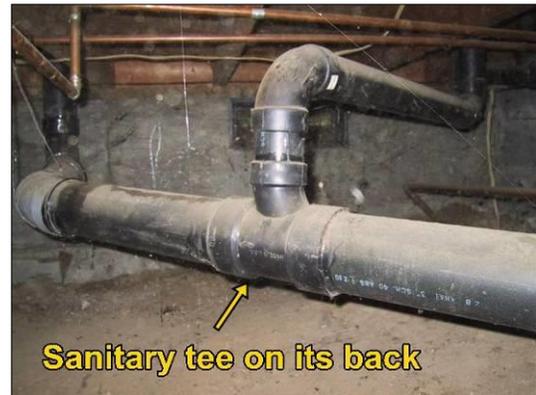
In the crawlspace under the kitchen & bathroom, the shower drainpipe joins the main drainpipe via a sanitary tee that's placed on its back. This is a classic amateur plumbing error. Sanitary tees are vent fittings; they don't have enough of a sweep to direct the wastewater in the proper path without slowing its velocity. The installer should have used a wye or a combo fitting in this location.³ The use of a sanitary tee might cause the waste pipe to drain poorly.

- 34. Have your plumber review the waste plumbing under the kitchen & bathroom and install proper fittings where necessary. In particular, remove the sanitary tee that's on its back and replace it with a proper wye or combo fitting.**

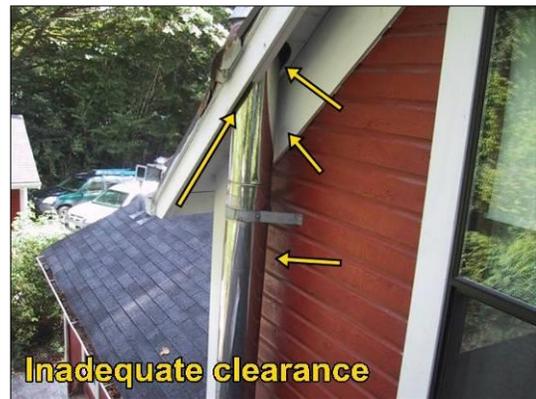
Inadequate Clearance at Wood Stove Vent

If the existing wood stove vent is an A-vent, then it lacks proper clearance to combustible surfaces at the side of the house and at the point where it passes through the roof. A-vents require 2" clearance to any combustible surface. This vent is slightly less than 2" from the building's siding. It's only $\frac{3}{4}$ " away from the frieze trim, and $\frac{5}{8}$ " away from the barge rafter & roof sheathing. During normal operation, the clearance around this vent is not important, but if there were to be a chimney fire, the clearance would become critical and might make the difference between containing the fire and allowing it to spread to the rest of the house.

- 43. Create proper clearance around the woodstove vent.**

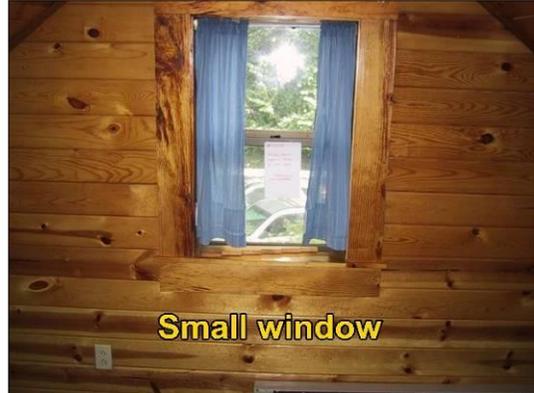
At the east bedroom, the window is too small to meet the standards for an emergency escape & rescue opening. During an emergency, this makes it more difficult for you to get out and for firemen to get in. Modern bedroom windows should be no more than 44” off the floor, no less than 20” wide, and have an openable area of not less than 5.7 square feet. If you ever decide to replace the window in this bedroom, consider installing larger egress windows at that time. In the meantime, understand the egress limitations in the house.

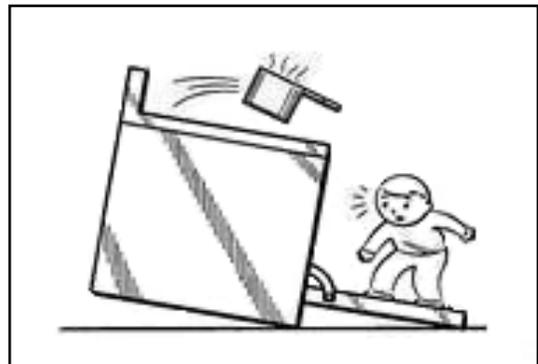
At the kitchen range, the anti-tip bracket is not installed. If you open the oven door and apply pressure to it, the range could tip forward and fall or spill the contents of hot pans on you.

54. Install the kitchen range's anti-tip bracket as required by the manufacturer.

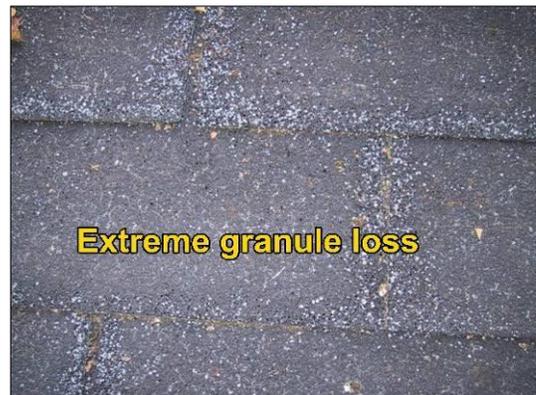
At the lower north roof sections, the shingles are exceptionally brittle and have suffered extreme granule loss, possibly as a result of aggressive power washing. These shingles are no longer serviceable.

55. Replace the shingles on the lower roof.

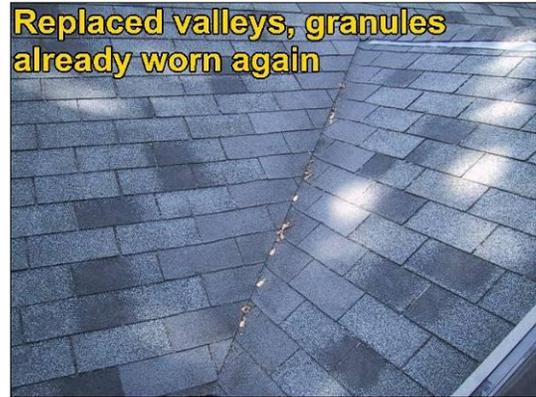
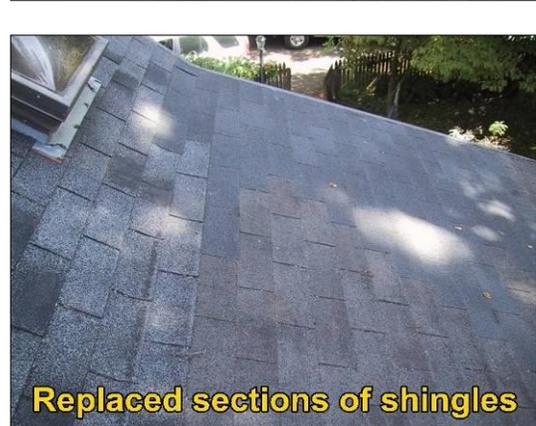
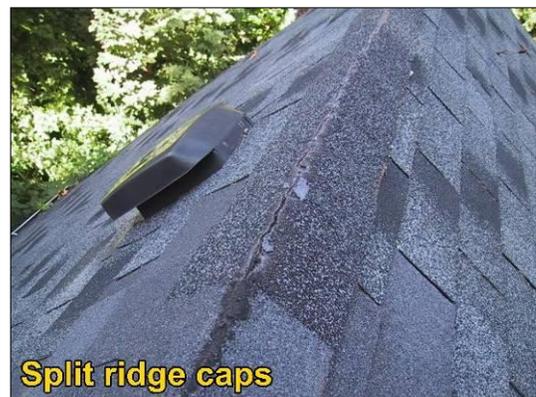
The upper roof shingles are not as brittle as the lower roof shingles but they still suffer from granule loss in some areas and they were poorly installed.

This roof is unreliable.

56. Replace the upper roof.

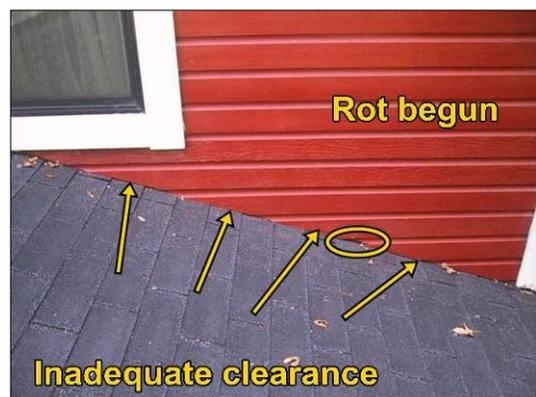
Where the roof surfaces meet the house sidewalls, there's inadequate clearance between the siding and the roof shingles. There should be 1" – 2" of clearance in these locations. Instead there's no clearance in places. This allows the siding to wick moisture up from the roof. In some places, the siding has begun to rot.

57. Create 1"-2" clearance between the siding and the roof at the sidewall joints.

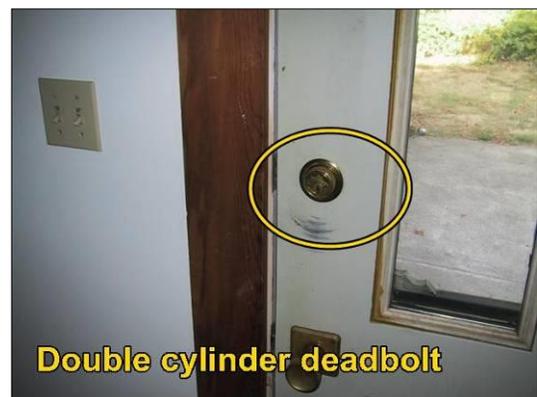
The north door is fitted with a double cylinder dead bolt. You'll need a key to get out of the house through this door. This is dangerous. If there's an emergency, you could be trapped in the house. All exterior exit doors are supposed to be able to be opened without the need for a key or any special tool.⁶

60. Install a thumb latch on the interior side of the north door's deadbolt.

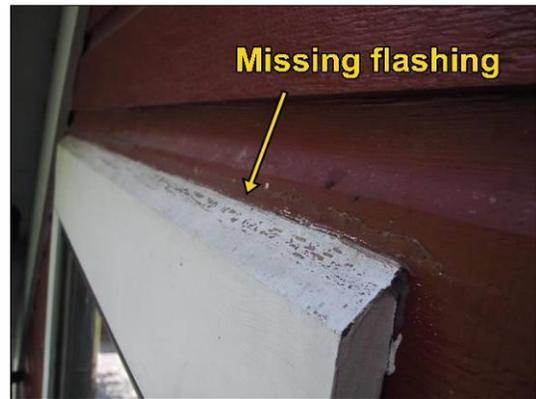
All projecting wood trim should be flashed.⁷ There's no flashing above the projecting wood trim at most of the window & door trim. These areas are caulked instead. Caulk fails over time.

- 61. Properly flash all projecting wood trim. If you choose to ignore this recommendation, establish a maintenance schedule to inspect the caulk above this trim every fall and replace the caulk as necessary.**

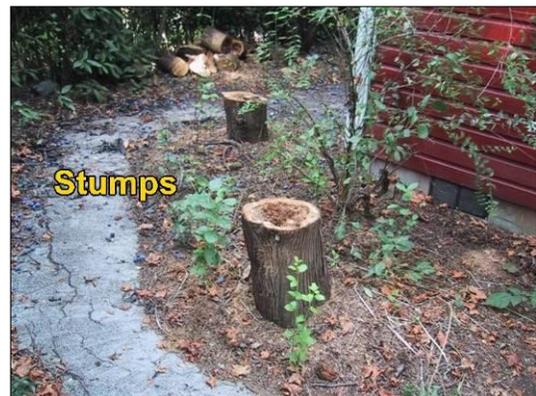
At the southwest yard are two tree stumps. These will become an attractive habitat for wood destroying insects. It's best to keep this kind of insect attraction away from the house.

- 63. Remove the tree stumps at the southwest yard.**

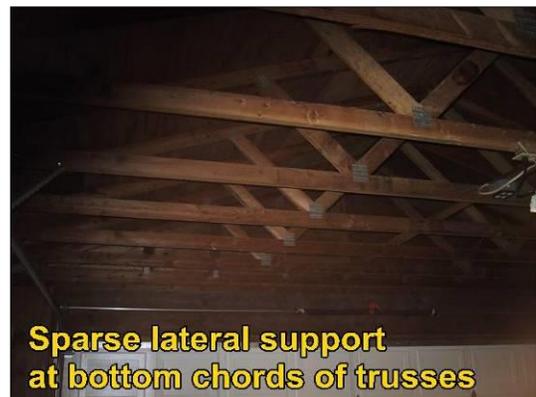
The roof trusses have only one lateral brace running down the center of the lower chords. There's a risk that, if the trusses are loaded close to their capacity, that the lower chords could deform and cause the trusses to collapse.

65. Have a contractor install additional lateral bracing at the garage roof trusses' bottom chords.
