# INSPECTION REPORT

**PROPERTY ADDRESS:** 835 SE Klickitat Ave, Portland, OR 97213

**INSPECTION REPORT ID:** 2441

**DATE AND TIME OF INSPECTION:** 10/17/2017, 08:45 AM - 02:00 PM

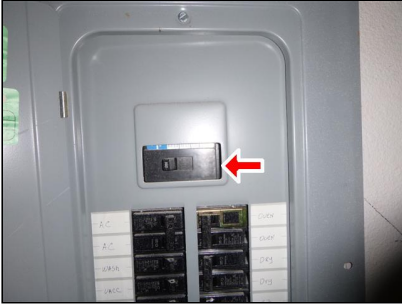
11.0 (Picture 1)

The main electrical shut-off for the home is located in the service panel located in the garage (Picture 1). This is for your information.

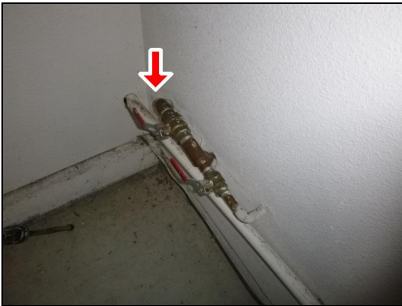
11.1 (Picture 1)

The main shut off is the valve located in the garage (Picture 1). This is for your information.

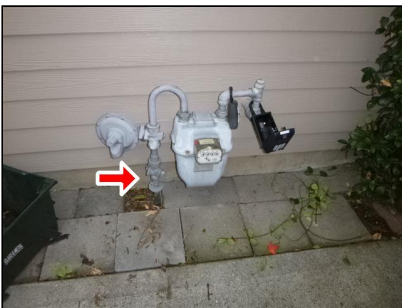
11.2 (Picture 1)

The main fuel shut off is located at the meter outside the home at the SW corner of the home (Picture 1). A wrench or pliers will be needed to turn the gas off.

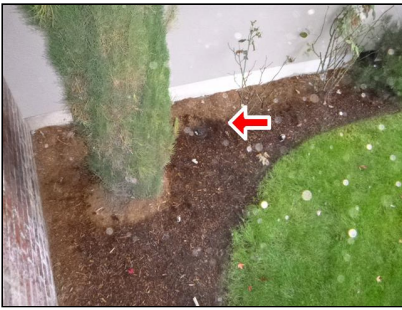
11.3 (Picture 1)

The sewer cleanout is located at the east side of the home (Picture 1). This is for your information.

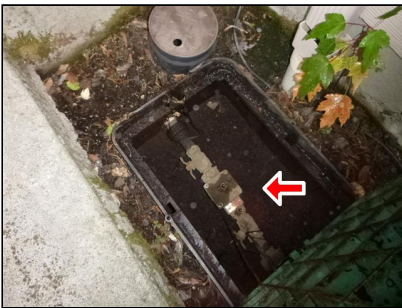
11.4 (Picture 1)

A back-flow prevention device is present for the irrigation system at the back of the home (Picture 1). This device will need to be certified annually. This is for your information.
