# Physical Inspection of 835 SE Klickitat Street

*Tuesday, October 17, 2017*

*Report Number: 171017A*

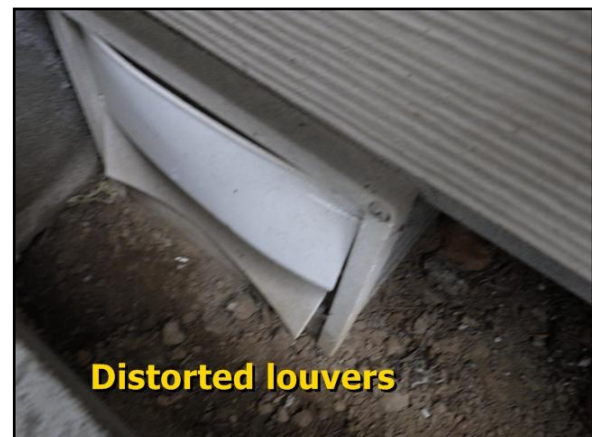
The downdraft fan's terminal is blocked by soil at the bottom and its plastic louvers are distorted.

- 37. Install a new outdoor terminal at the range's downdraft fan duct. Ensure that the new terminal operates freely without binding or sticking.**

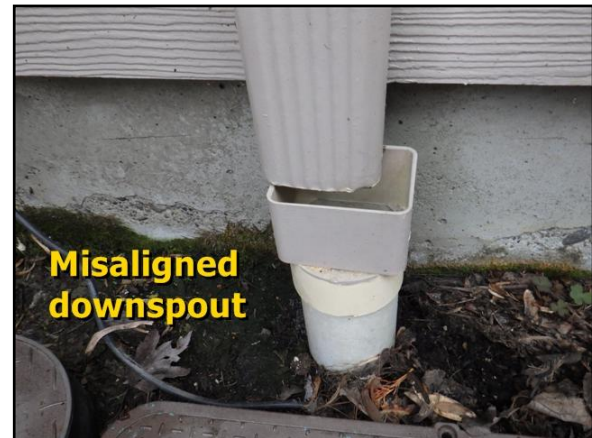
At the northwest corner of the garage, the downspout doesn't fully align with its underground drain pipe. Some of its water spills on the ground right next to the foundation.

- 55. Align the garage's northwest downspout with its underground drainpipe.**
